<p>D & D ENGINEERING, INC. 8901 S. LA CIENEGA BLVD, SUITE 106 INGLEWOOD, CA 90301 Phone: 424-393-4122</p>	PROJECT CONDOR	SCALE: AS SHOWN
	PERIMETER CONDITIONS EXHIBIT	DATE: 2017/10/24
		SHT NO.: 01 OF 01

PHOTO KEY MAP

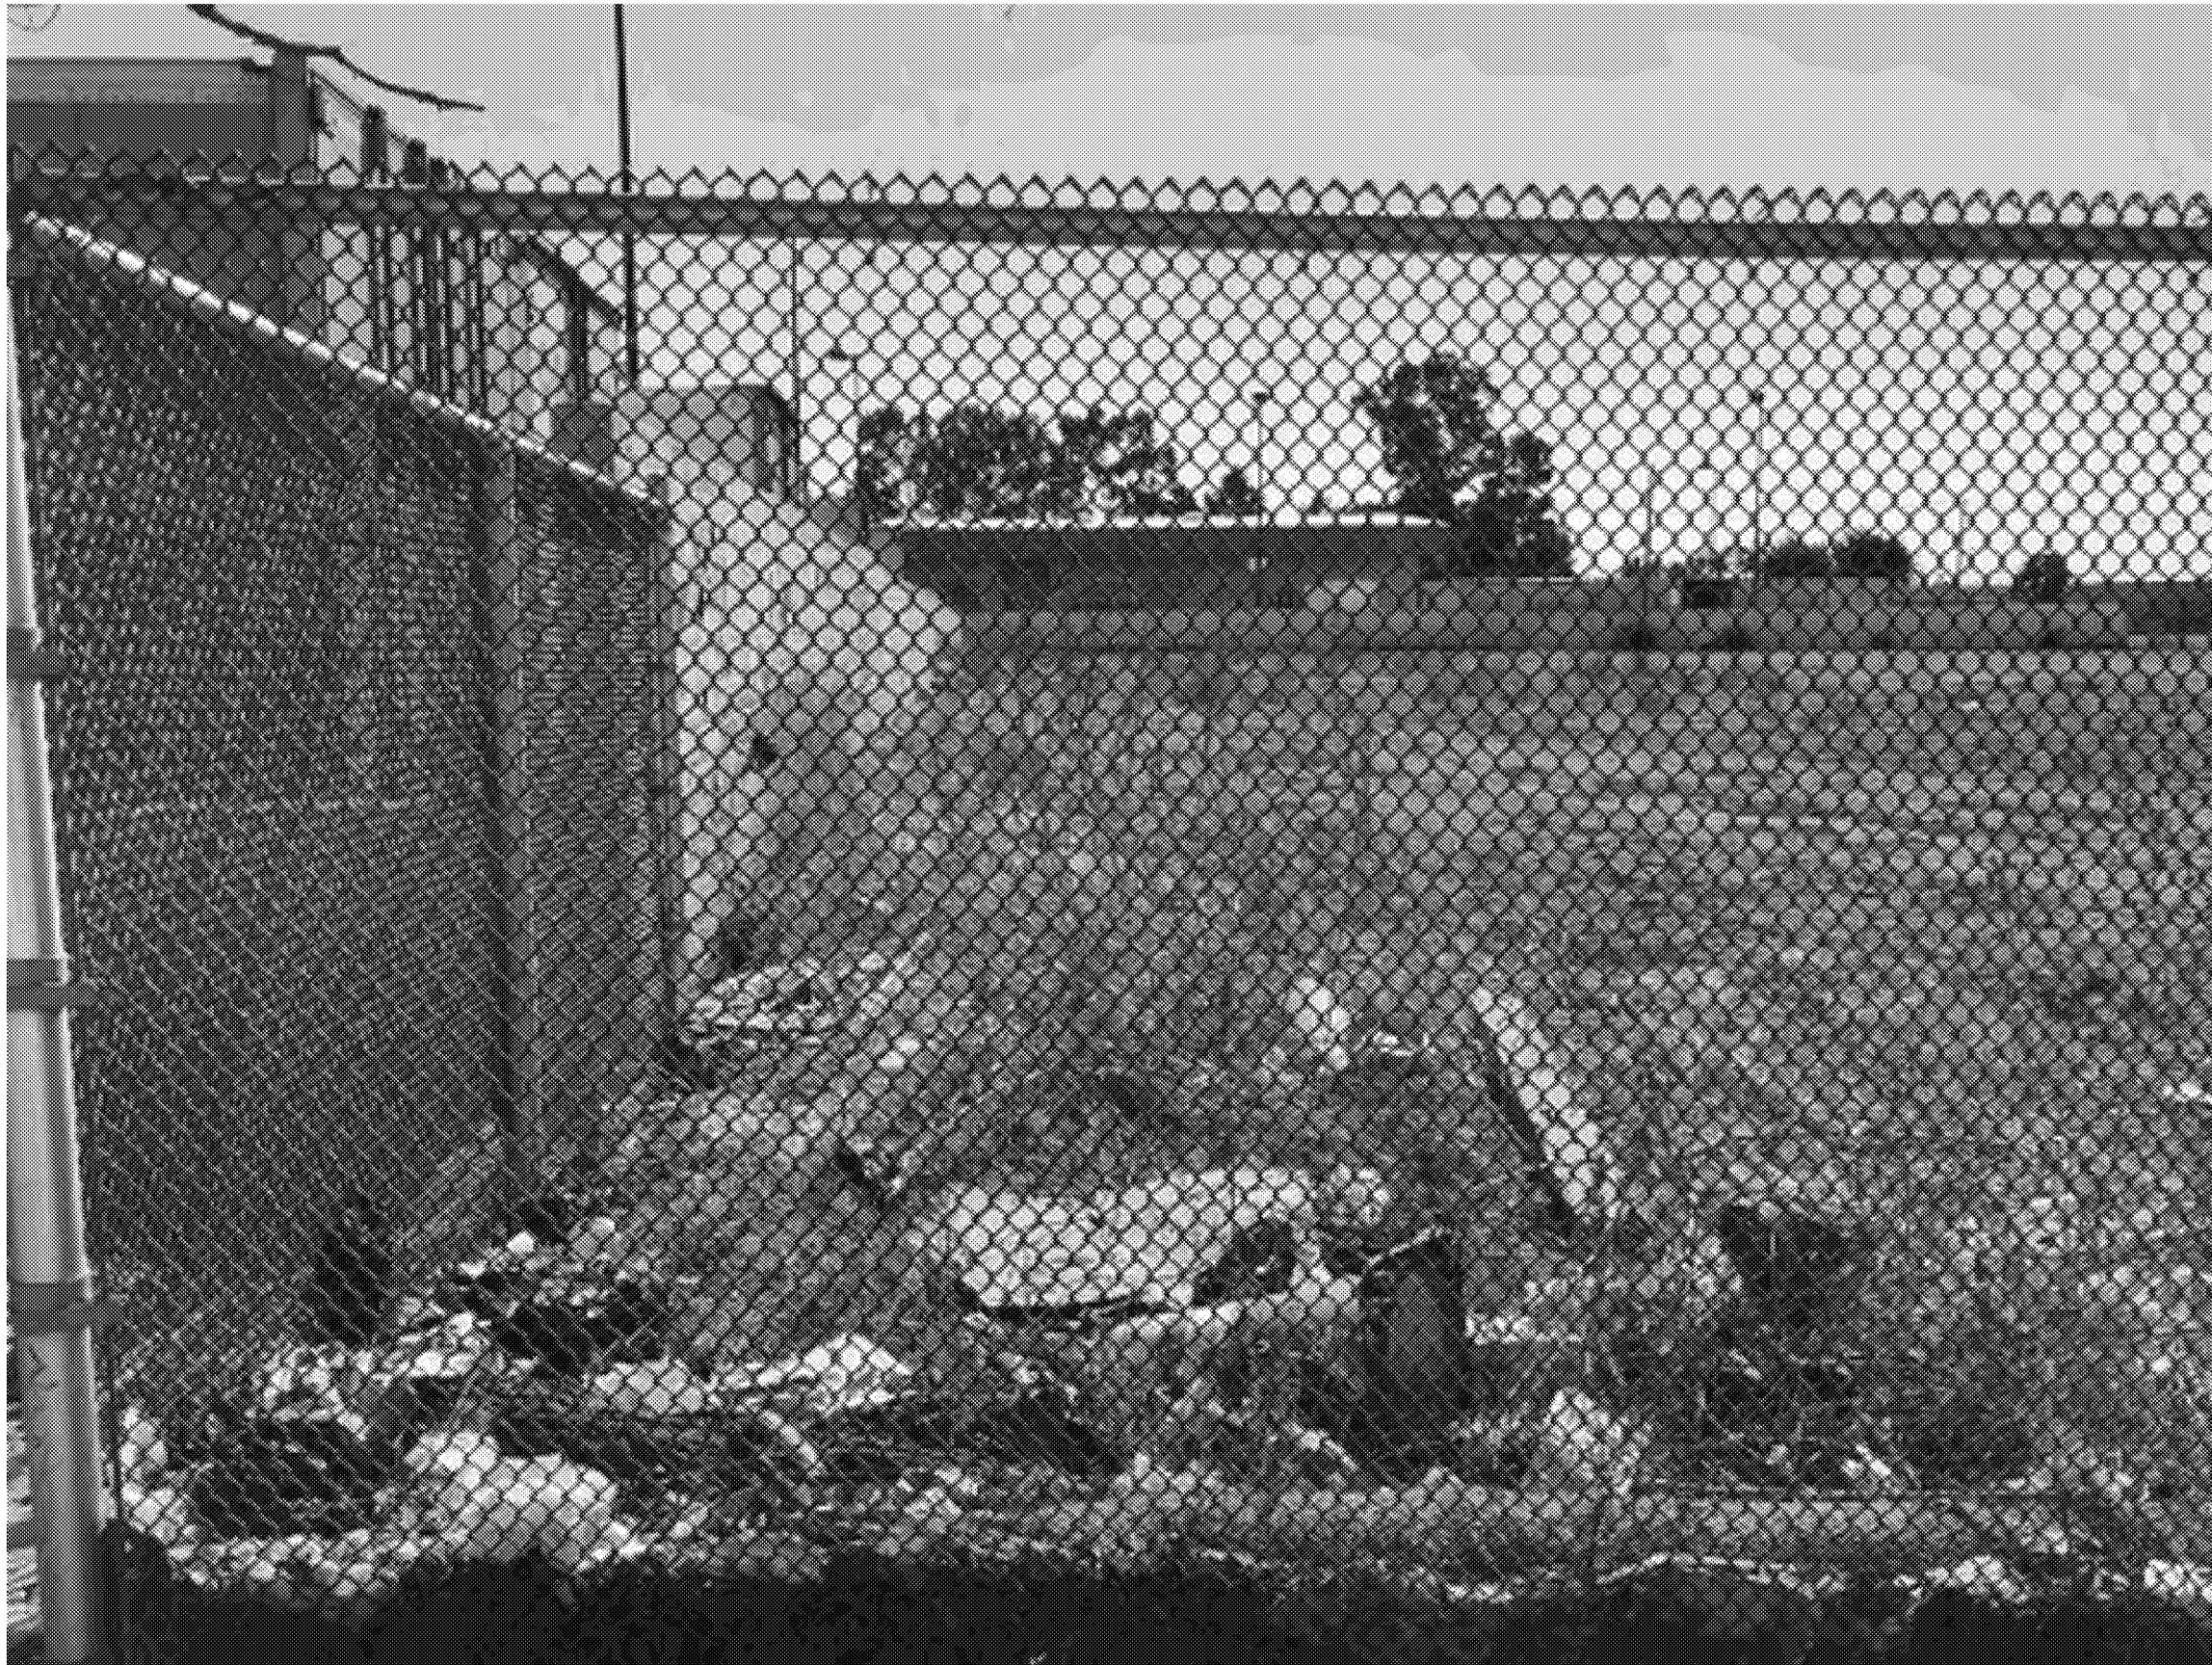
1

SOUTHBOUND VIEW FROM NORTHEAST
CORNER OF PARCEL, ALONG CENTURY

SITE SURROUNDED BY CHAIN LINK
FENCE, CMU WALLS AND A WROUGHT
IRON FENCE WITH PILLASTERS ON

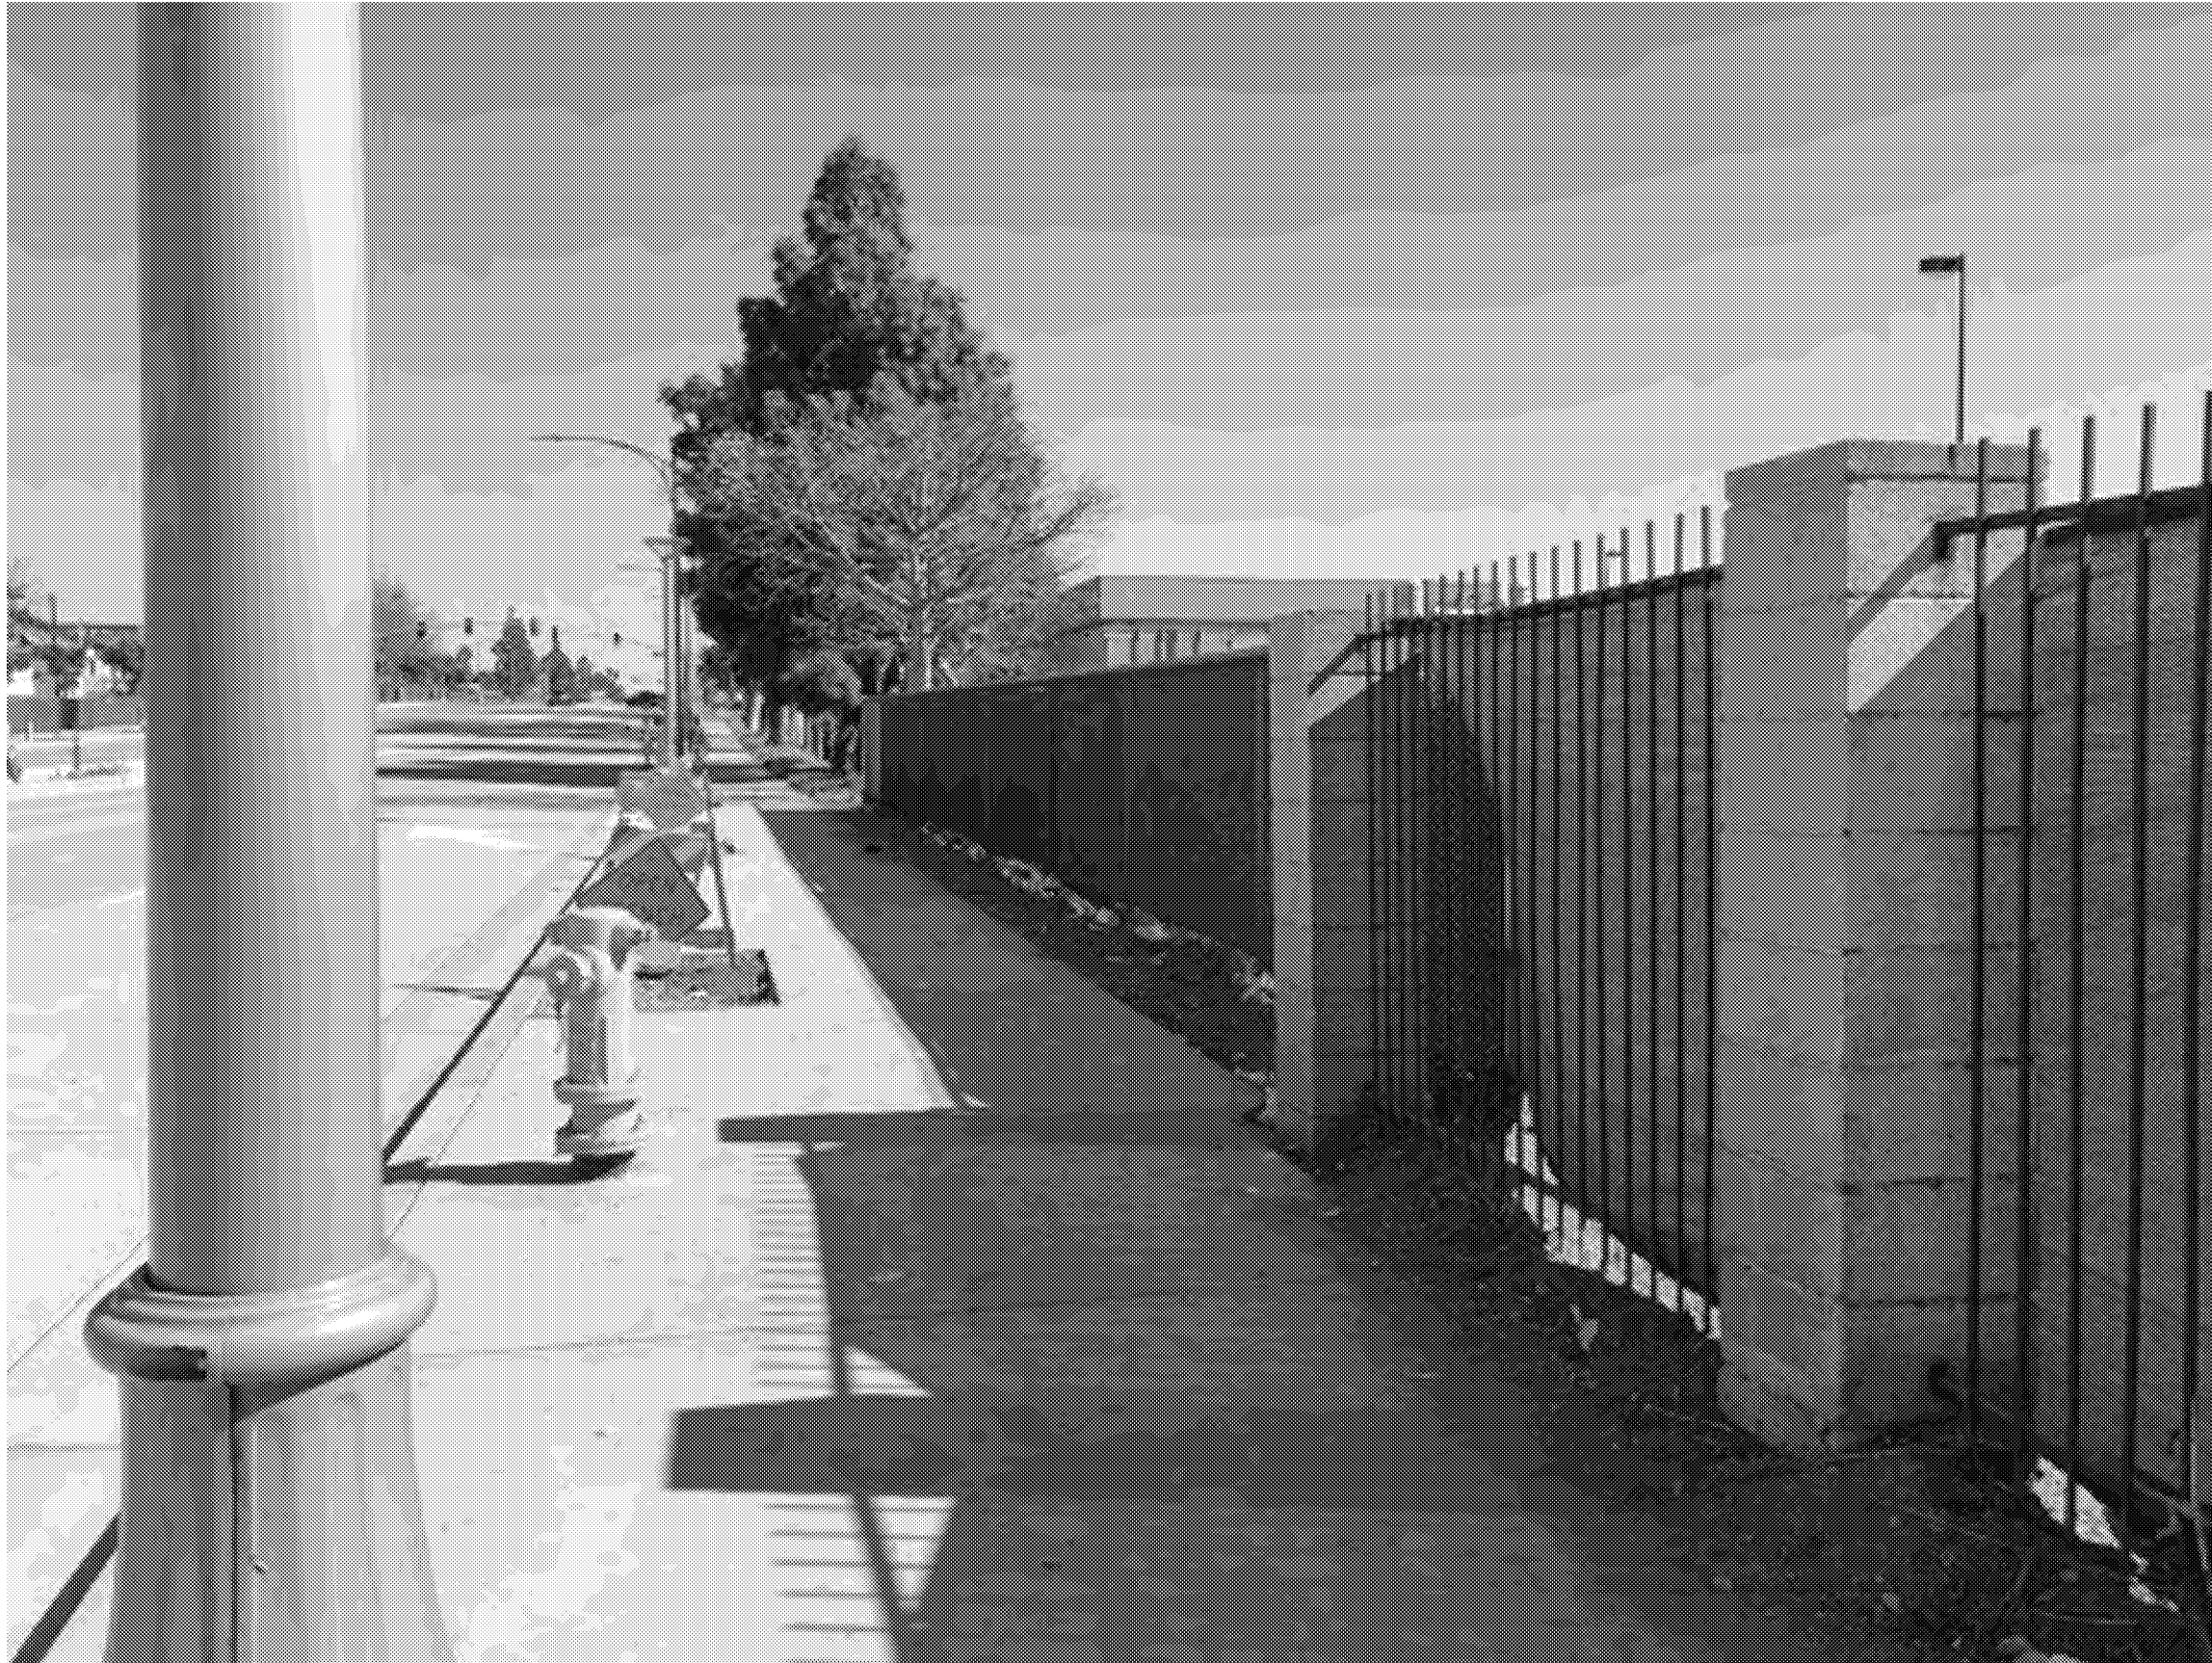
2

SOUTHEAST VIEW FROM MIDDLE OF
PARCEL ALONG CENTURY

SITE SURROUNDED BY CHAIN LINK
FENCE, CMU WALLS AND A WROUGHT
IRON FENCE WITH PILLASTERS ON

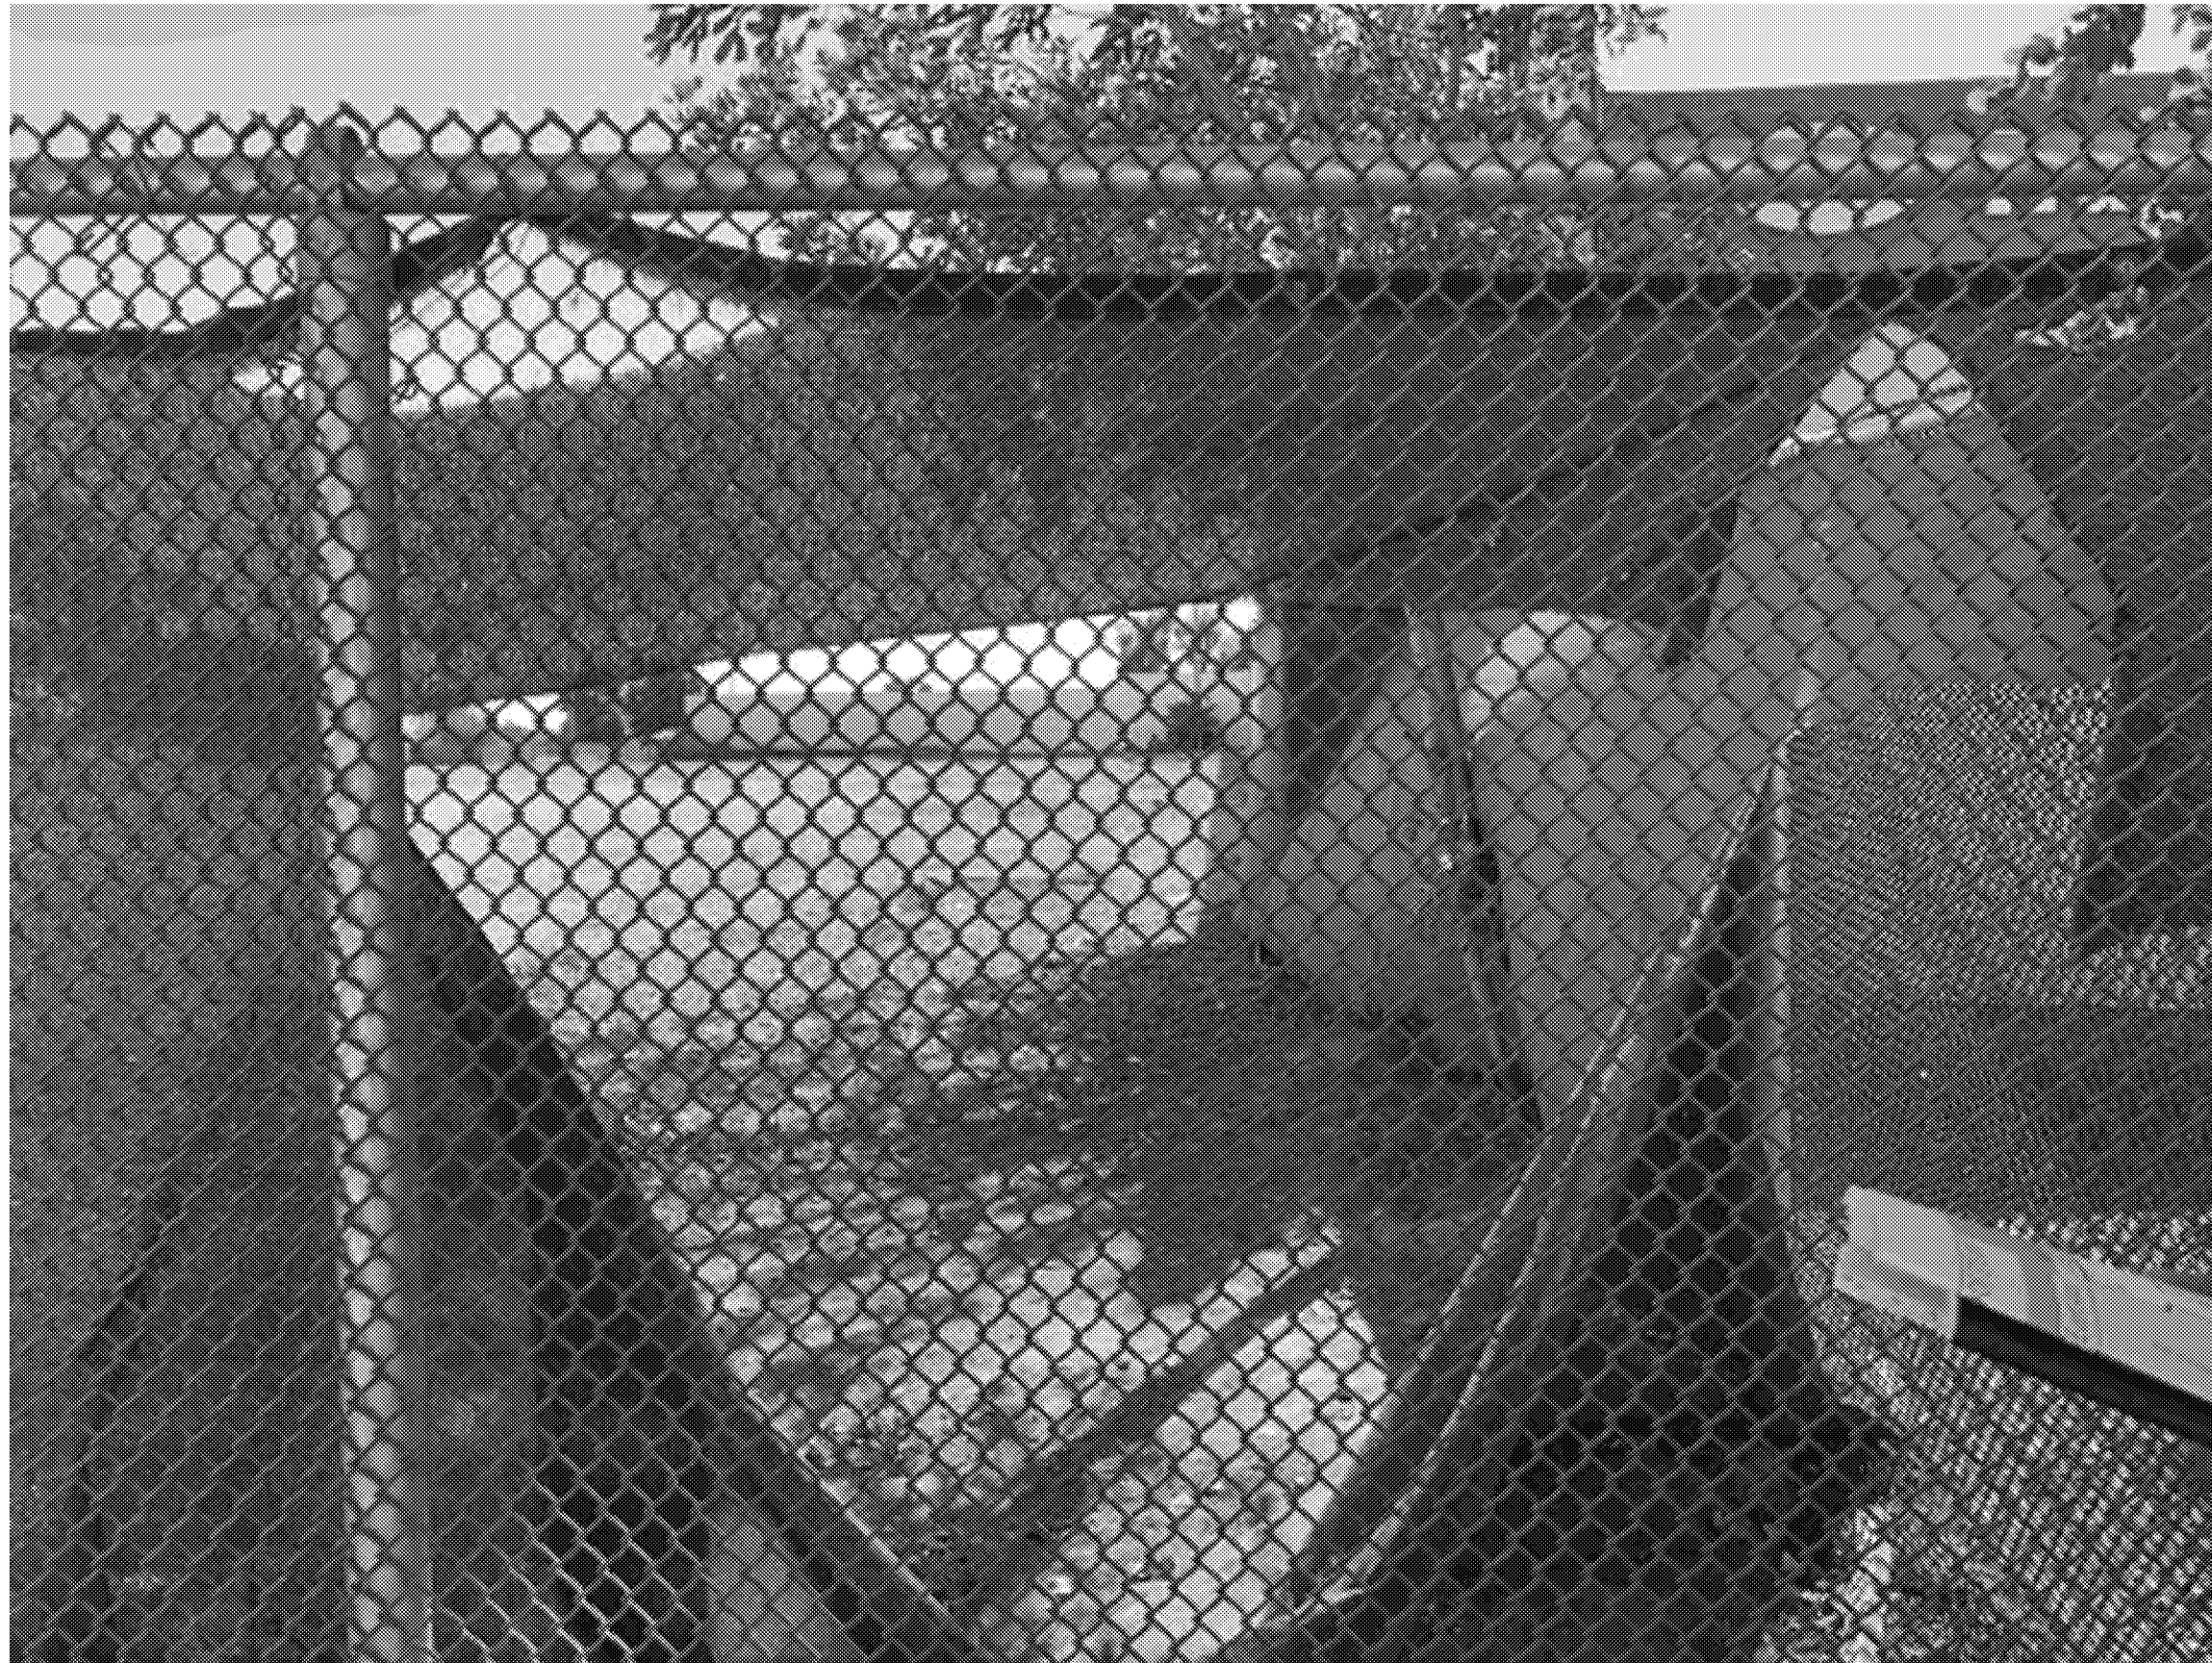
3

SOUTHBOUND VIEW FROM NORTHWEST CORNER OF PARCEL, ALONG CENTURY

SITE SURROUNDED BY CHAIN LINK FENCE, CMU WALLS AND A WROUGHT IRON FENCE WITH PILLASTERS ON

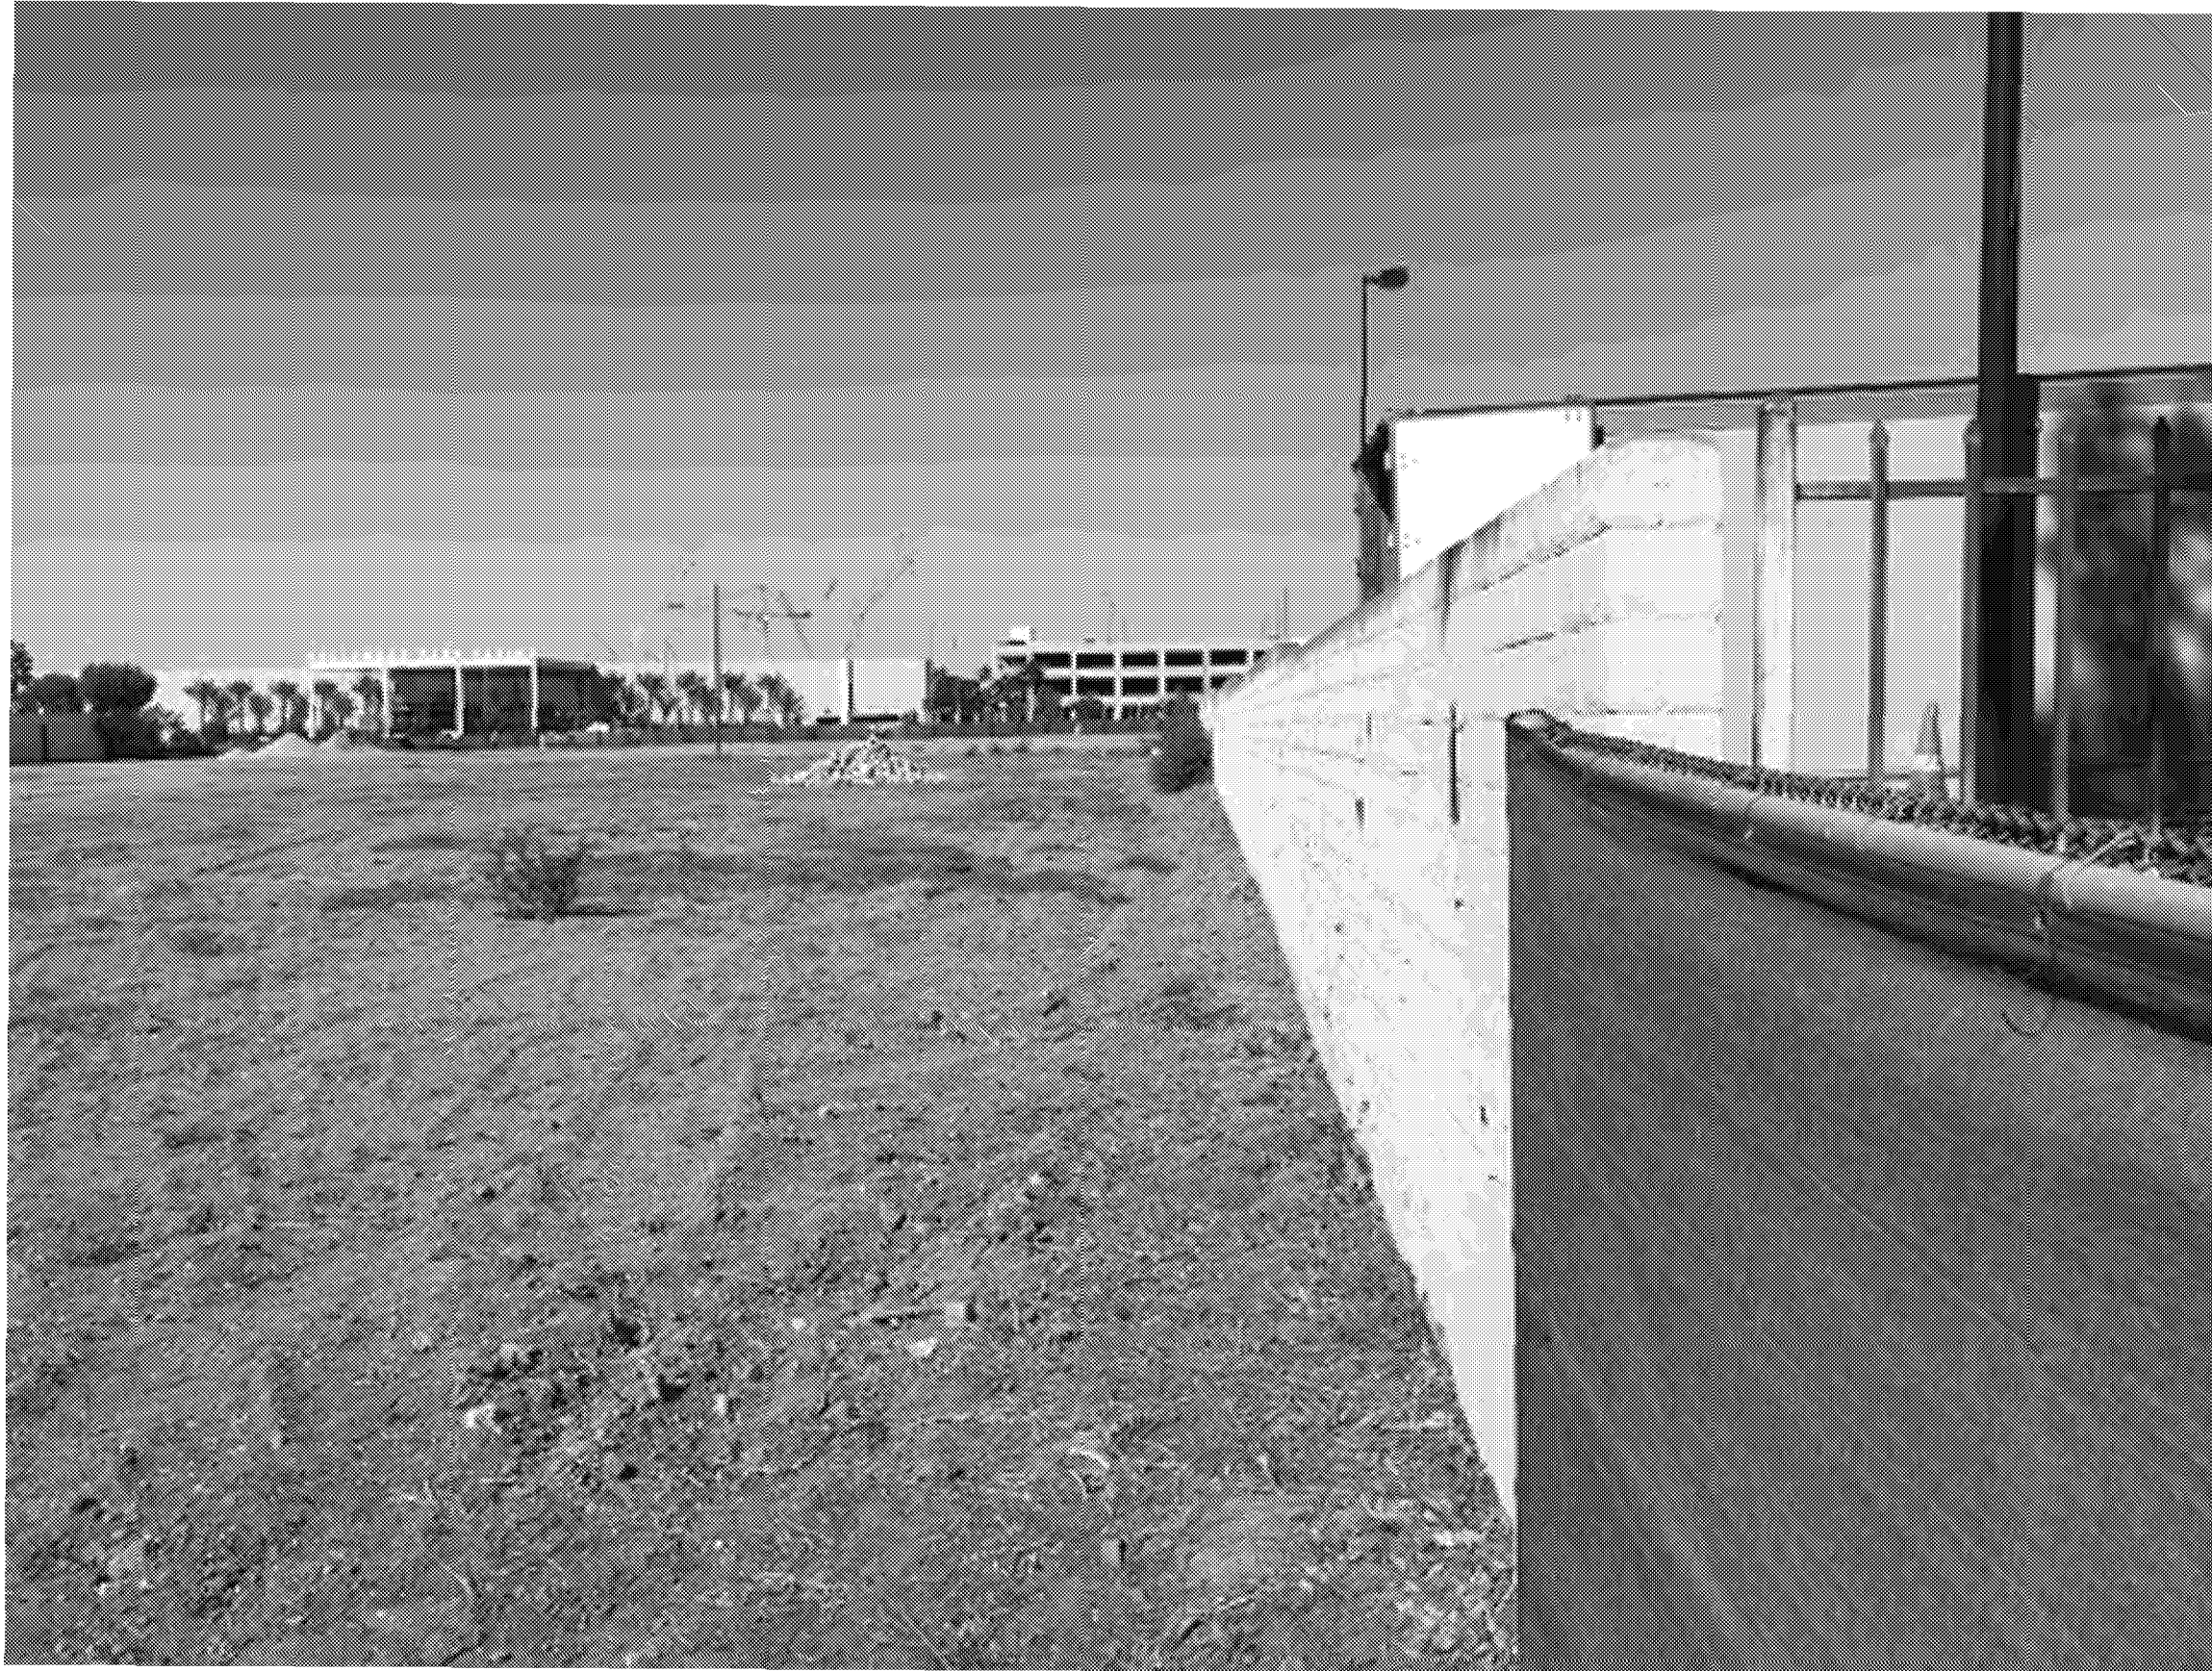
4

NORTHBOUND VIEW FROM SOUTHEAST
CORNER OF PARCEL, ALONG 102ND

SITE SURROUNDED BY CHAIN LINK
FENCE, CMU WALLS AND A WROUGHT
IRON FENCE WITH PILLASTERS ON

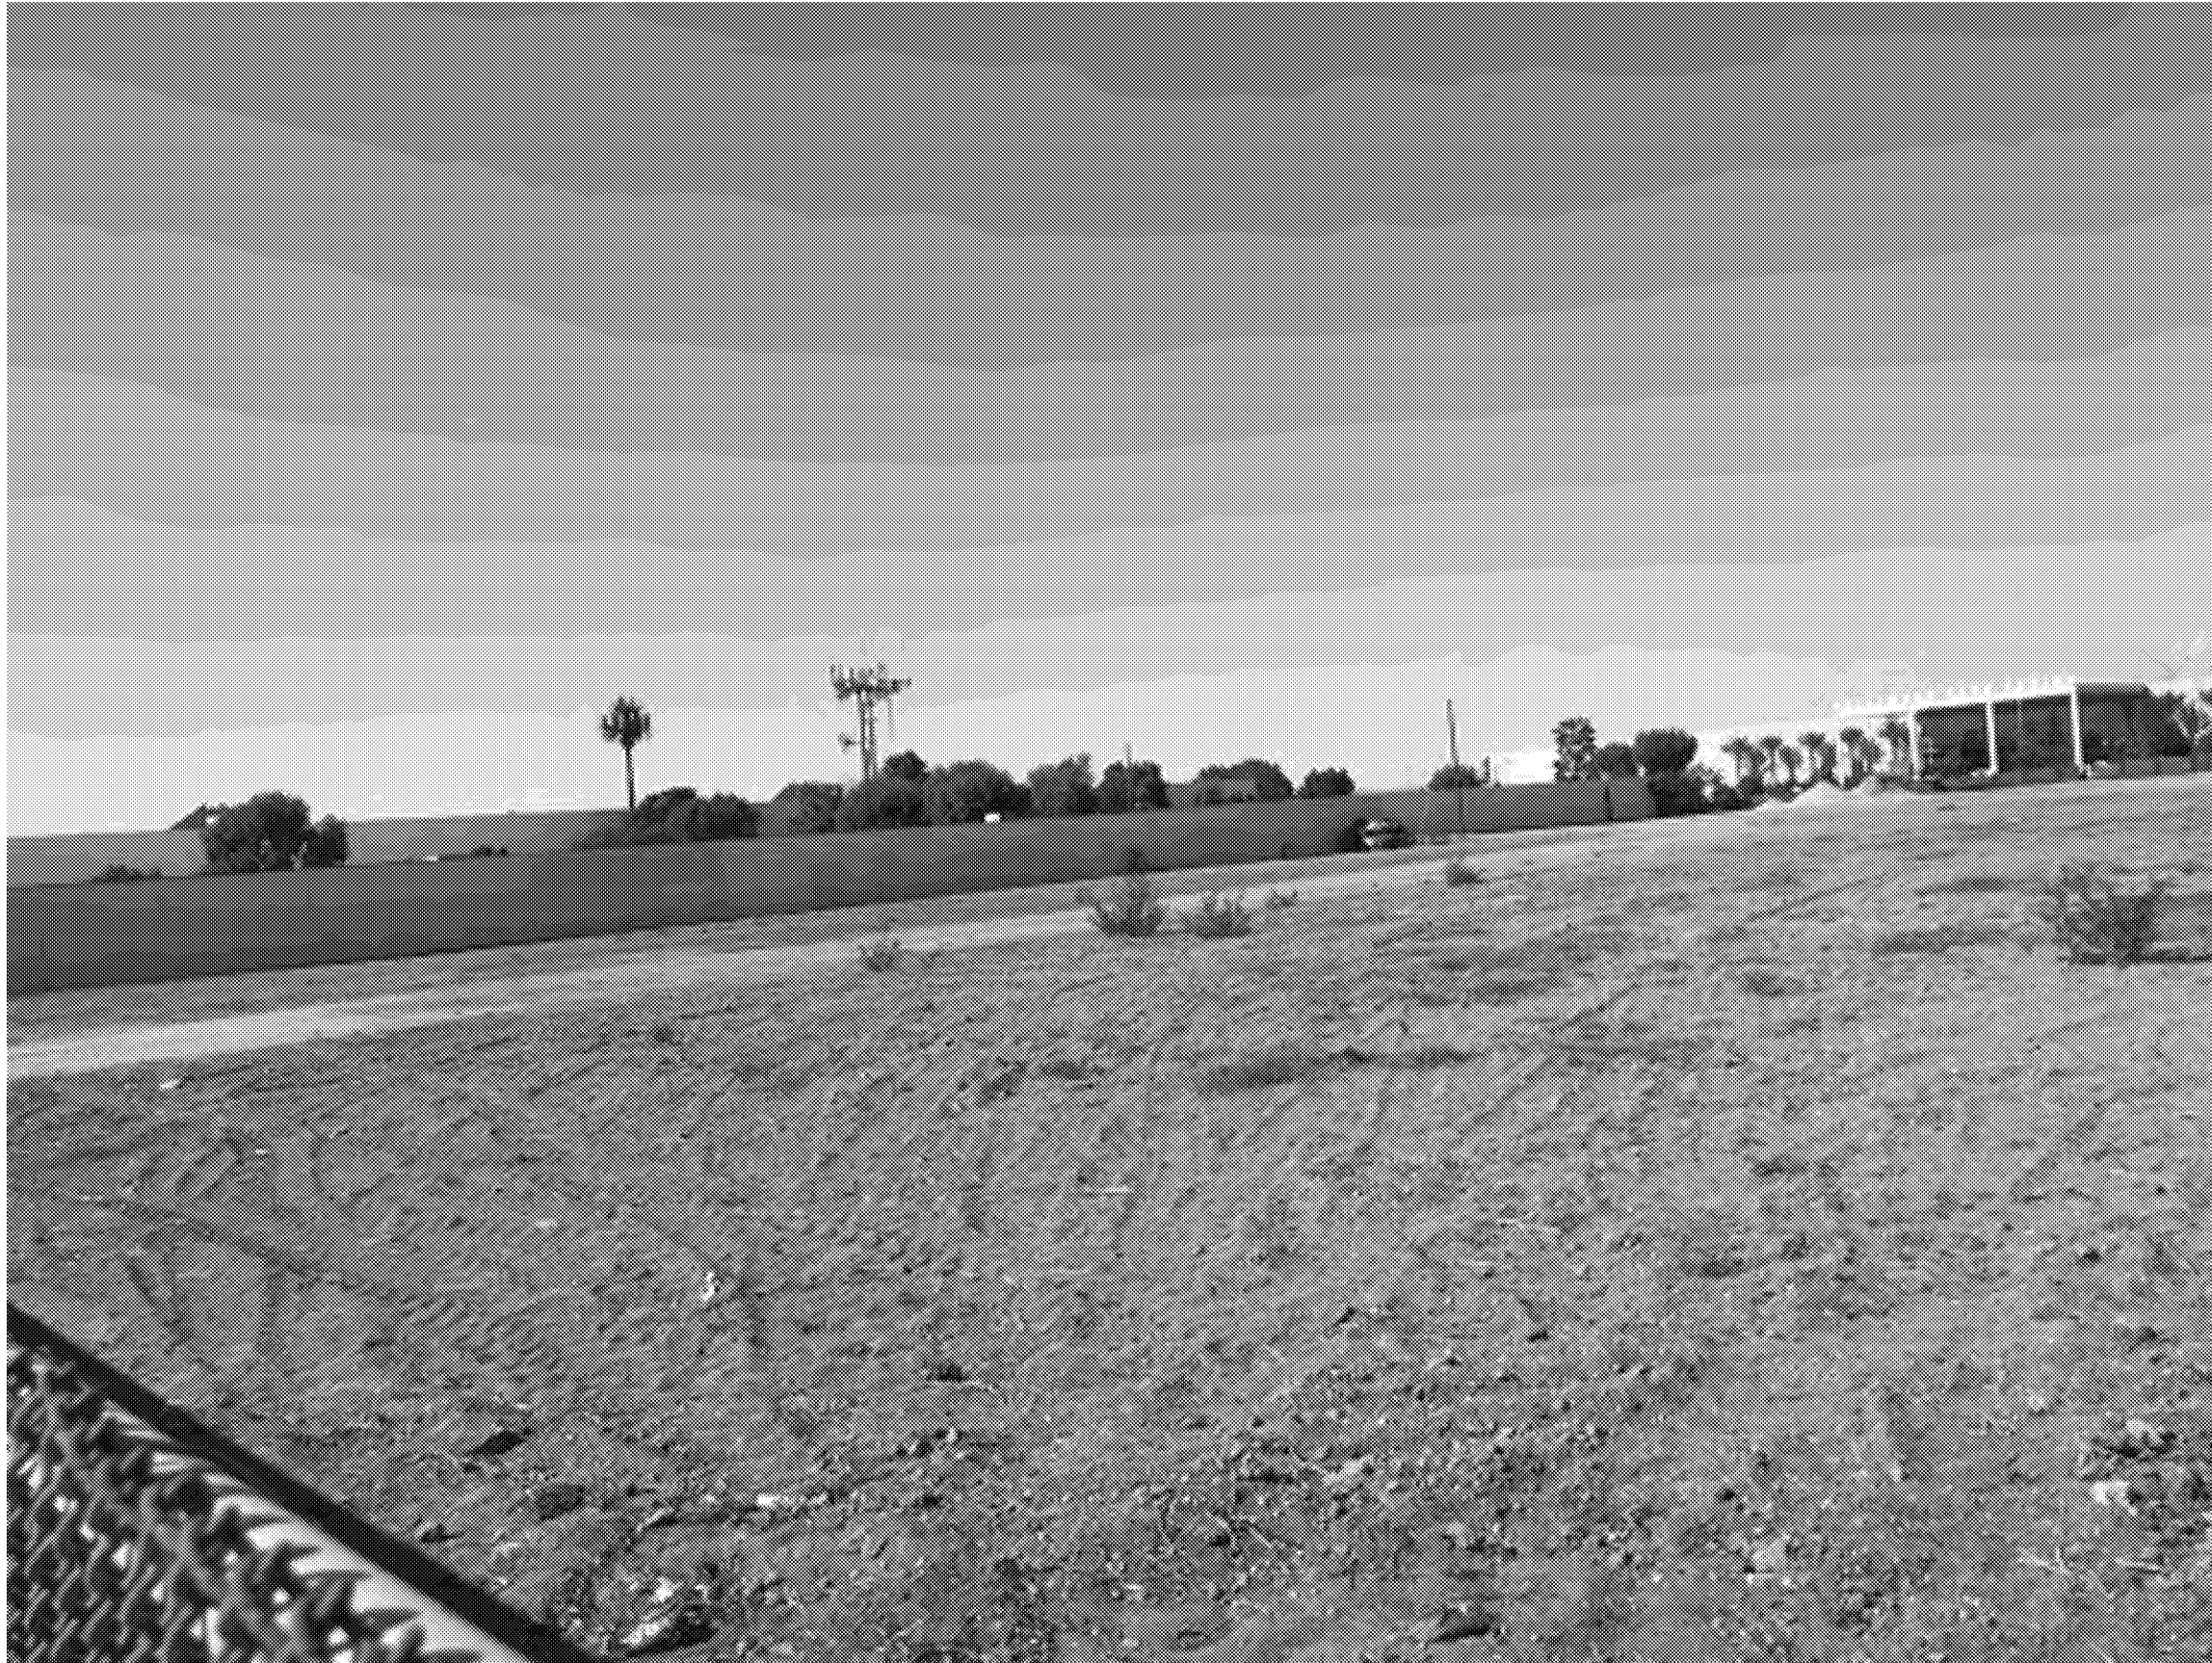
5

NORTHWEST VIEW FROM SOUTHEAST
CORNER OF PARCEL, ALONG 102ND

SITE SURROUNDED BY CHAIN LINK
FENCE, CMU WALLS AND A WROUGHT
IRON FENCE WITH PILLASTERS ON

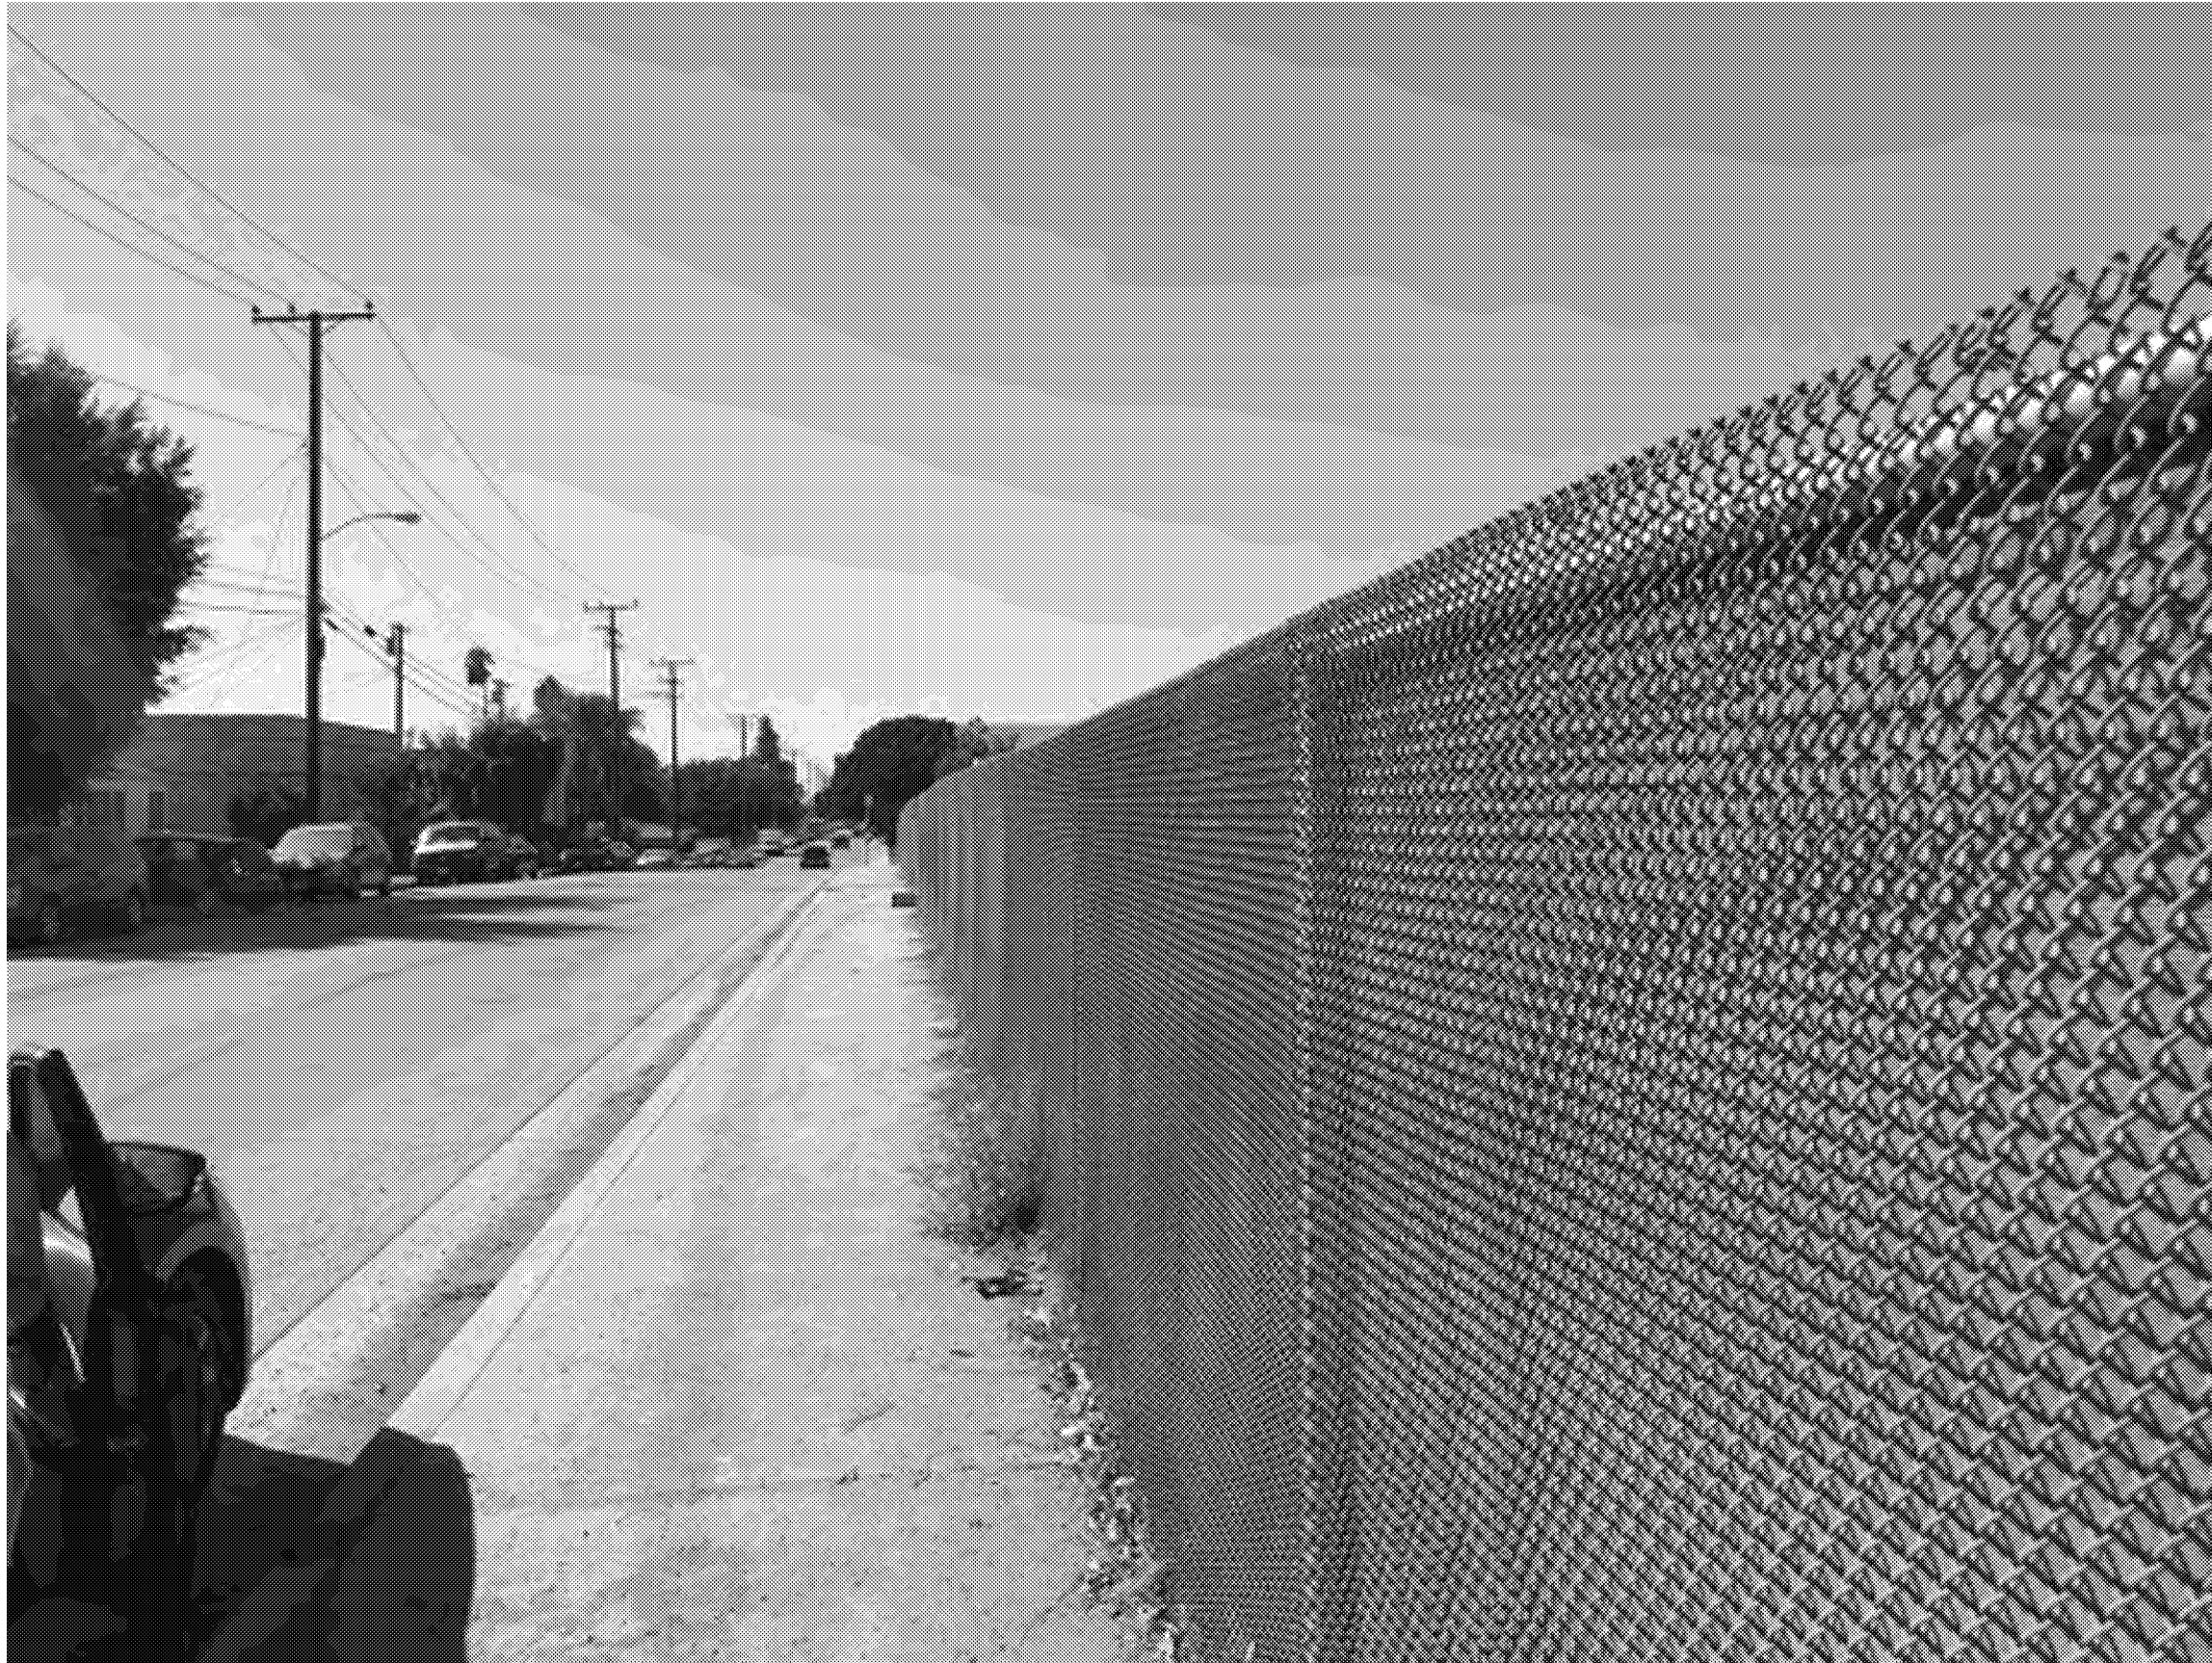
6

WESTBOUND VIEW FROM SOUTHEAST
CORNER OF PARCEL, ALONG 102ND

SITE SURROUNDED BY CHAIN LINK
FENCE, CMU WALLS AND A WROUGHT
IRON FENCE WITH PILLASTERS ON
