<p>D & D ENGINEERING, INC. 8901 S. LA CIENEGA BLVD, SUITE 106 INGLEWOOD, CA 90301 Phone: 424-393-4122</p>	PROJECT CONDOR	SCALE: AS SHOWN
	PERIMETER CONDITIONS EXHIBIT	DATE: 2017/10/24
		SHT NO.: 01 OF 01

PHOTO KEY MAP

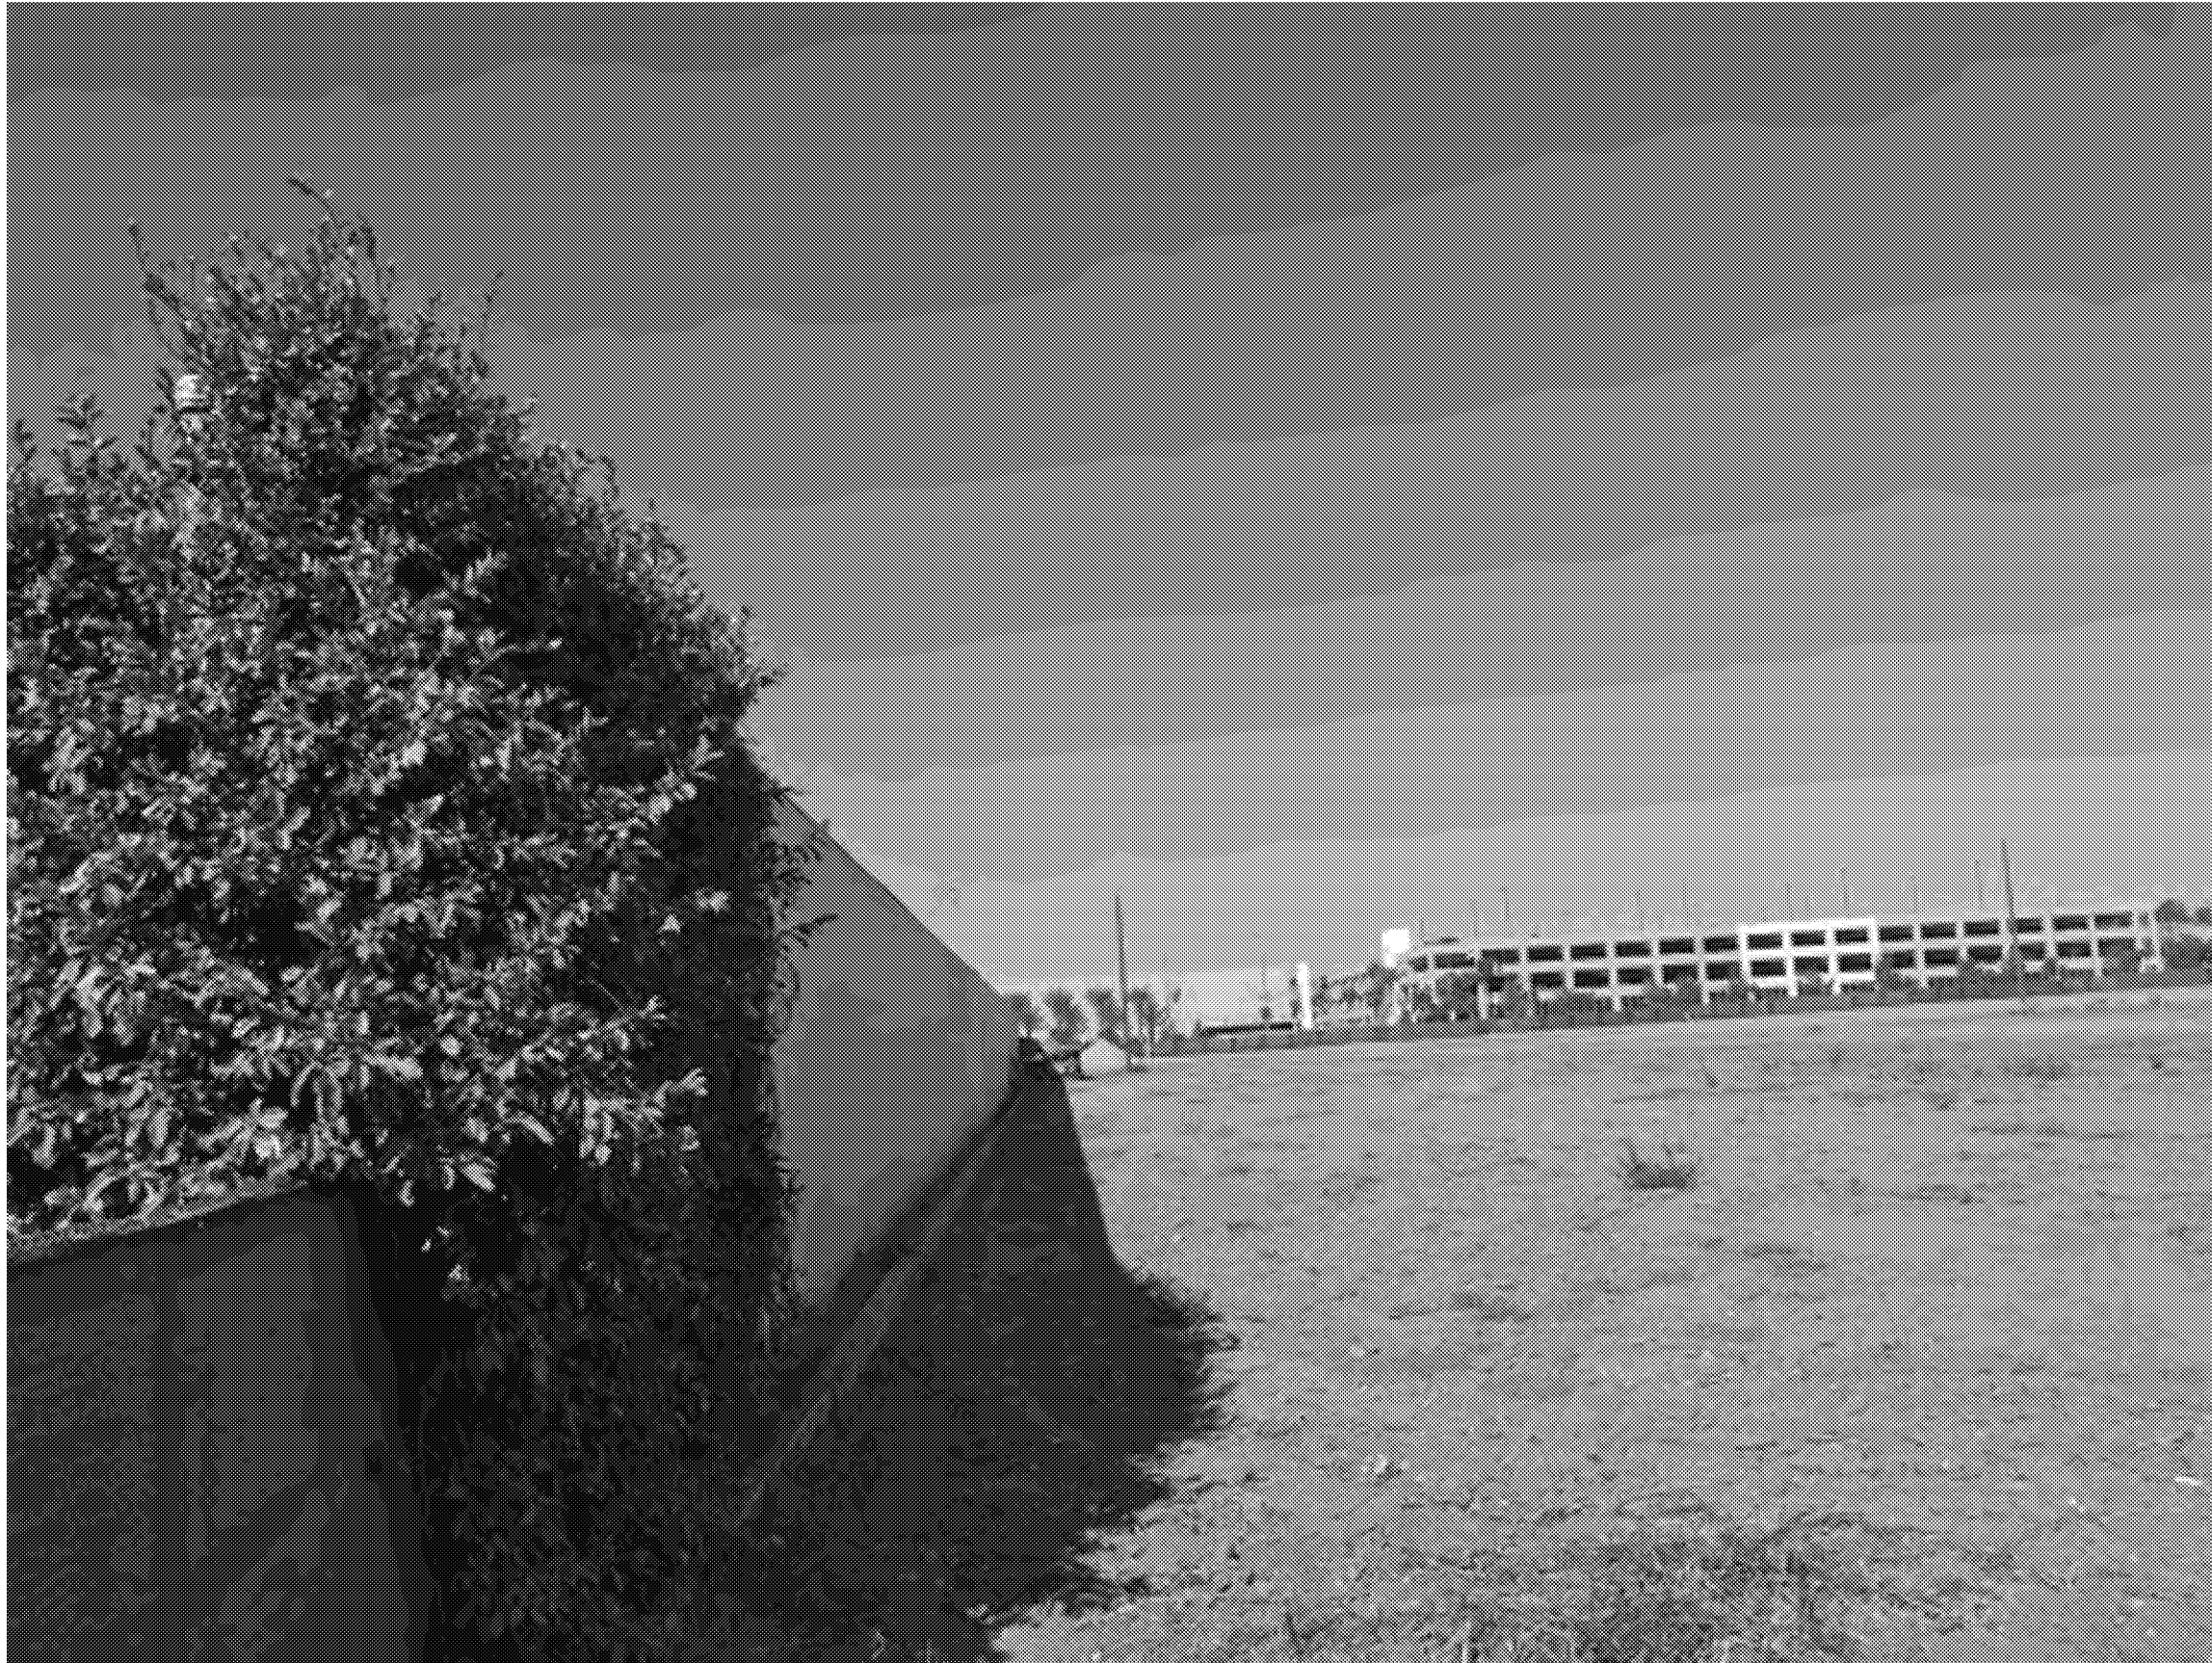
7

NORTHBOUND VIEW FROM SOUTHWEST
CORNER OF PARCEL, ALONG 102ND

SITE SURROUNDED BY CHAIN LINK
FENCE, CMU WALLS AND A WROUGHT
IRON FENCE WITH PILLASTERS ON

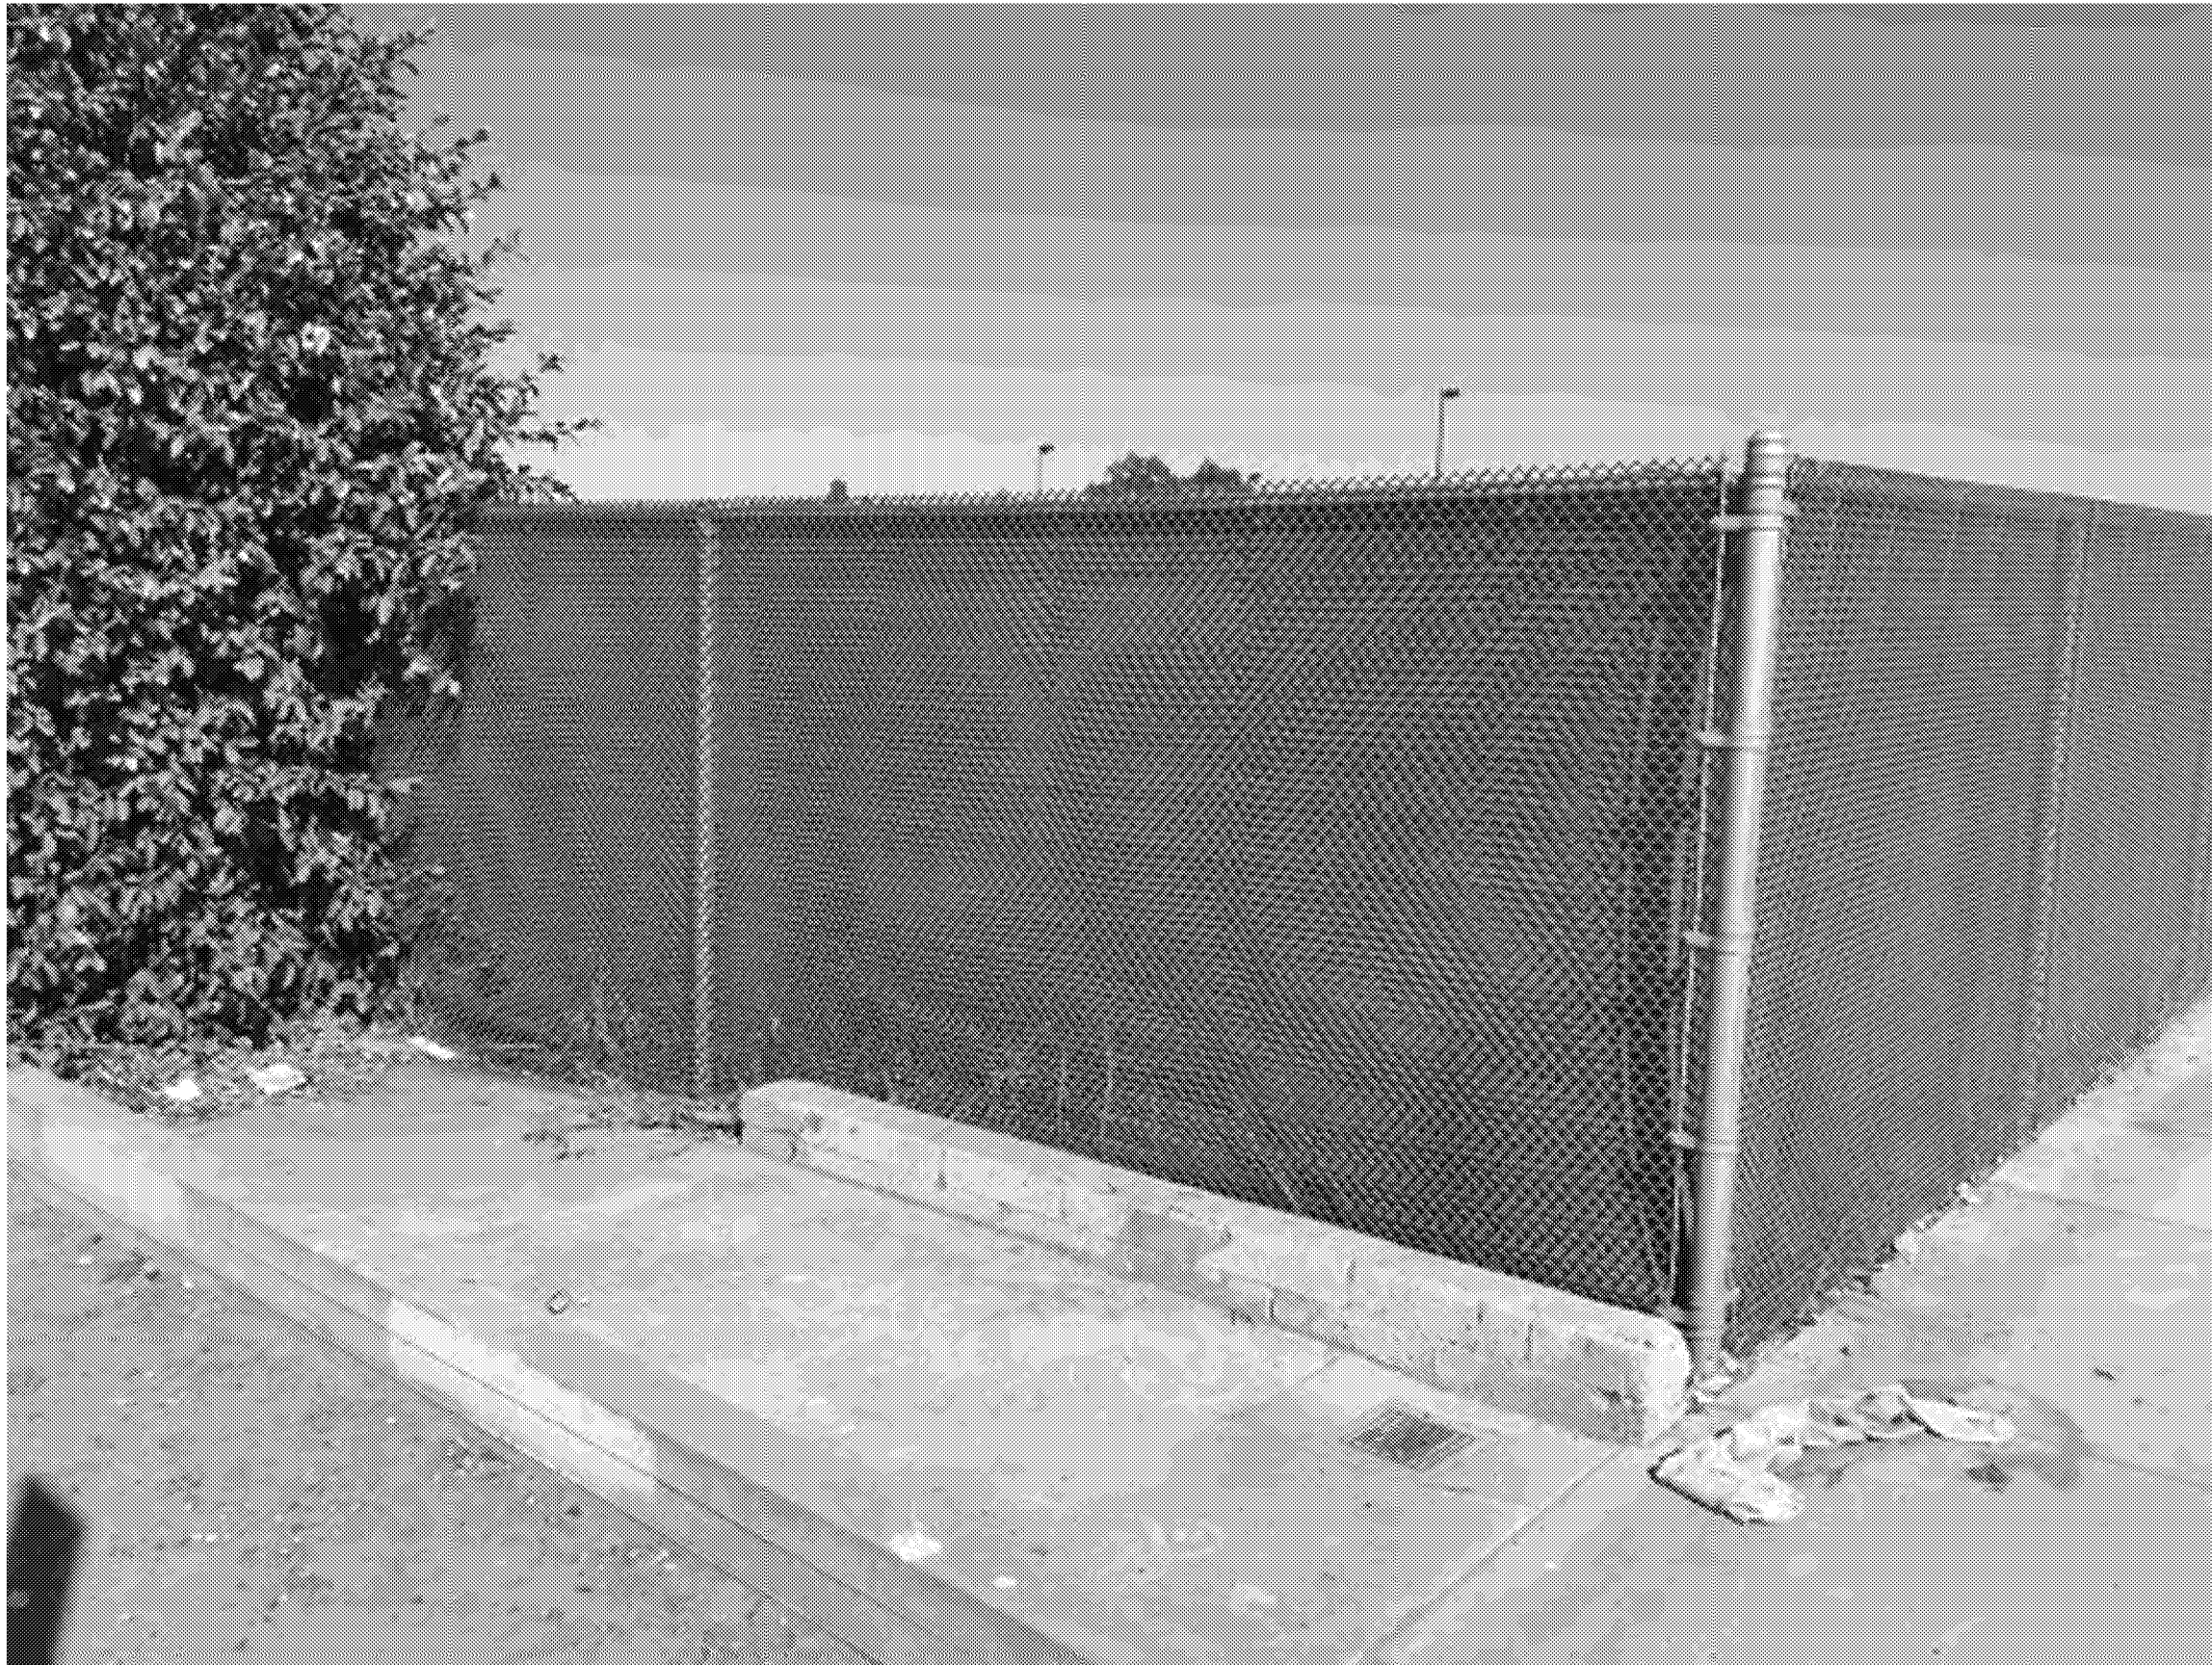
EASTBOUND VIEW FROM SOUTHWEST
CORNER OF PARCEL, ALONG 102ND

SITE SURROUNDED BY CHAIN LINK
FENCE, CMU WALLS AND A WROUGHT
IRON FENCE WITH PILLASTERS ON

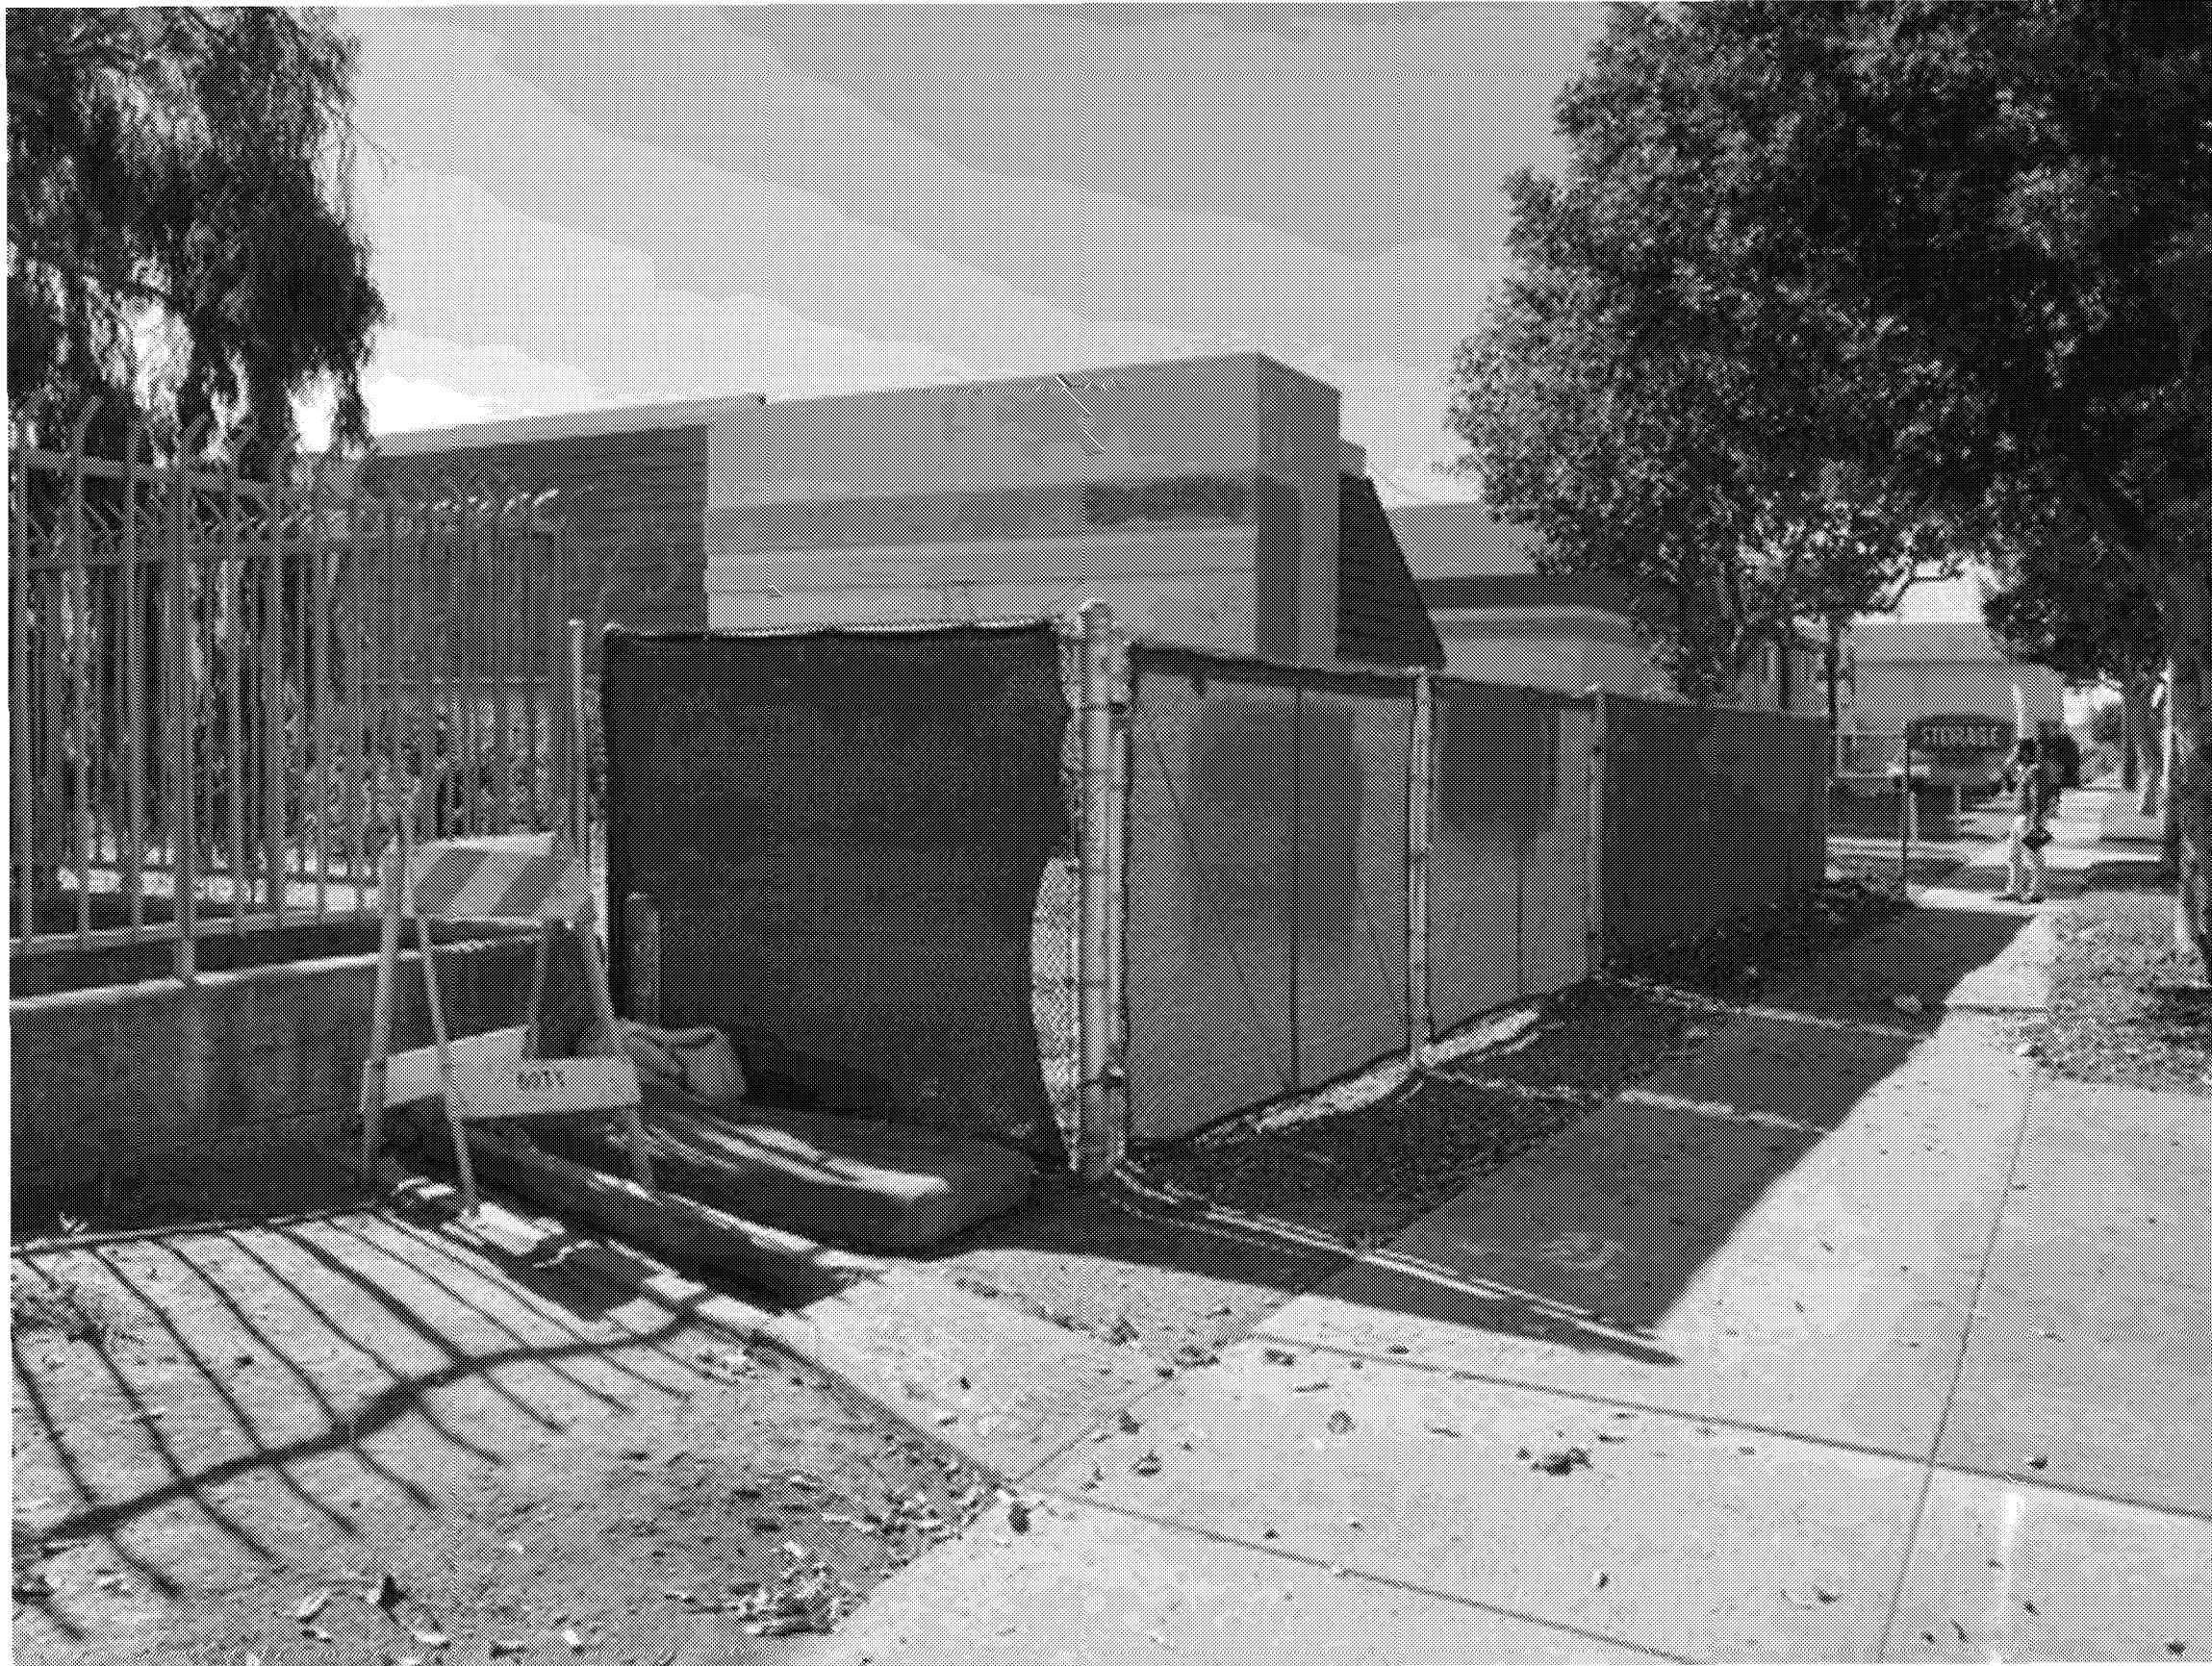
9

WESTBOUND VIEW FROM NORTHEAST
CORNER OF PARCEL, ALONG CENTURY

SITE SURREOUNDED BY CHAIN LINK
FENCE, CMU WALLS AND A WROUGHT
IRON FENCE WITH PILASTERS

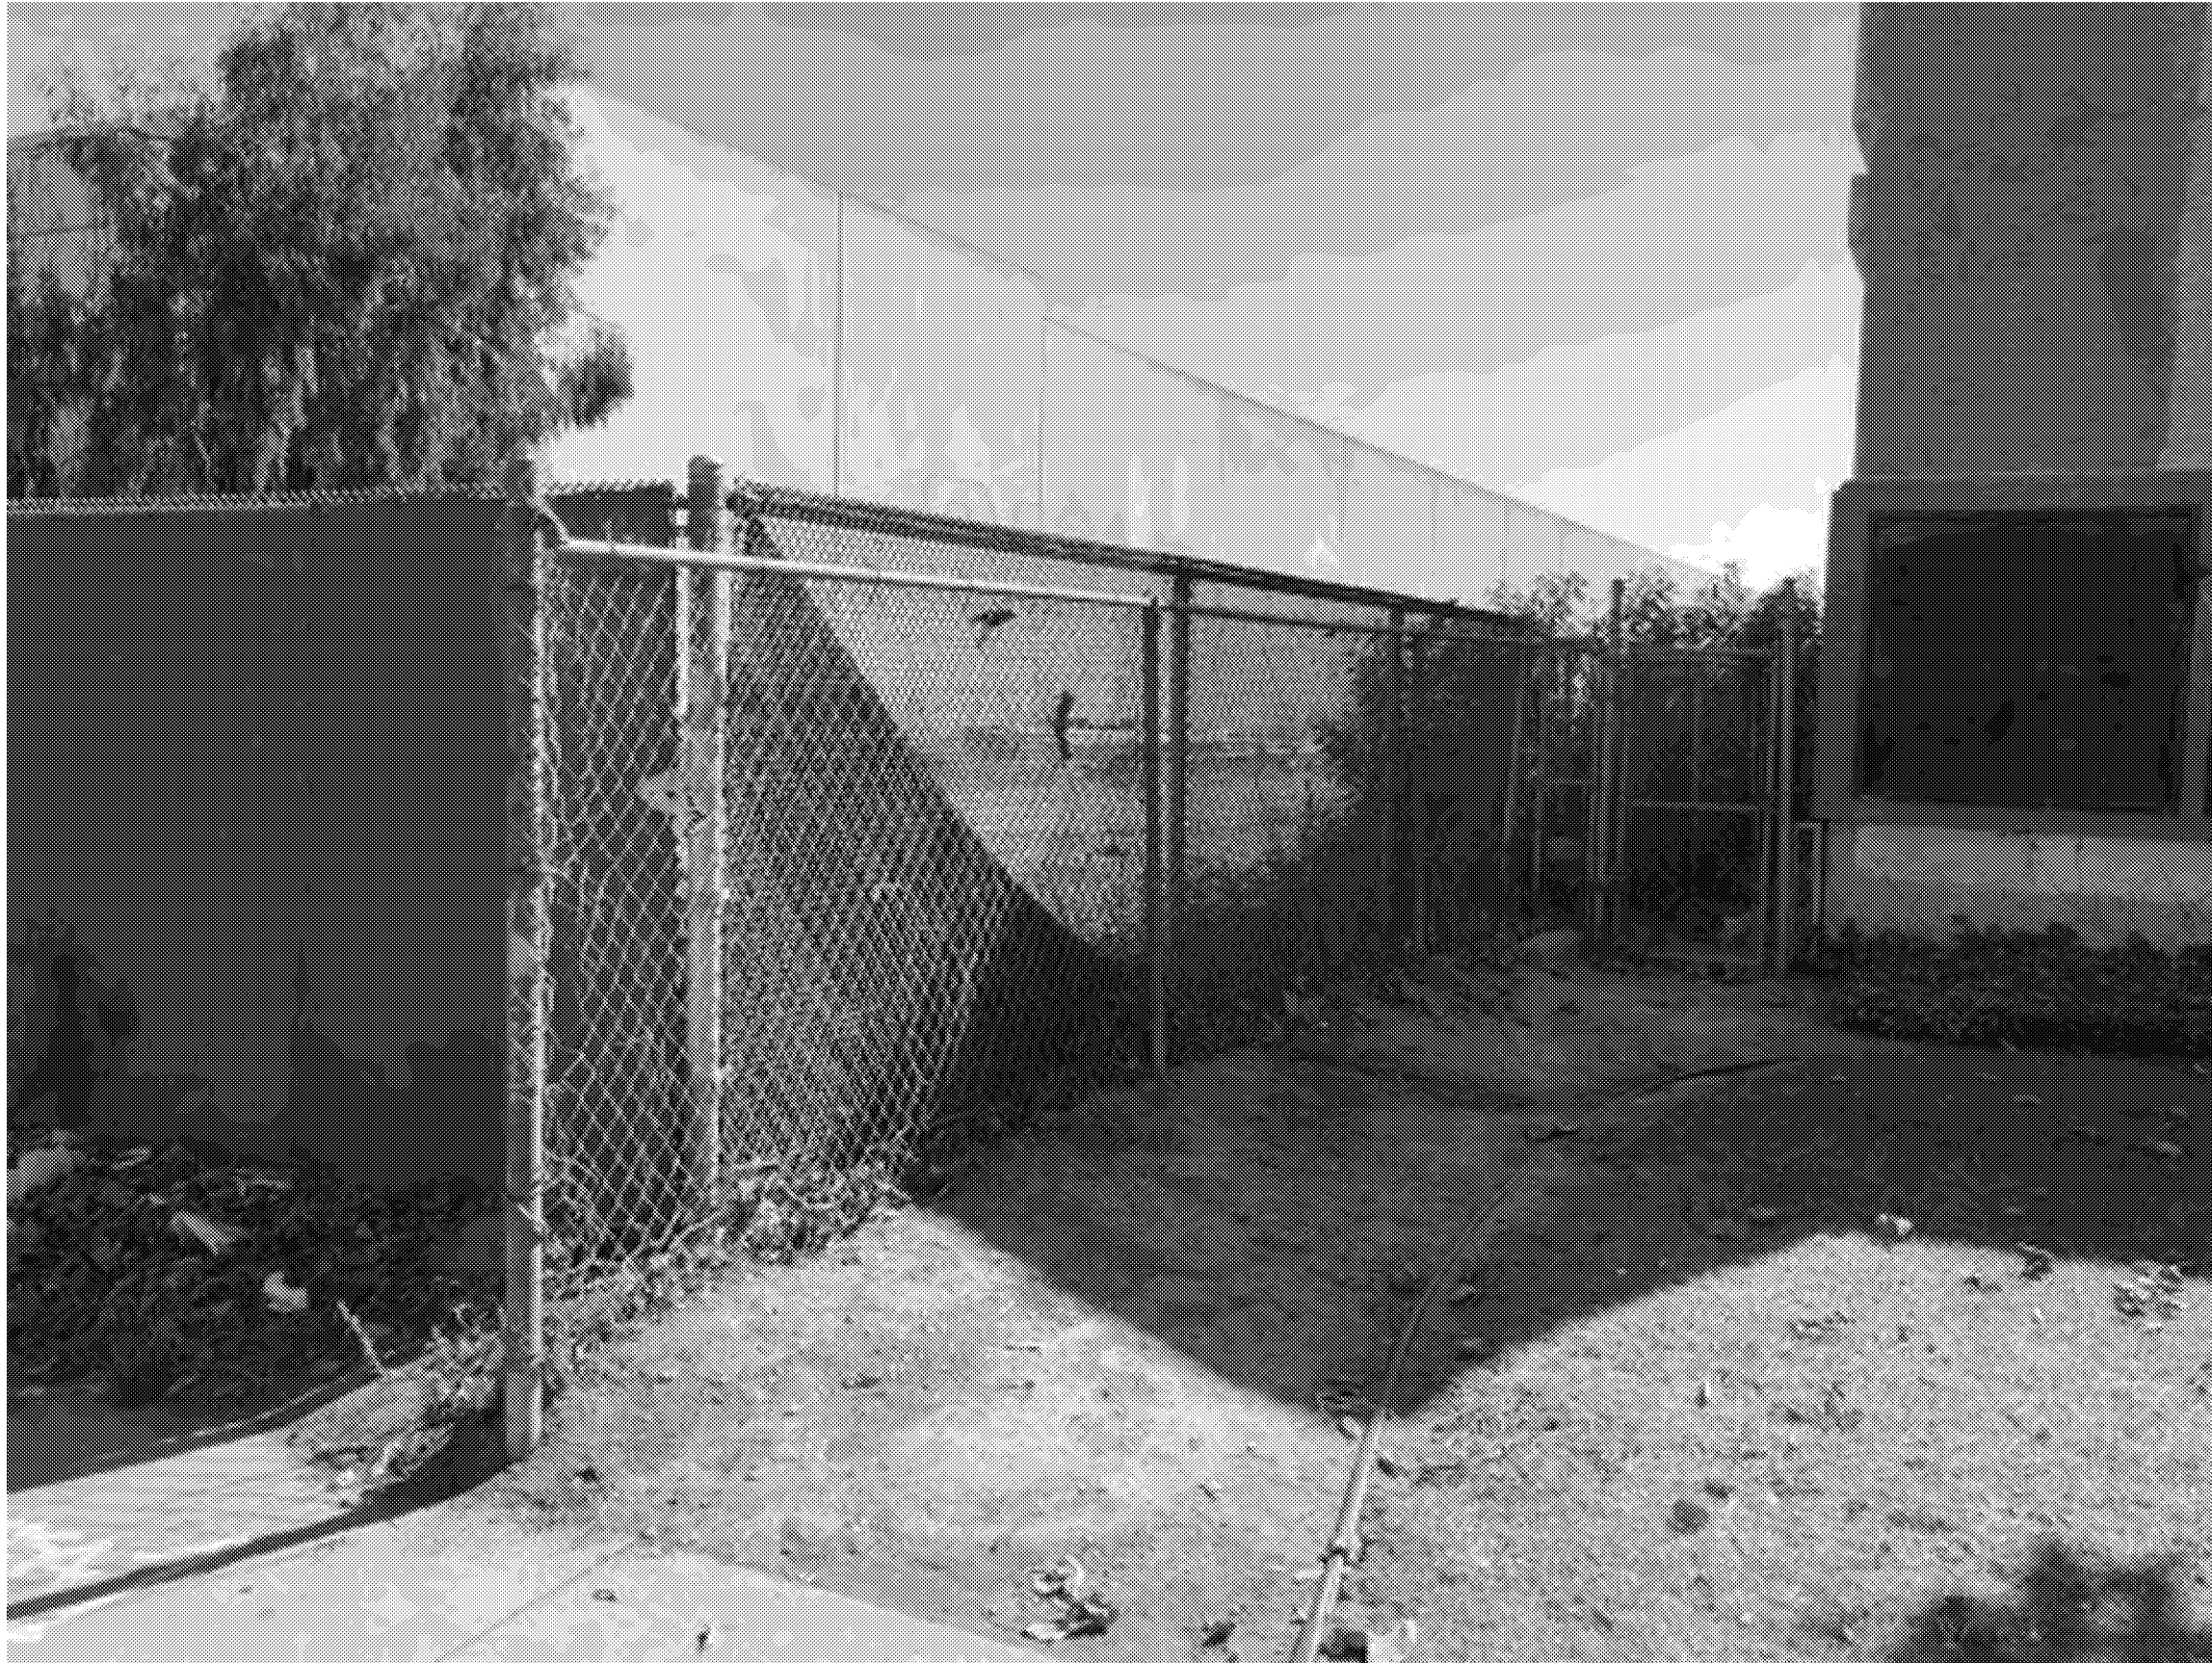
10

EASTBOUND VIEW FROM NORTHWEST
CORNER OF PARCEL, ALONG CENTURY

SITE SURROUNDED BY CHAIN LINK
FENCE, CMU WALLS AND A WROUGHT
IRON FENCE WITH PILASTERS

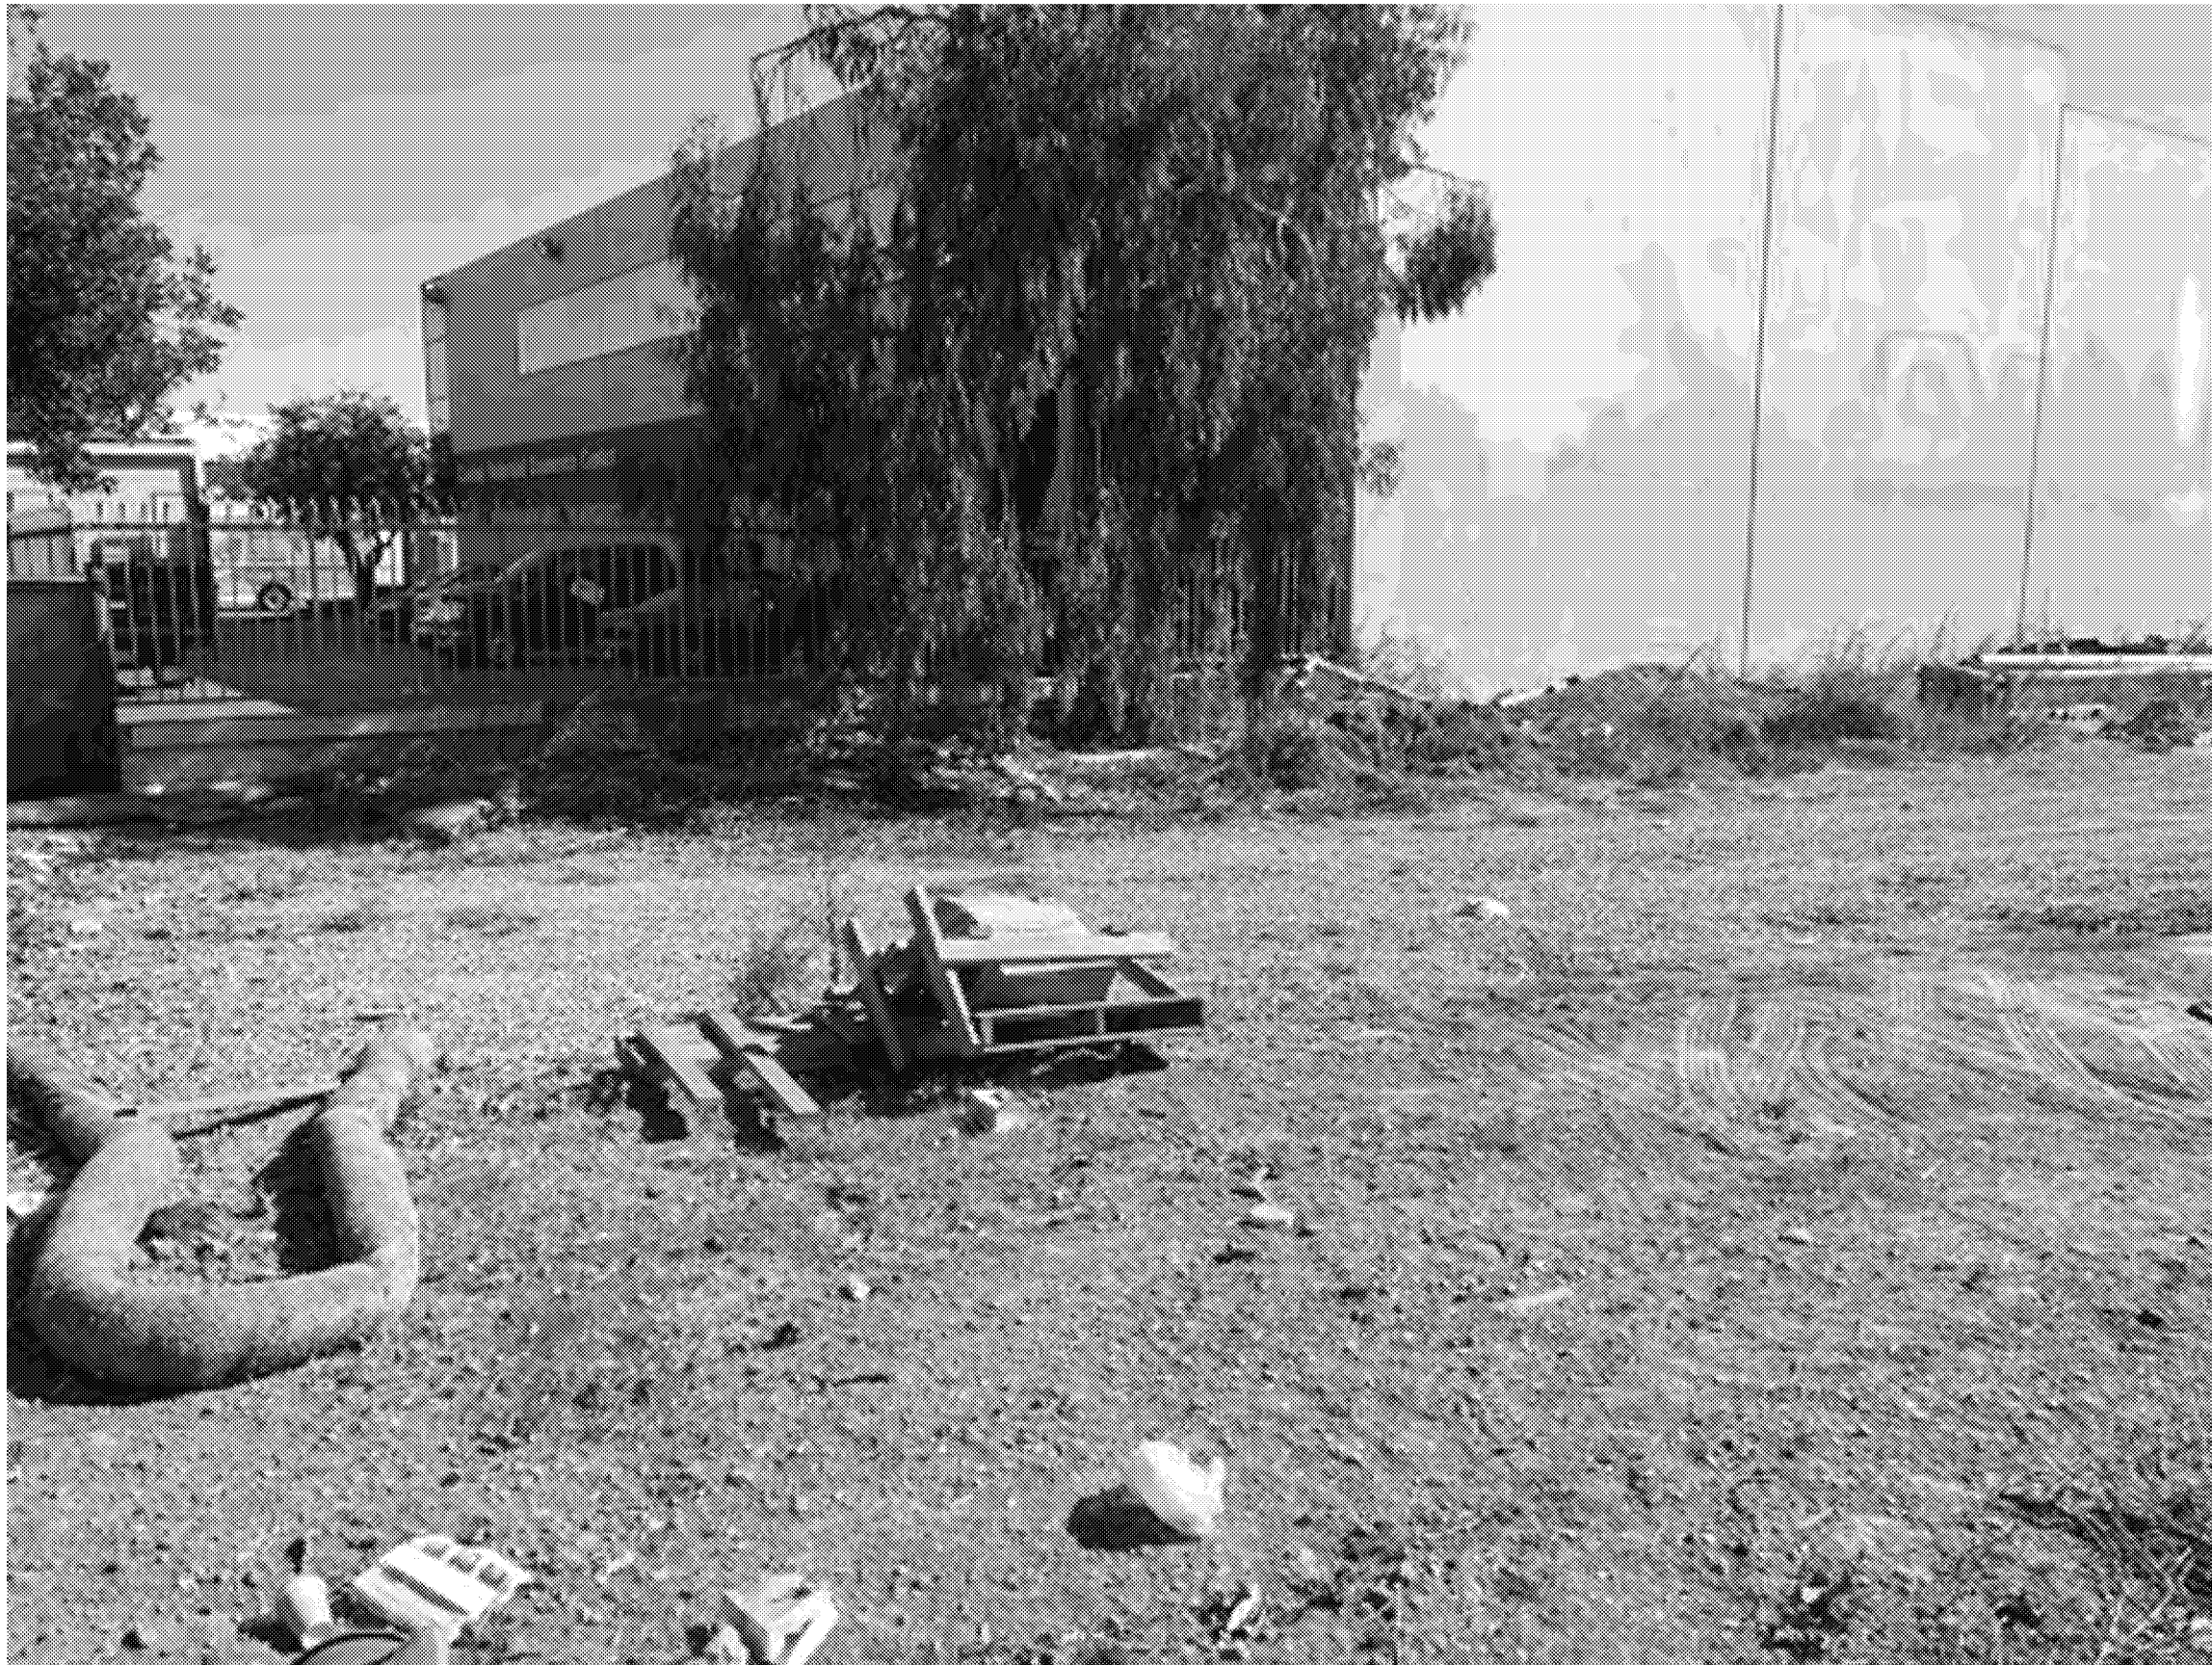
11

WESTBOUND VIEW FROM NORTHEAST
CORNER OF PARCEL, ALONG CENTURY

SITE SURROUNDED BY CHAIN LINK
FENCE, CMU WALLS AND A WROUGHT
IRON FENCE WITH PILASTERS

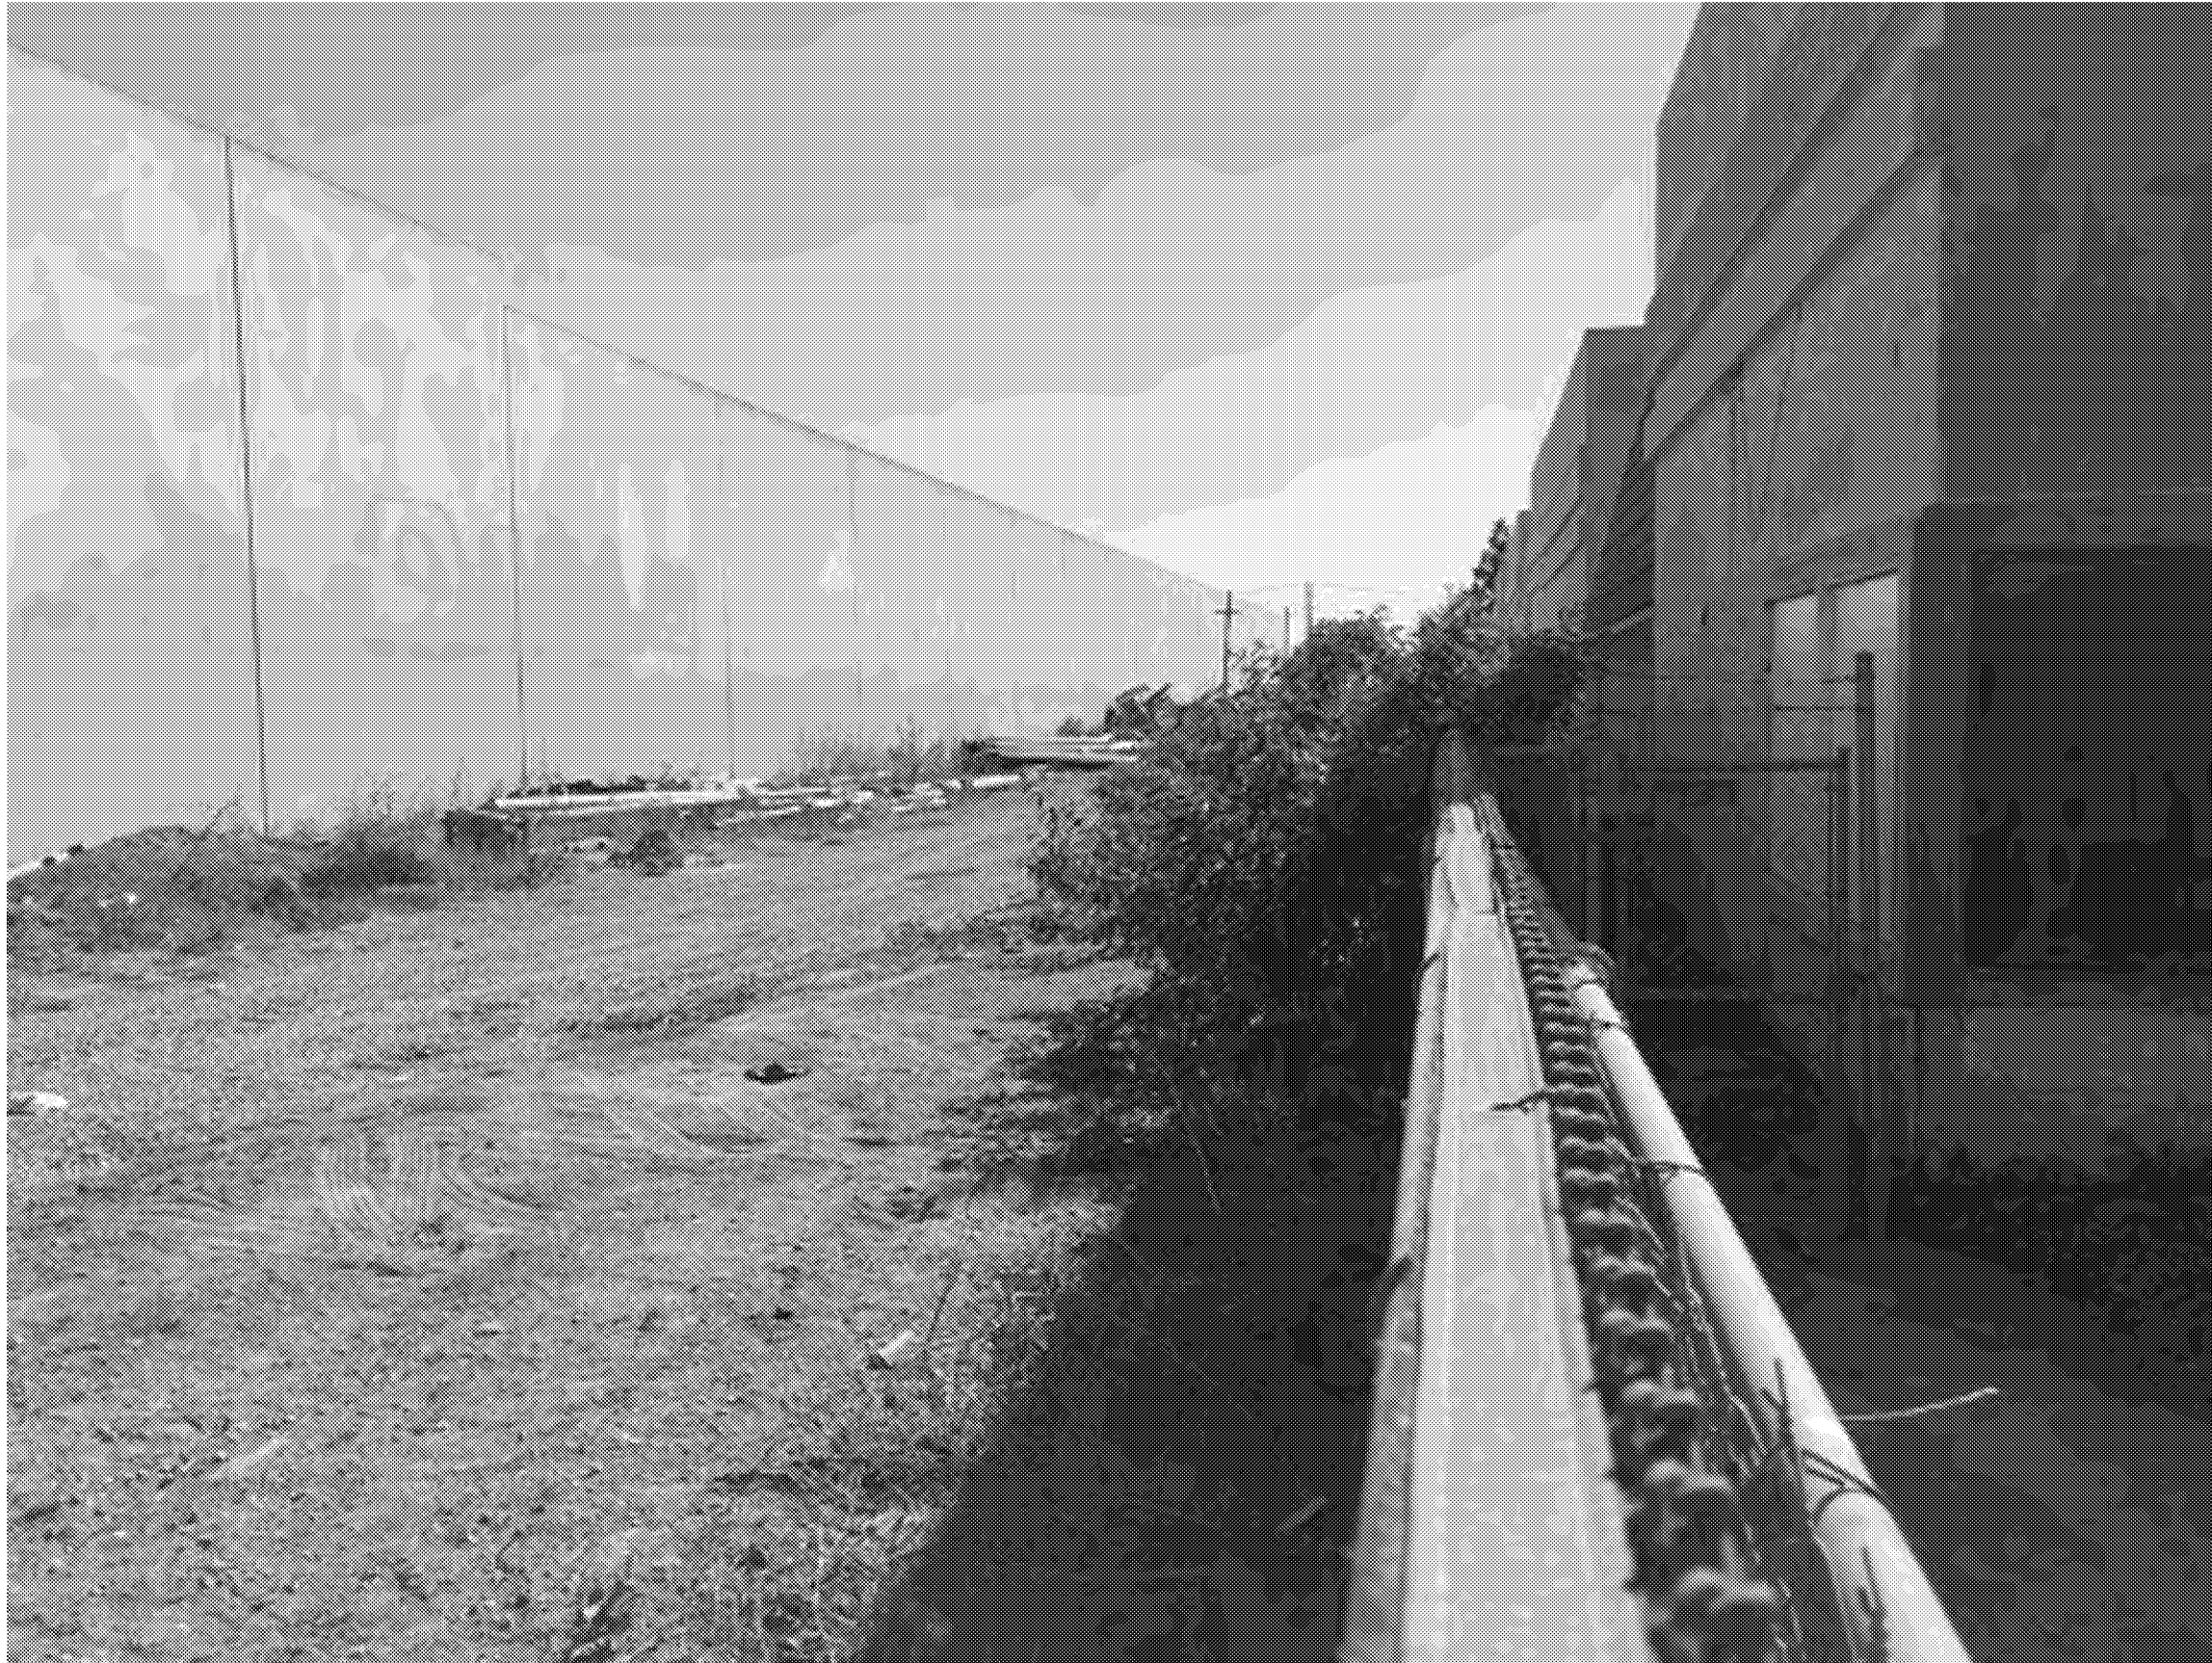
12

SOUTHBOUND VIEW FROM NORTHEAST
CORNER OF PARCEL, ALONG CENTURY

SITE SURROUNDED BY CHAIN LINK
FENCE, CMU WALLS AND A WROUGHT
IRON FENCE WITH PILASTERS
