<p>D & D ENGINEERING, INC. 8901 S. LA CIENEGA BLVD, SUITE 106 INGLEWOOD, CA 90301 Phone: 424-393-4122</p>	PROJECT CONDOR	SCALE: AS SHOWN
	PERIMETER CONDITIONS EXHIBIT	DATE: 2017/10/24
		SHT NO.: 01 OF 01

PHOTO KEY MAP

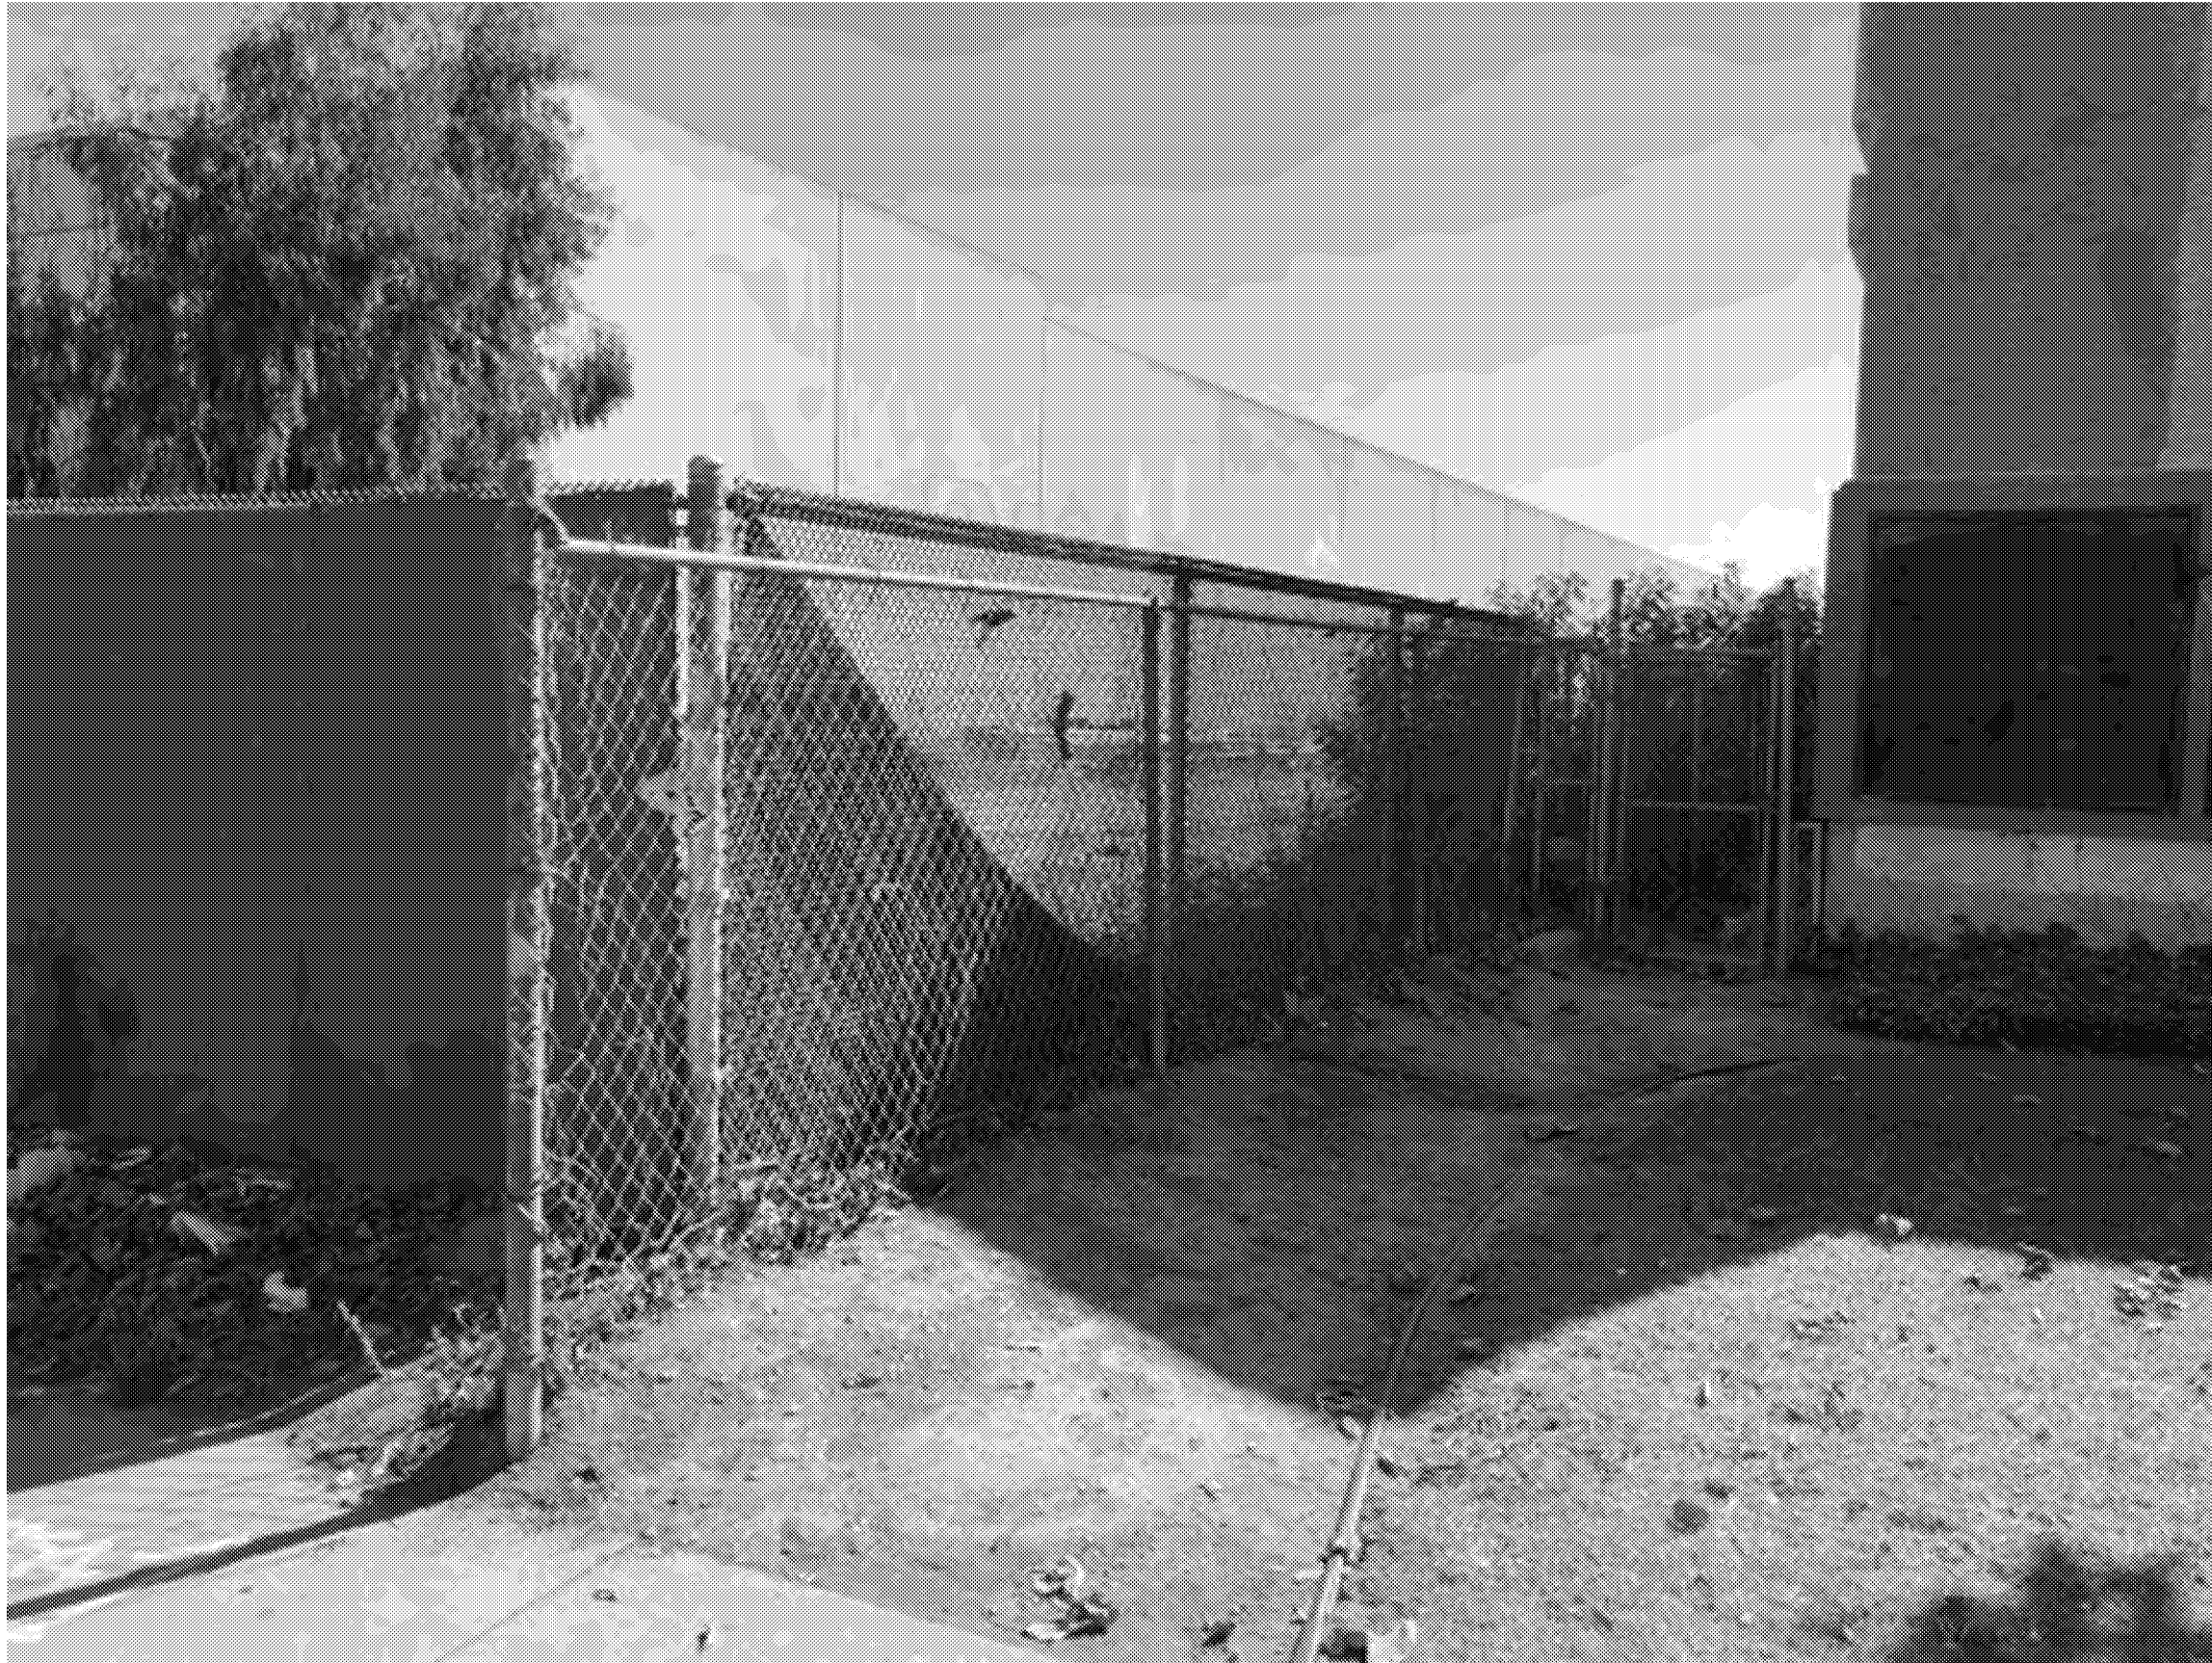
13

WESTBOUND VIEW FROM NORTHEAST
CORNER OF PARCEL, ALONG CENTURY

SITE SURROUNDED BY CHAIN LINK
FENCE, CMU WALLS AND A WROUGHT
IRON FENCE WITH PILASTERS

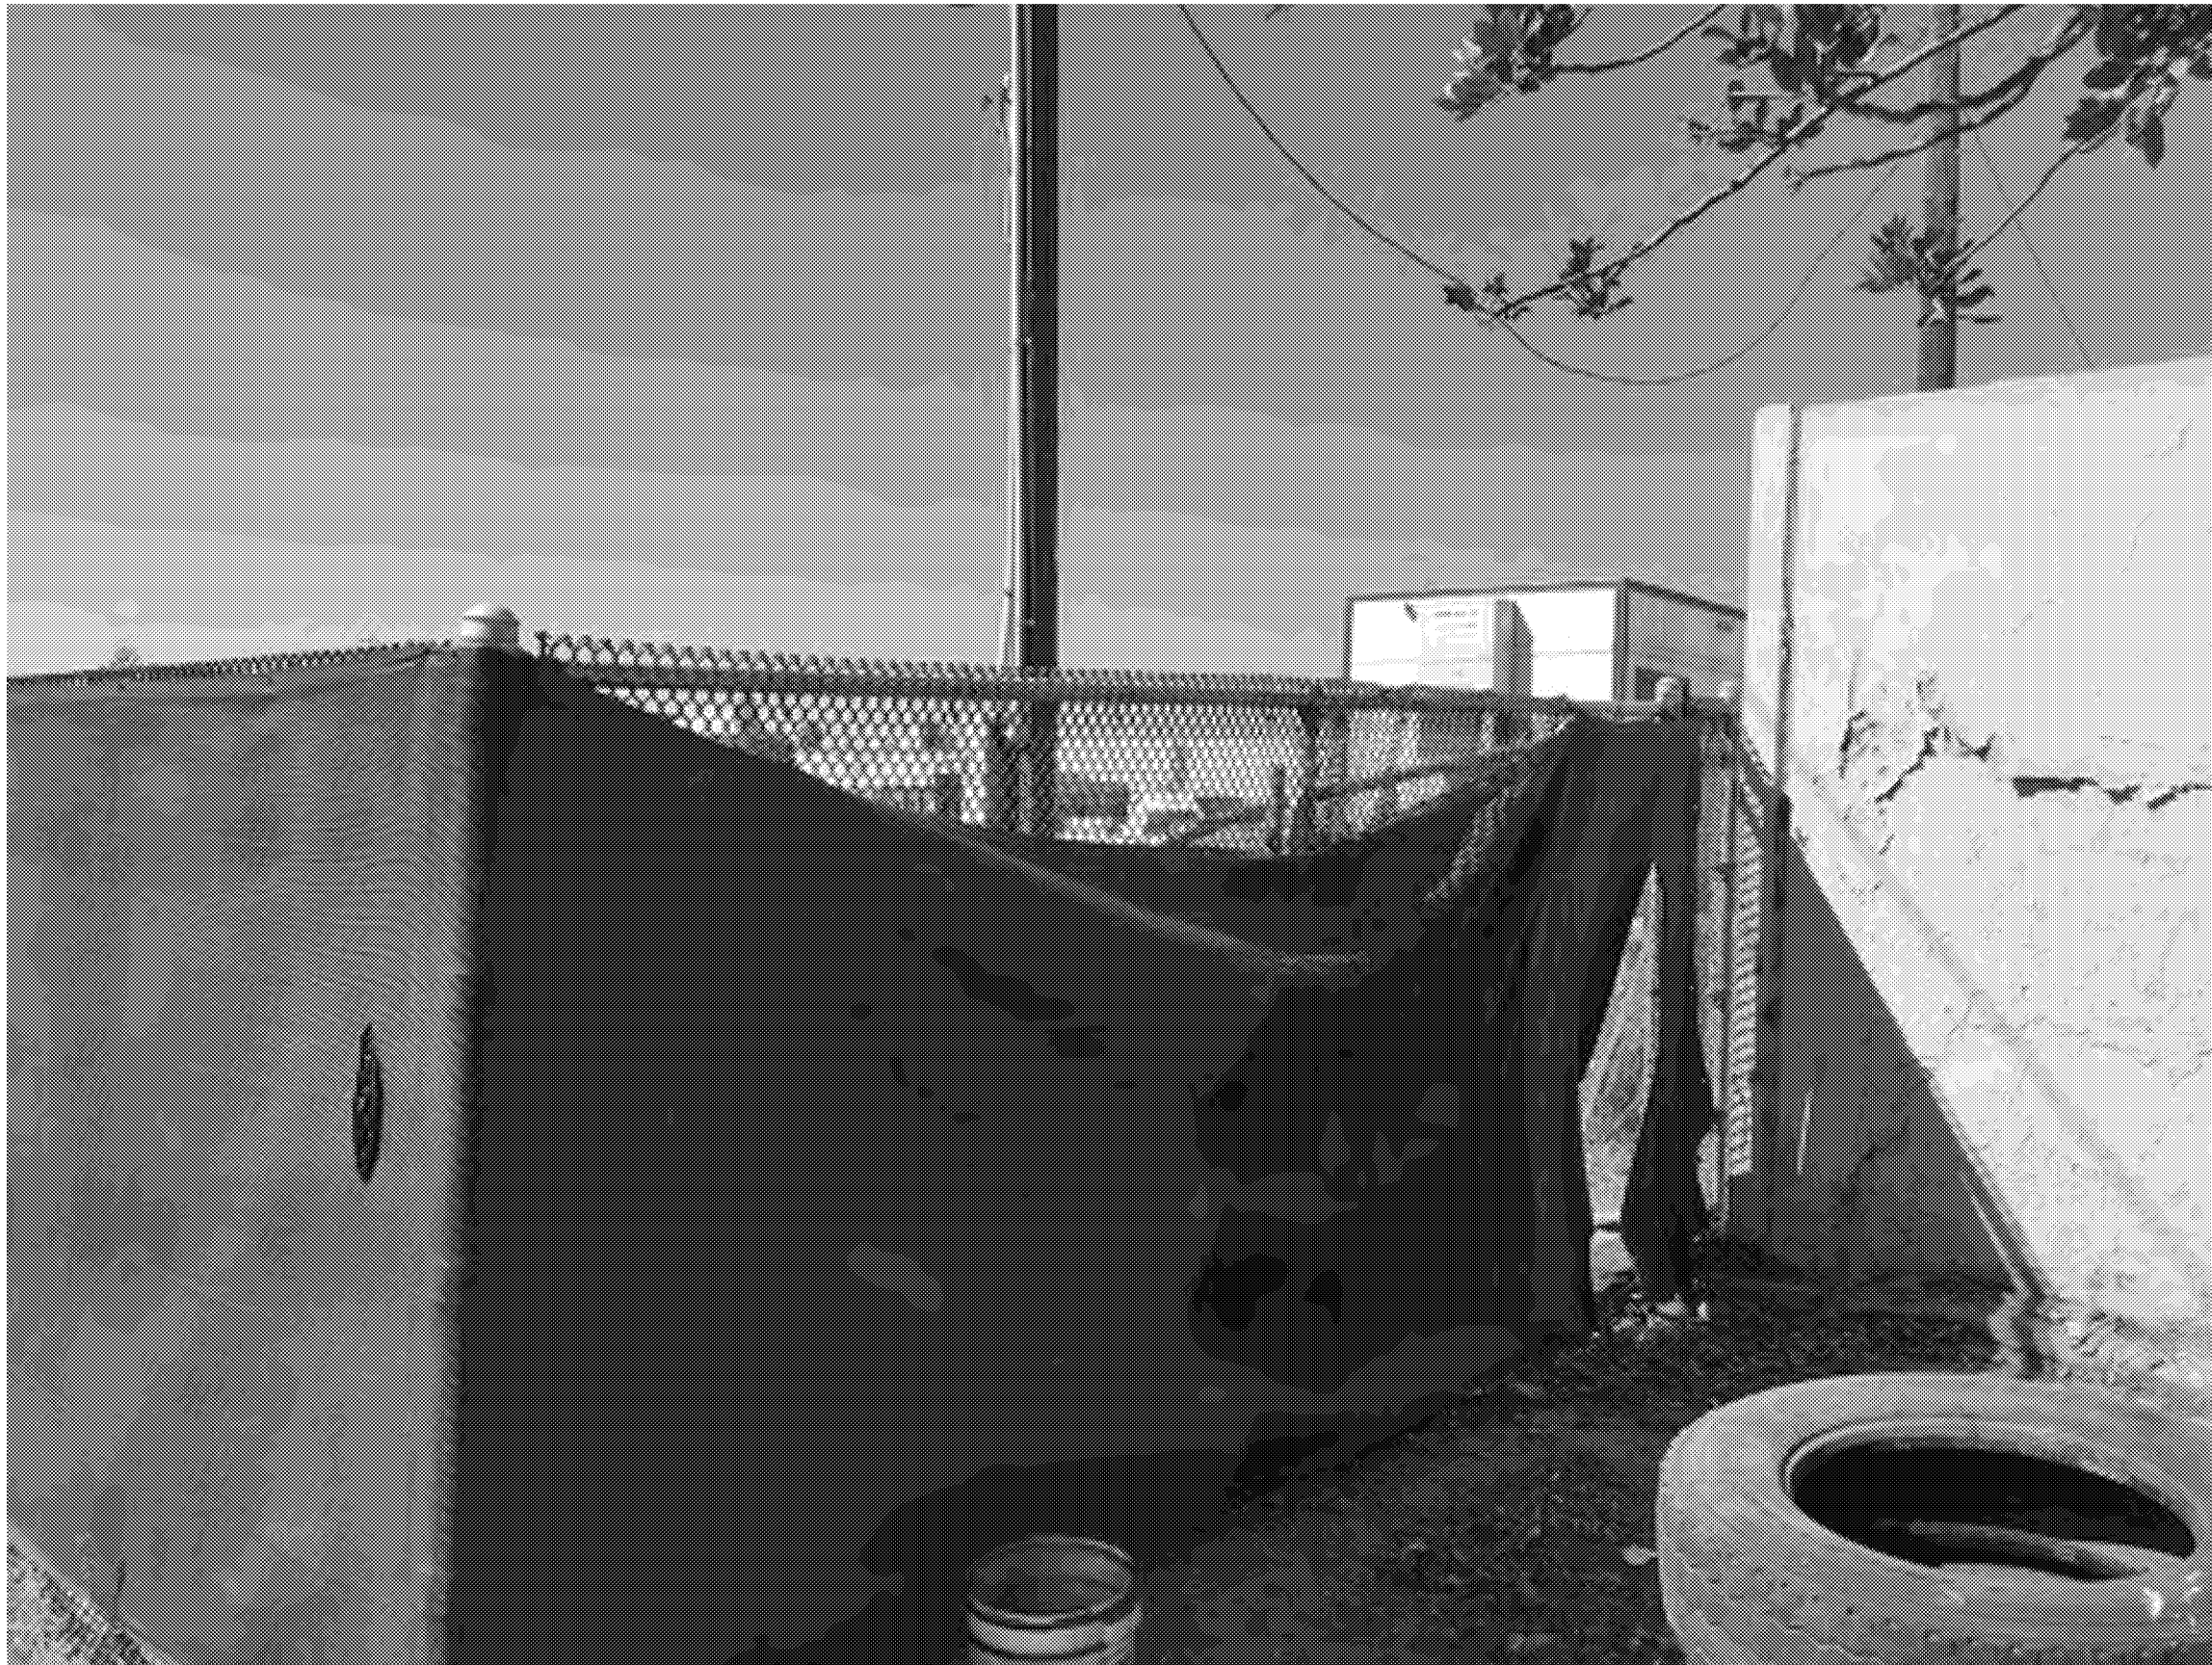
14

WESTBOUND VIEW FROM SOUTHEAST
CORNER OF PARCEL, ALONG 102ND

SITE SURROUNDED BY CHAIN LINK
FENCE, CMU WALLS AND A WROUGHT
IRON FENCE WITH PILASTERS

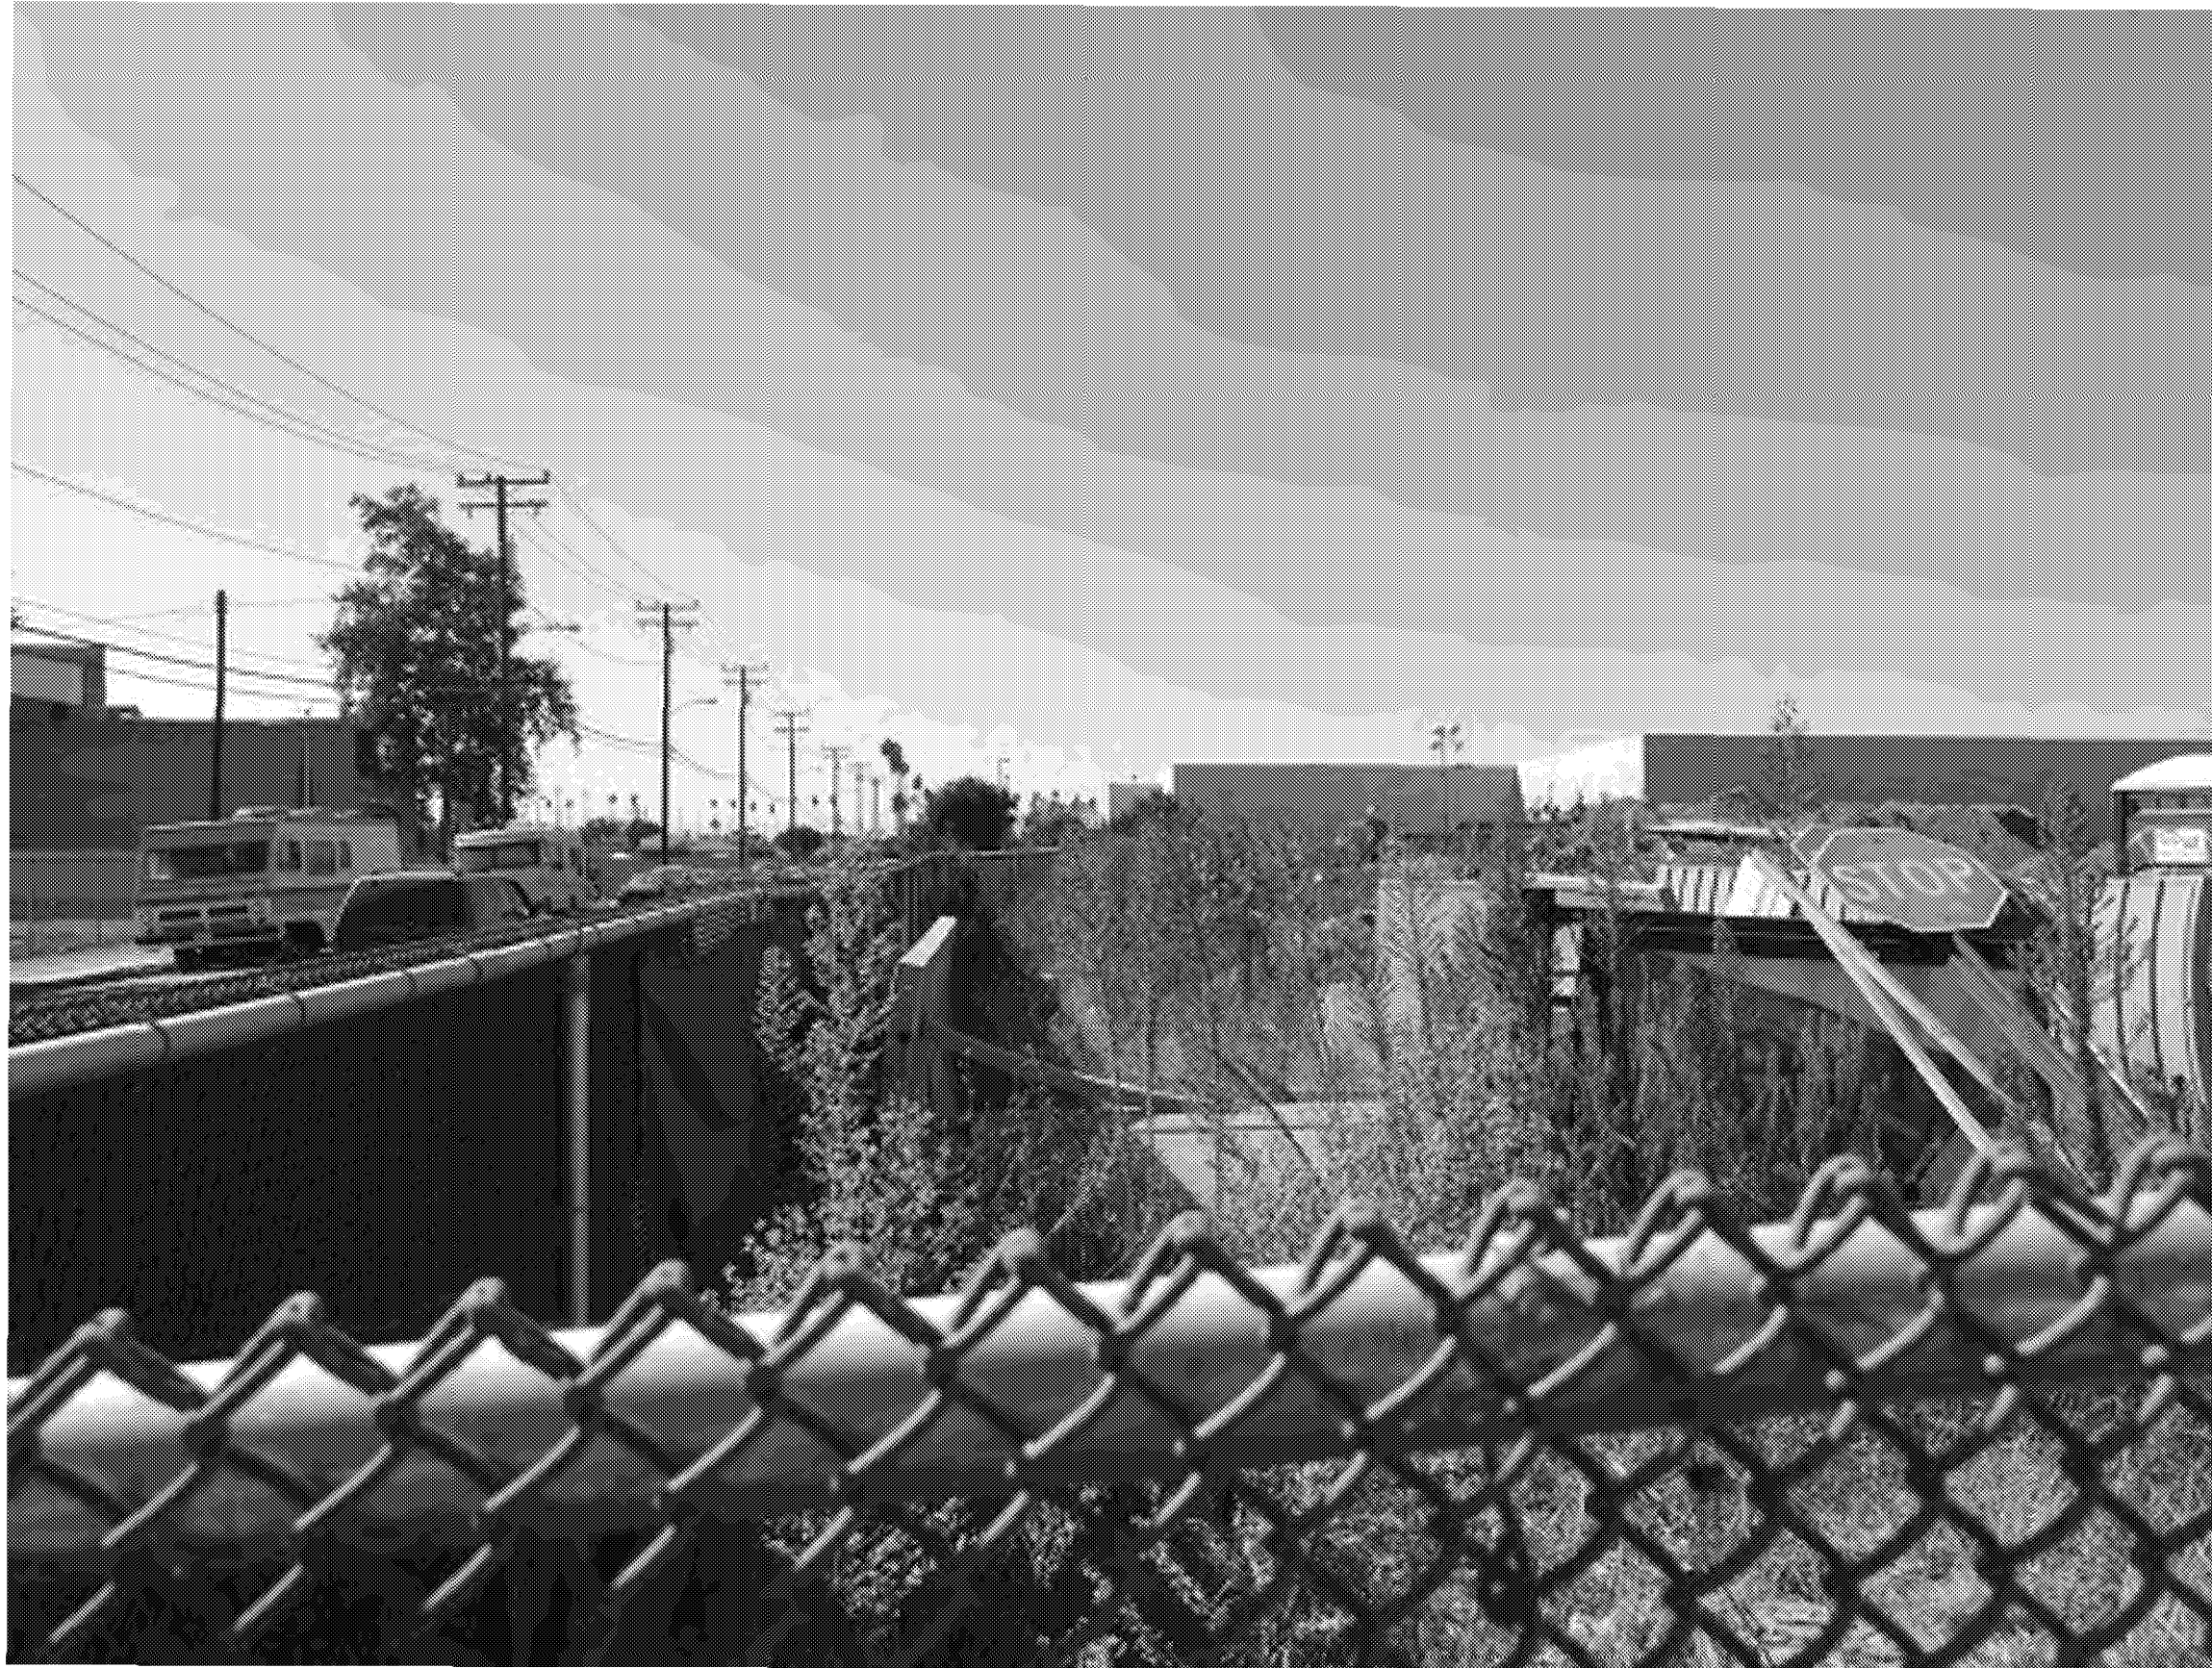
15

WESTBOUND VIEW FROM SOUTHEAST
CORNER OF PARCEL, ALONG 102ND

SITE SURROUNDED BY CHAIN LINK
FENCE, CMU WALLS AND A WROUGHT
IRON FENCE WITH PILASTERS

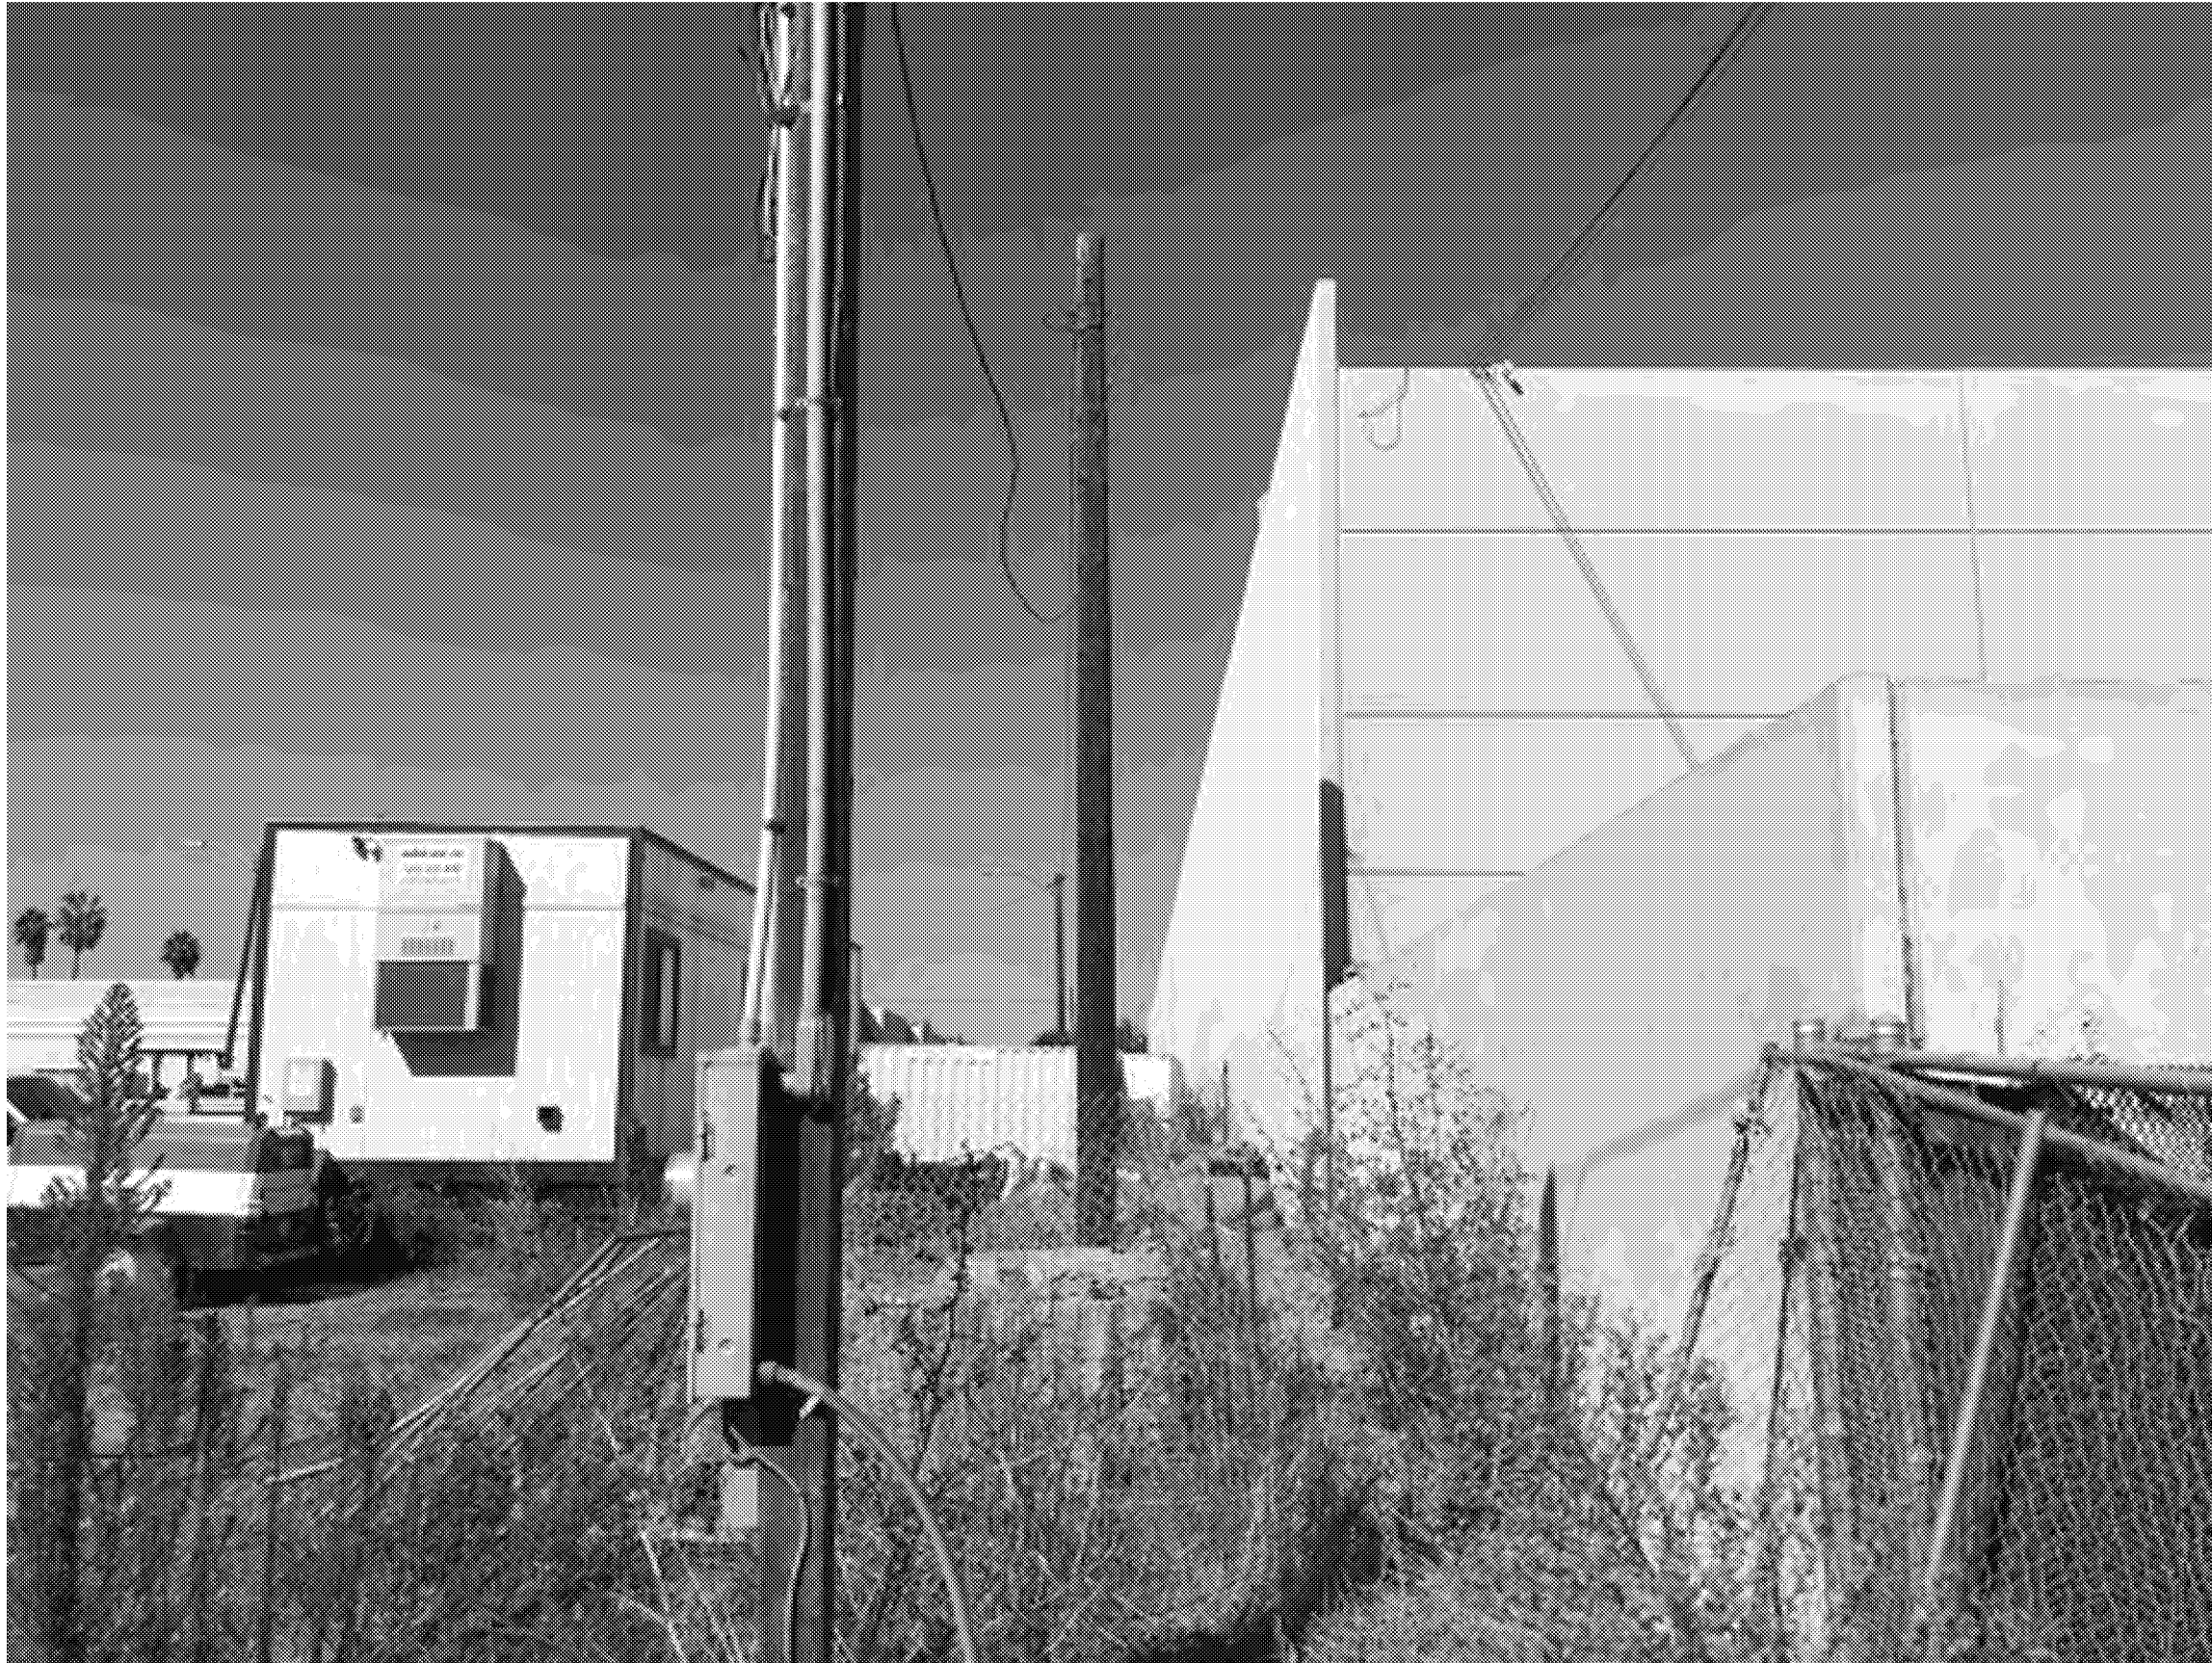
16

NORTHBOUND VIEW FROM SOUTHEAST
CORNER OF PARCEL, ALONG 102ND

SITE SURROUNDED BY CHAIN LINK
FENCE, CMU WALLS AND A WROUGHT
IRON FENCE WITH PILASTERS

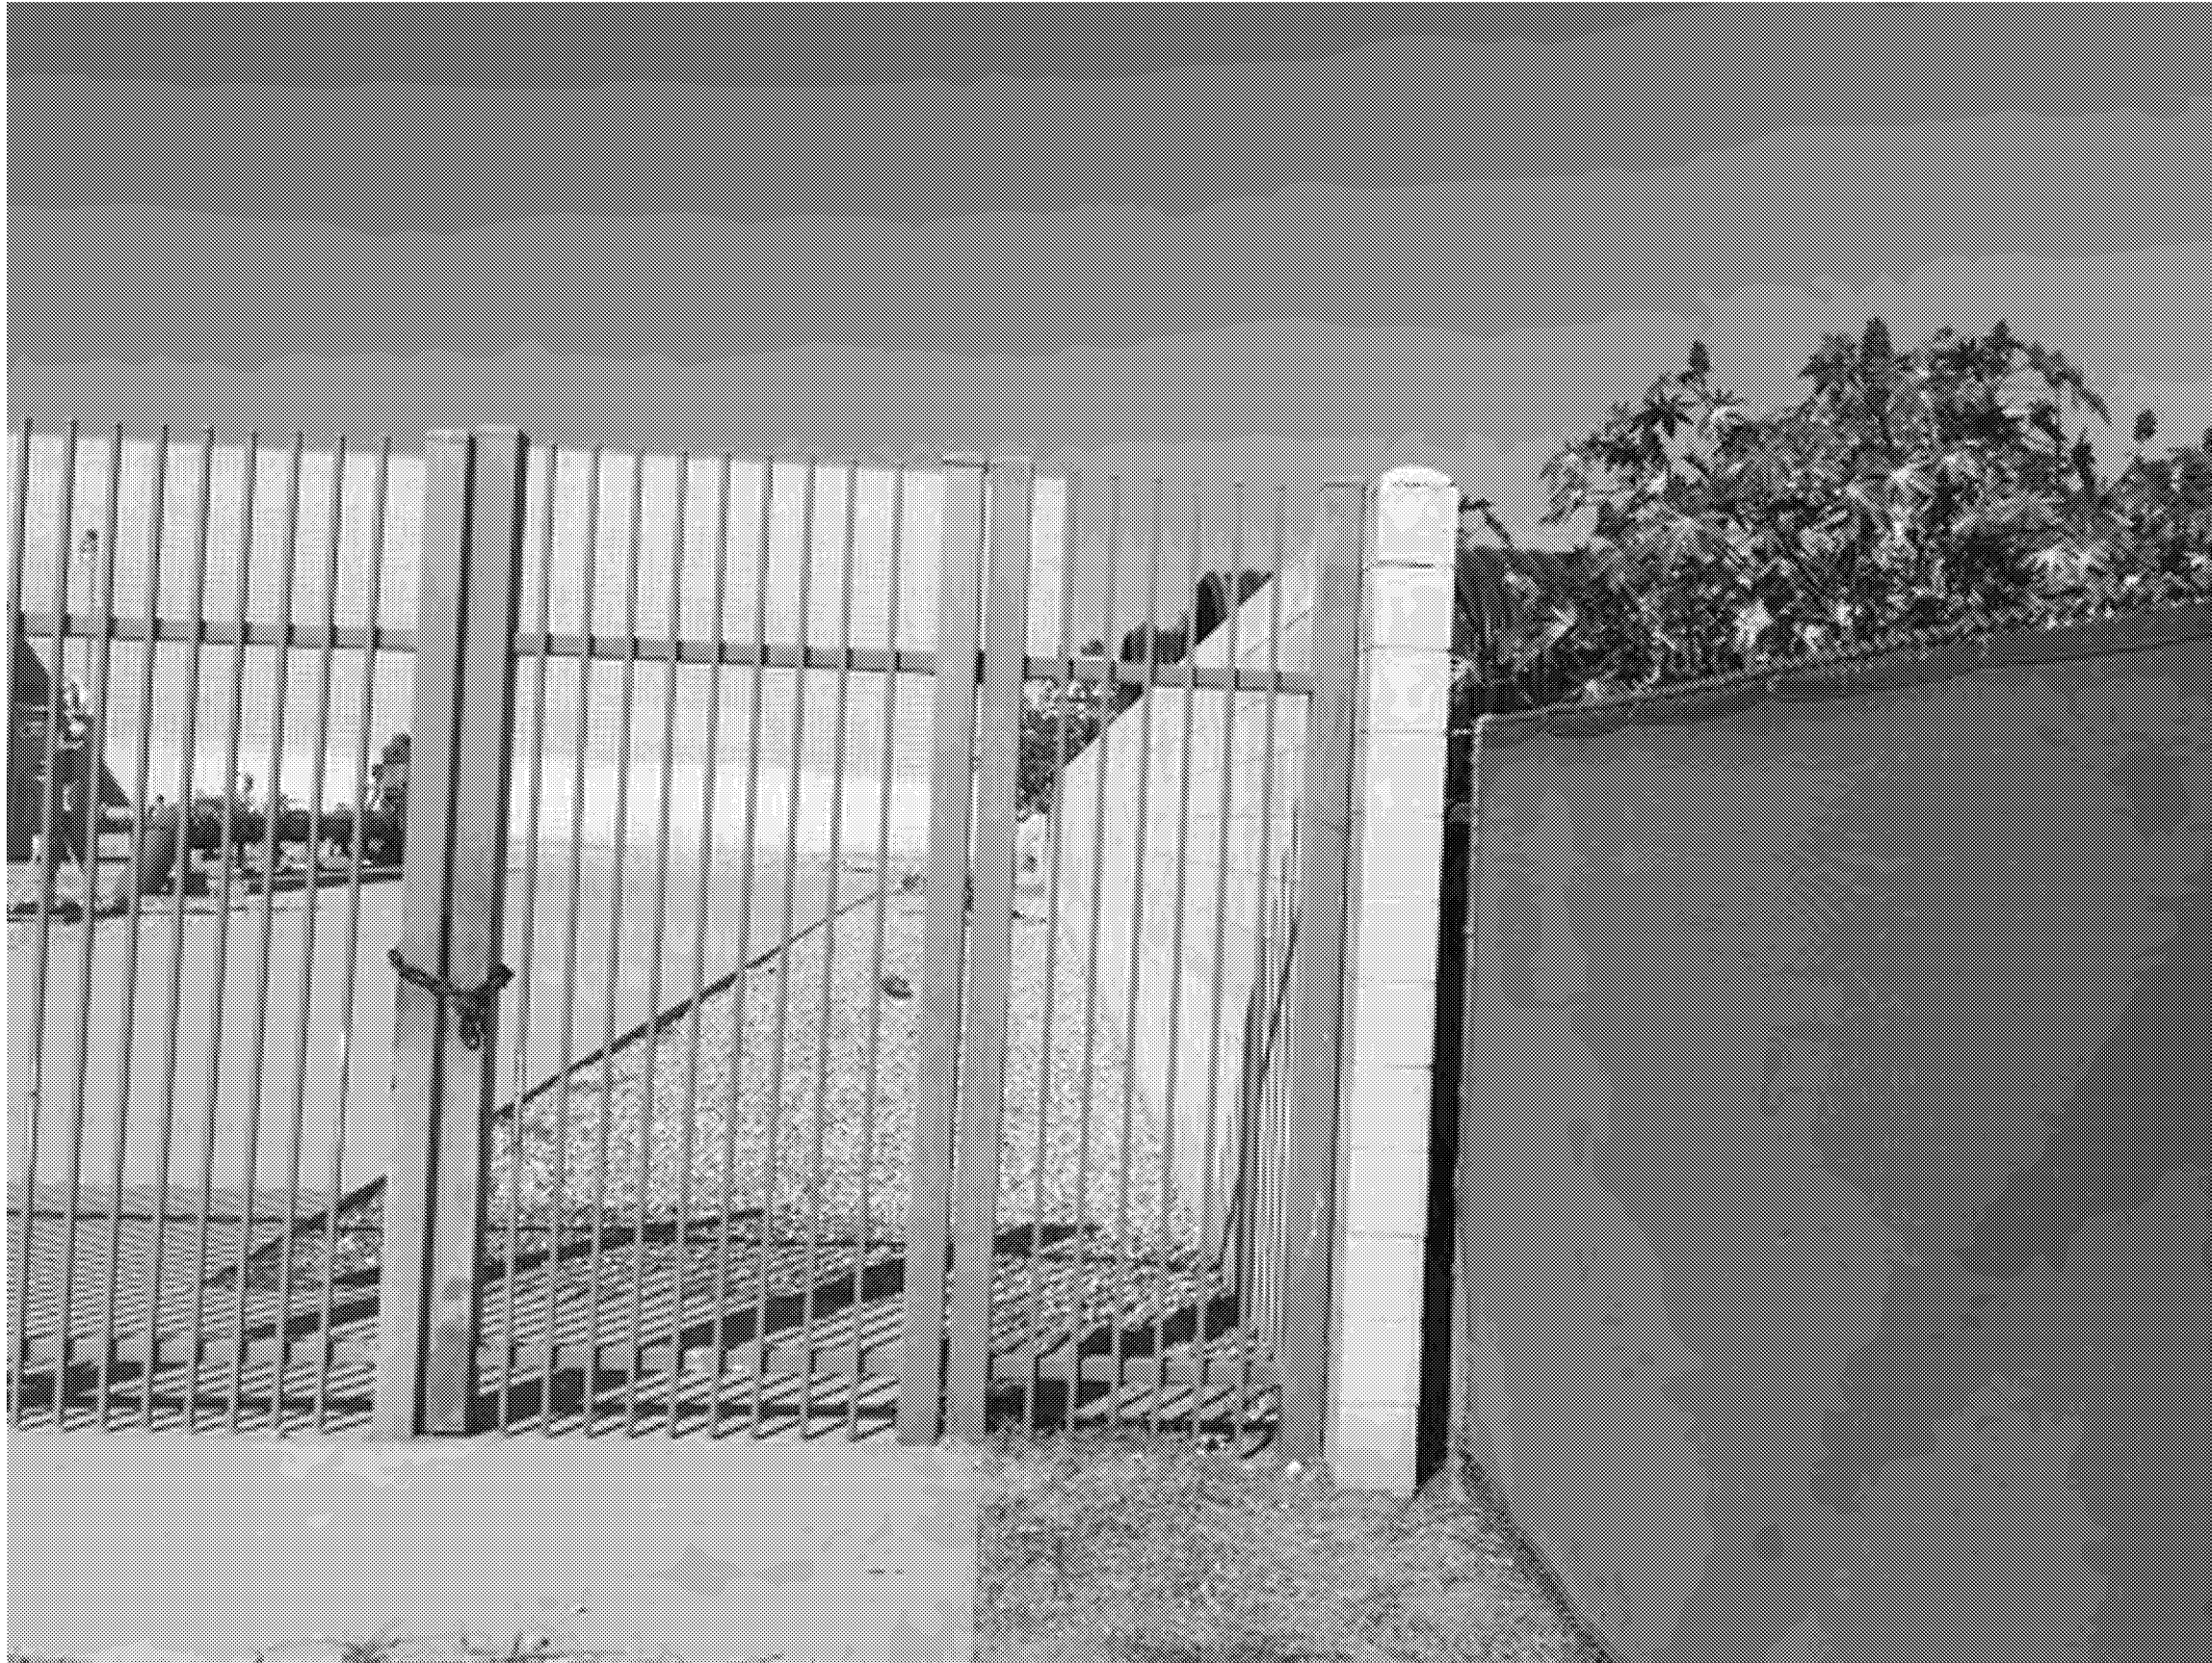
17

NORTHBOUND VIEW FROM SOUTHWEST
CORNER OF PARCEL, ALONG 102ND

SITE SURROUNDED BY CHAIN LINK
FENCE, CMU WALLS AND A WROUGHT
IRON FENCE WITH PILASTERS

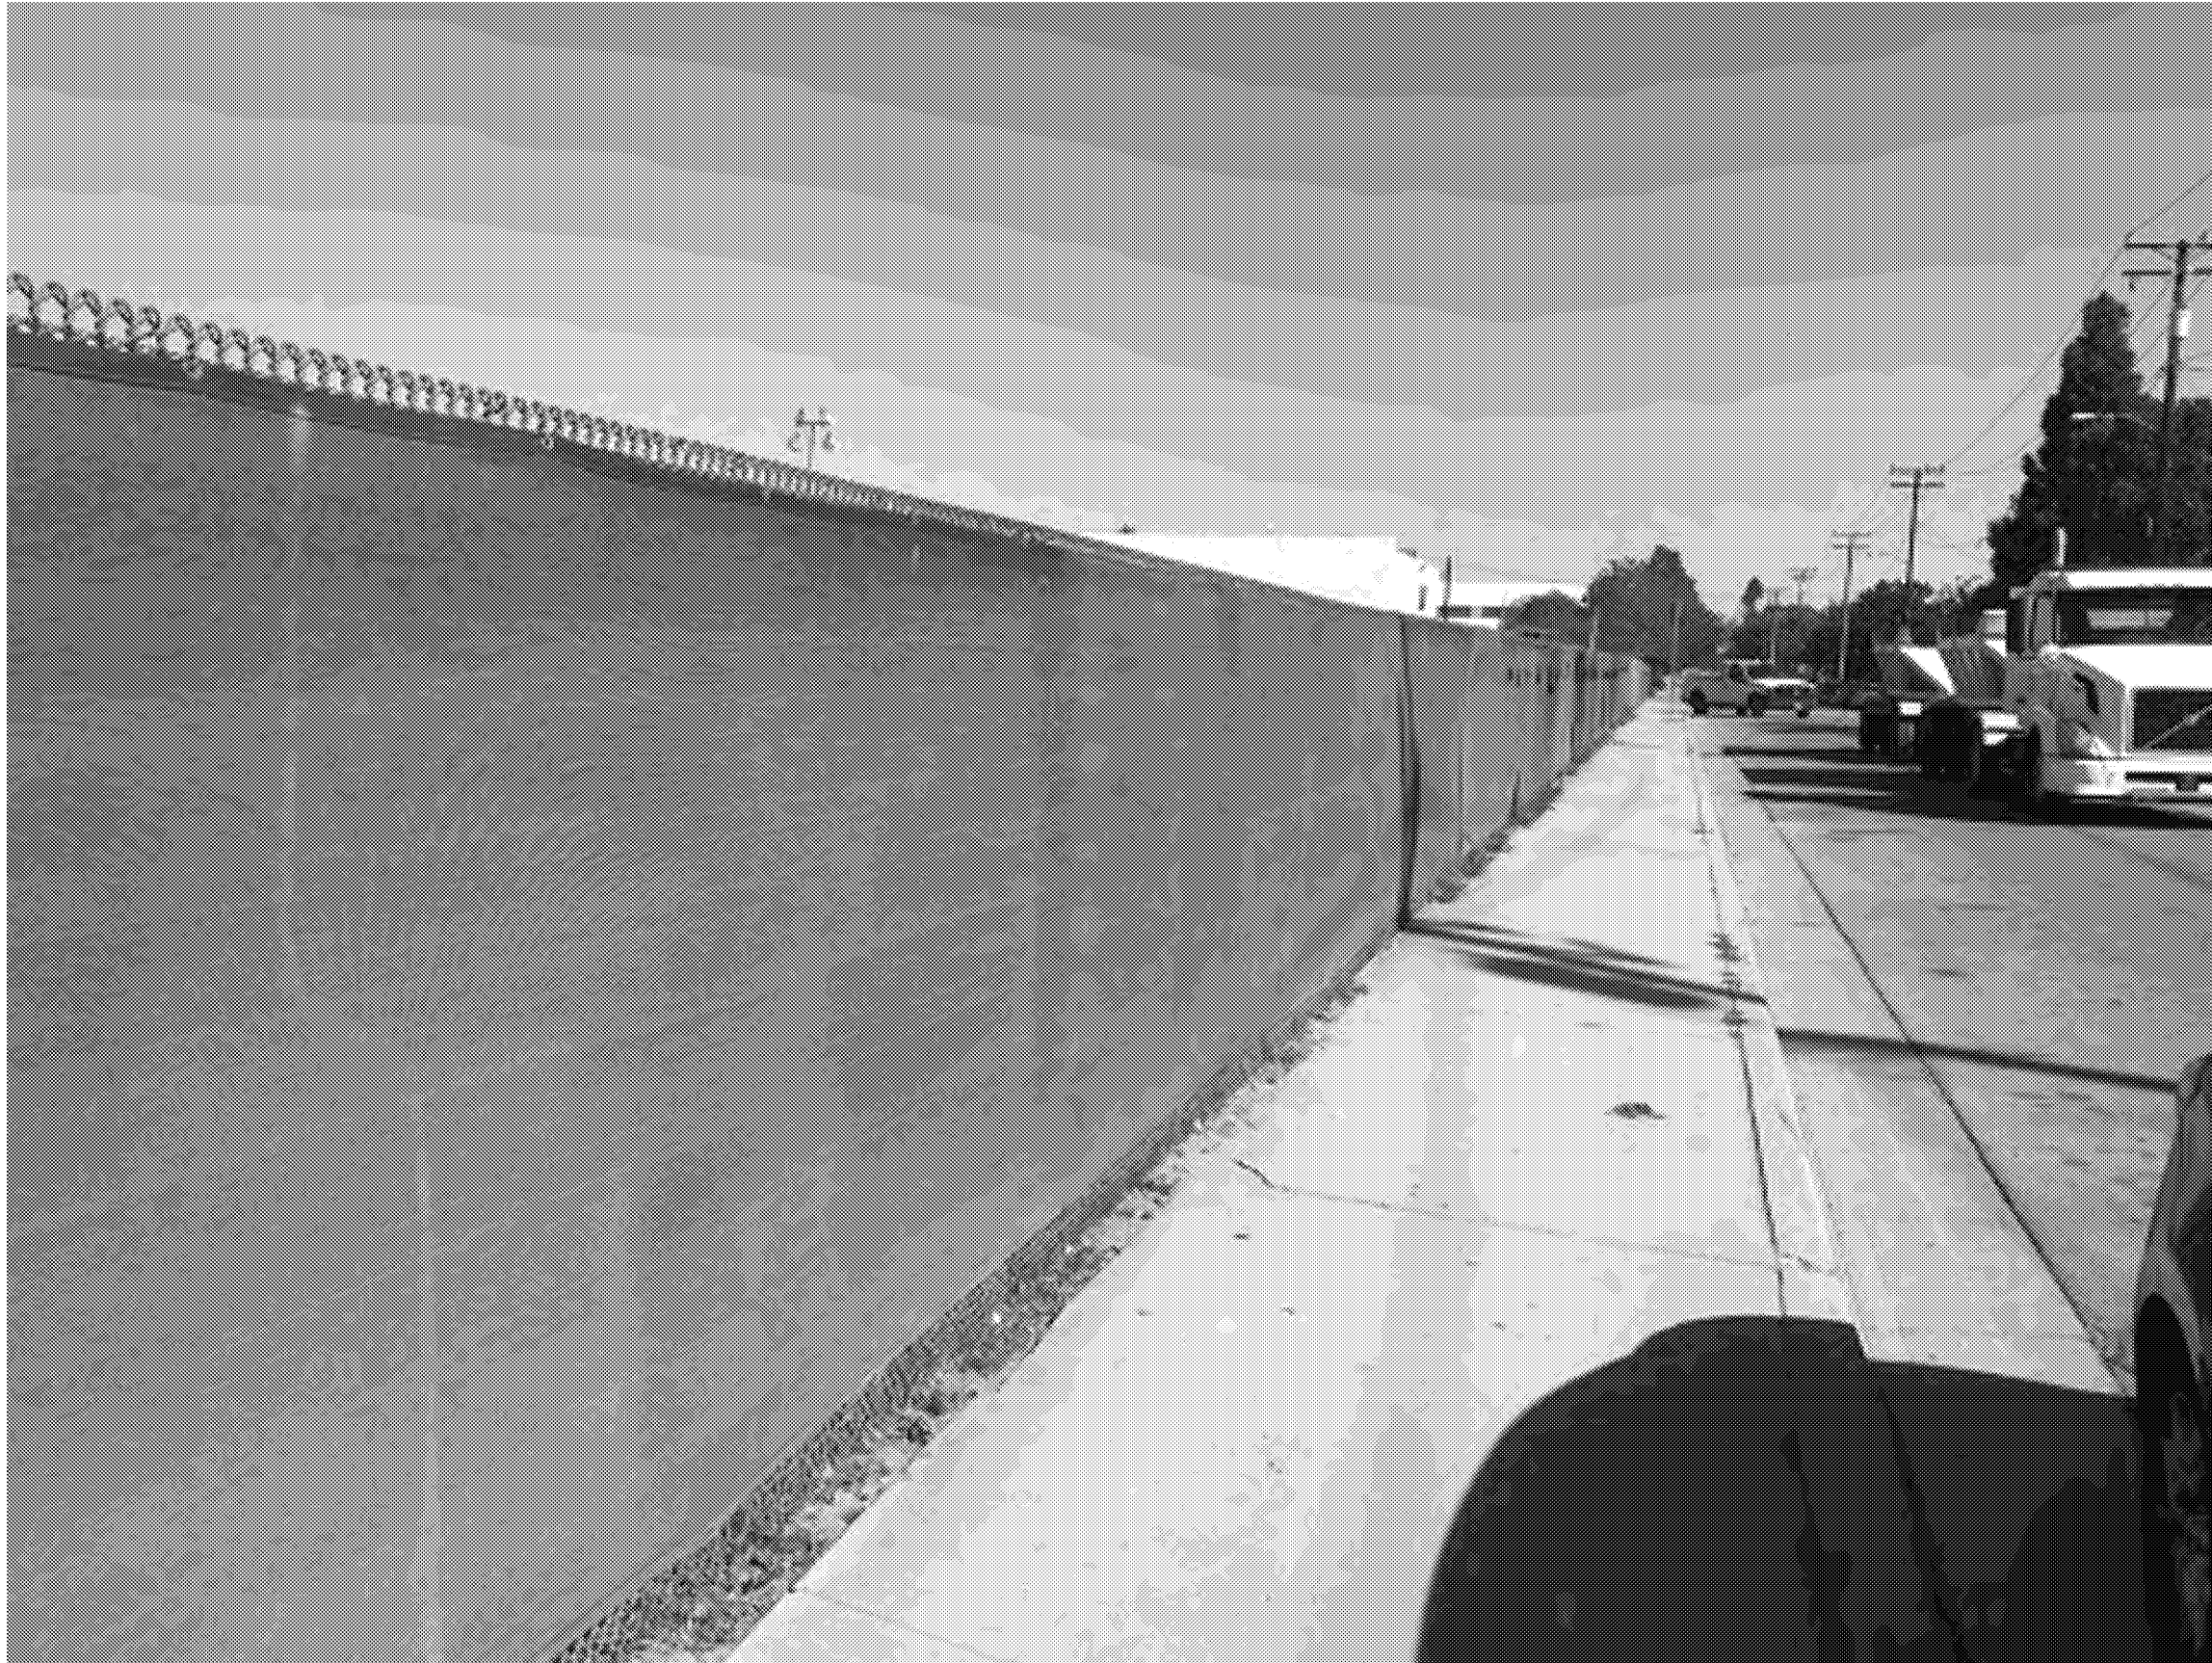
18

EASTBOND VIEW FROM SOUTHWEST
CORNER OF PARCEL, ALONG 102ND

SITE SURREOUNDED BY CHAIN LINK
FENCE, CMU WALLS AND A WROUGHT
IRON FENCE WITH PILASTERS
