<p>D & D ENGINEERING, INC. 8901 S. LA CIENEGA BLVD, SUITE 106 INGLEWOOD, CA 90301 Phone: 424-393-4122</p>	PROJECT CONDOR	SCALE: AS SHOWN
	PERIMETER CONDITIONS EXHIBIT	DATE: 2017/10/24
		SHT NO.: 01 OF 01

PHOTO KEY MAP

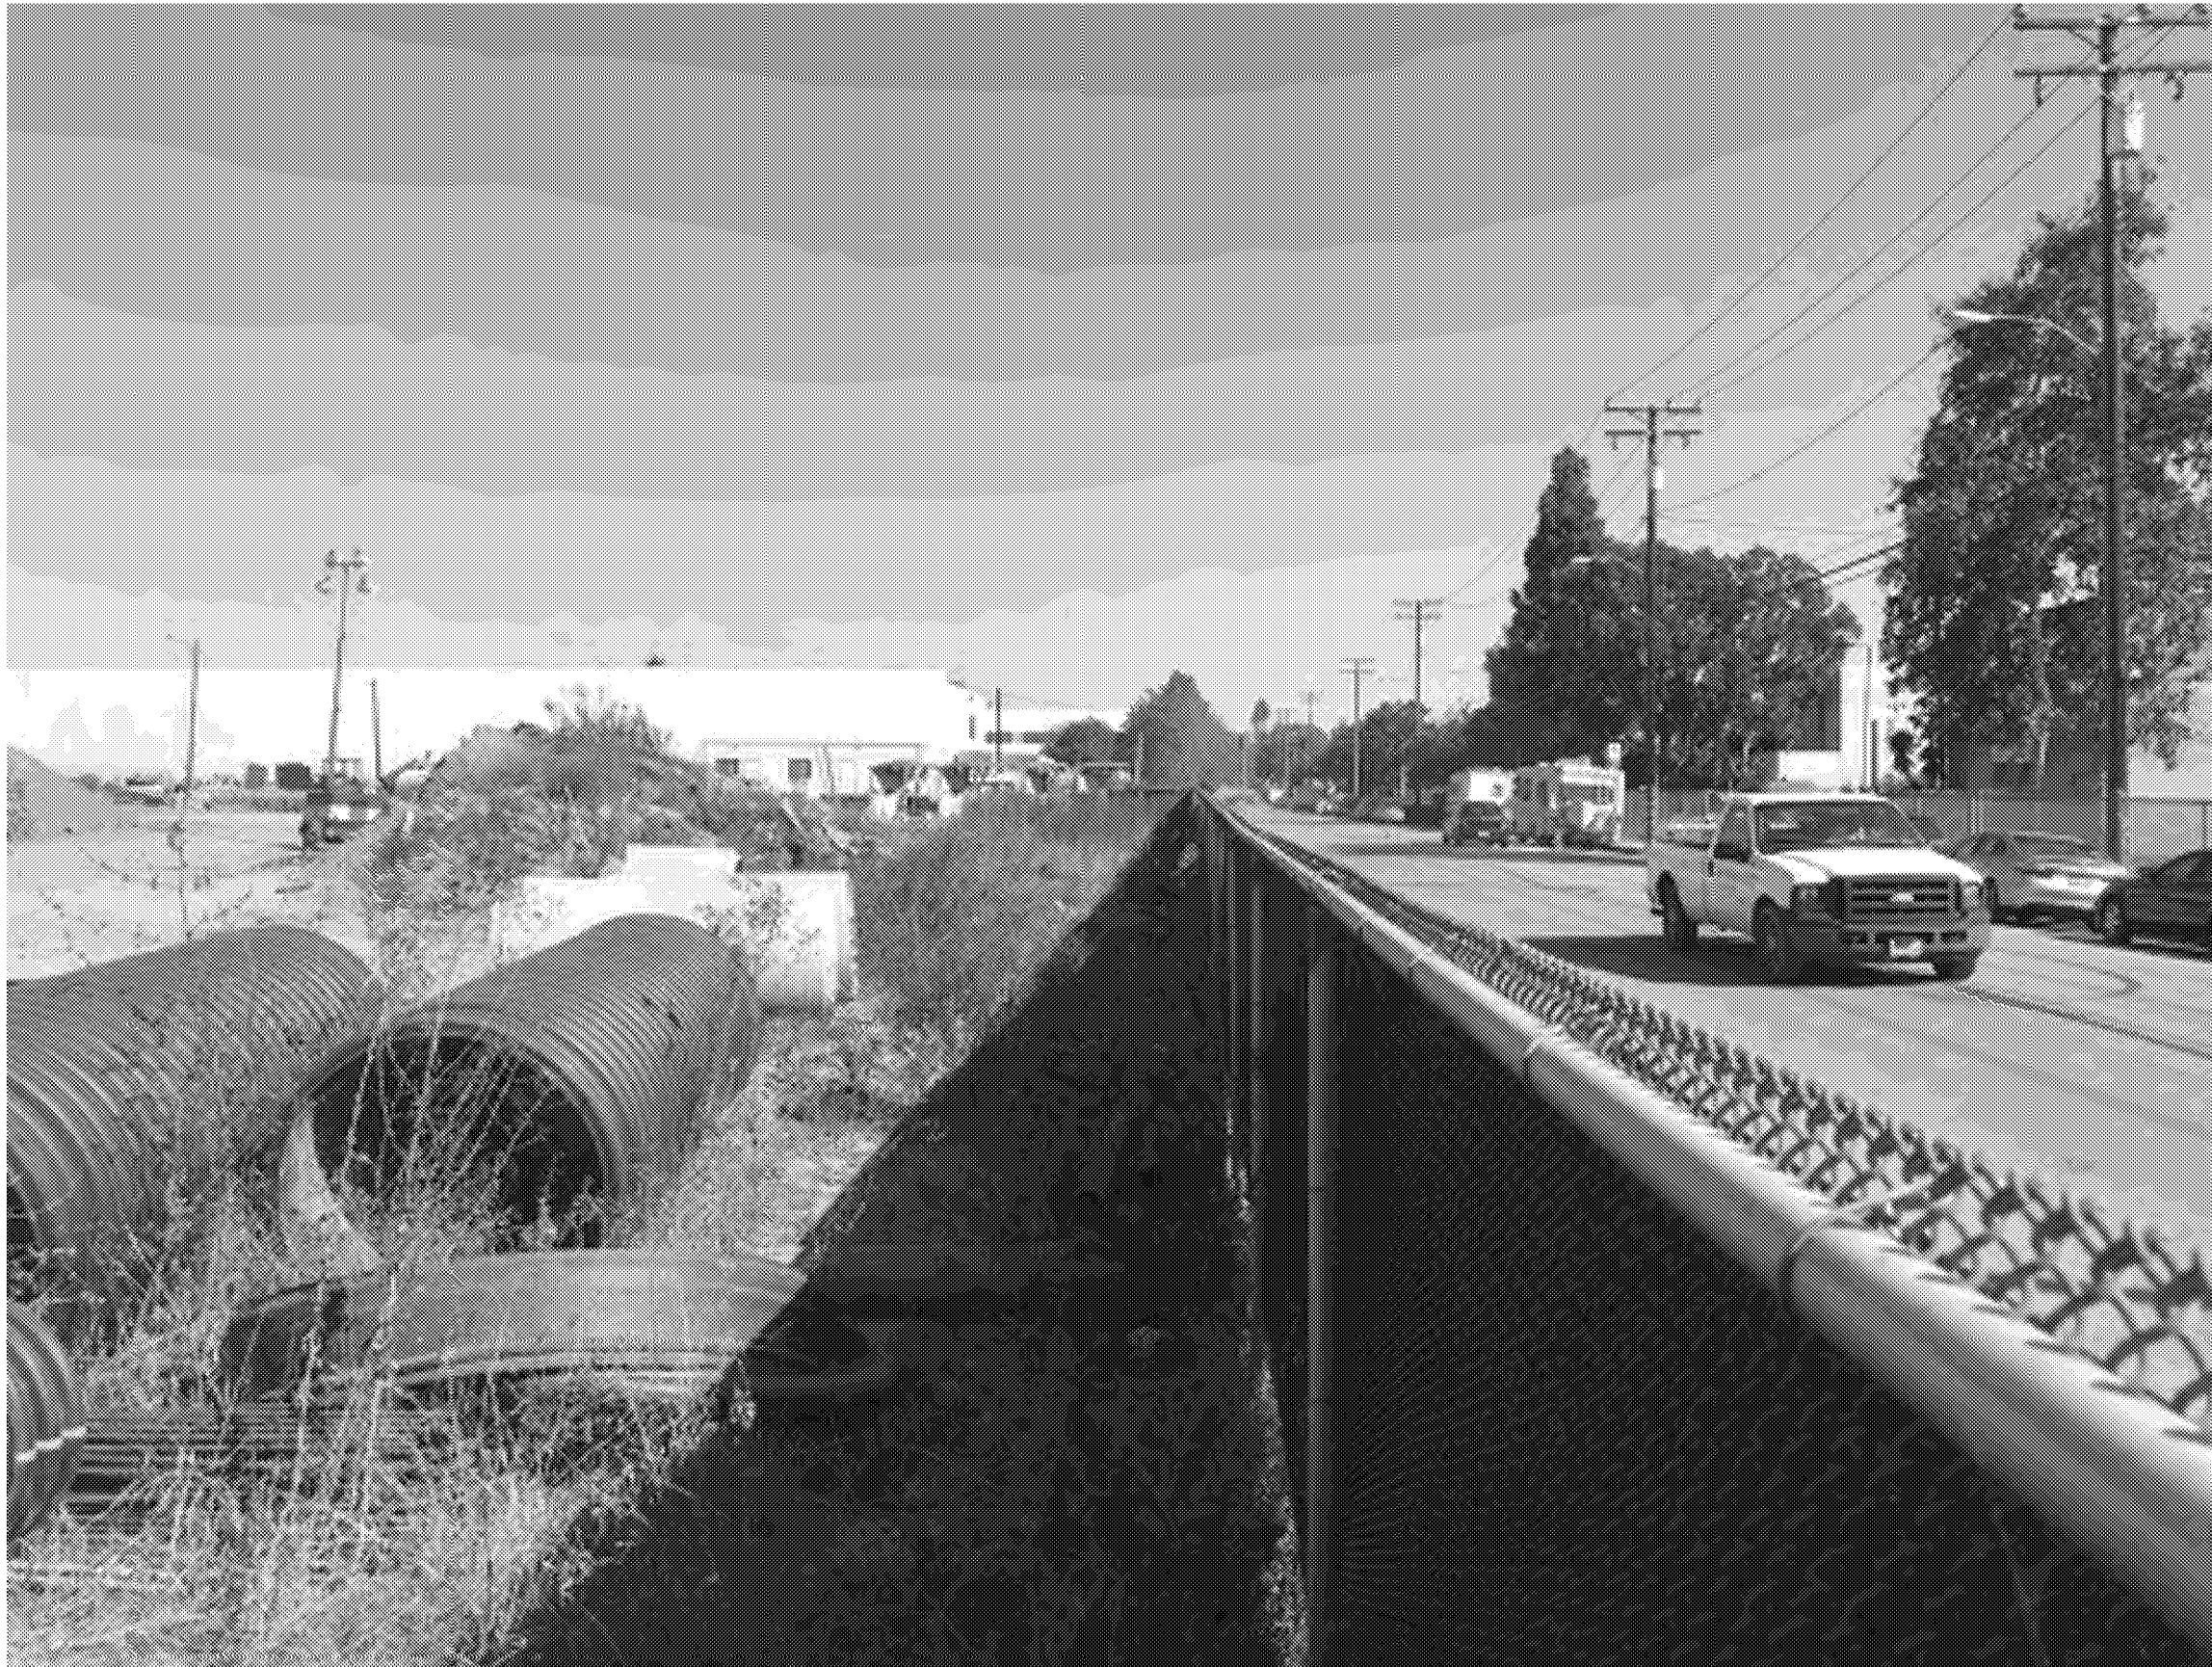
EASTBOUND VIEW FROM SOUTHEAST
CORNER OF PARCEL, ALONG 102ND

SITE SURREOUNDED BY CHAIN LINK
FENCE, CMU WALLS AND A WROUGHT
IRON FENCE WITH PILASTERS

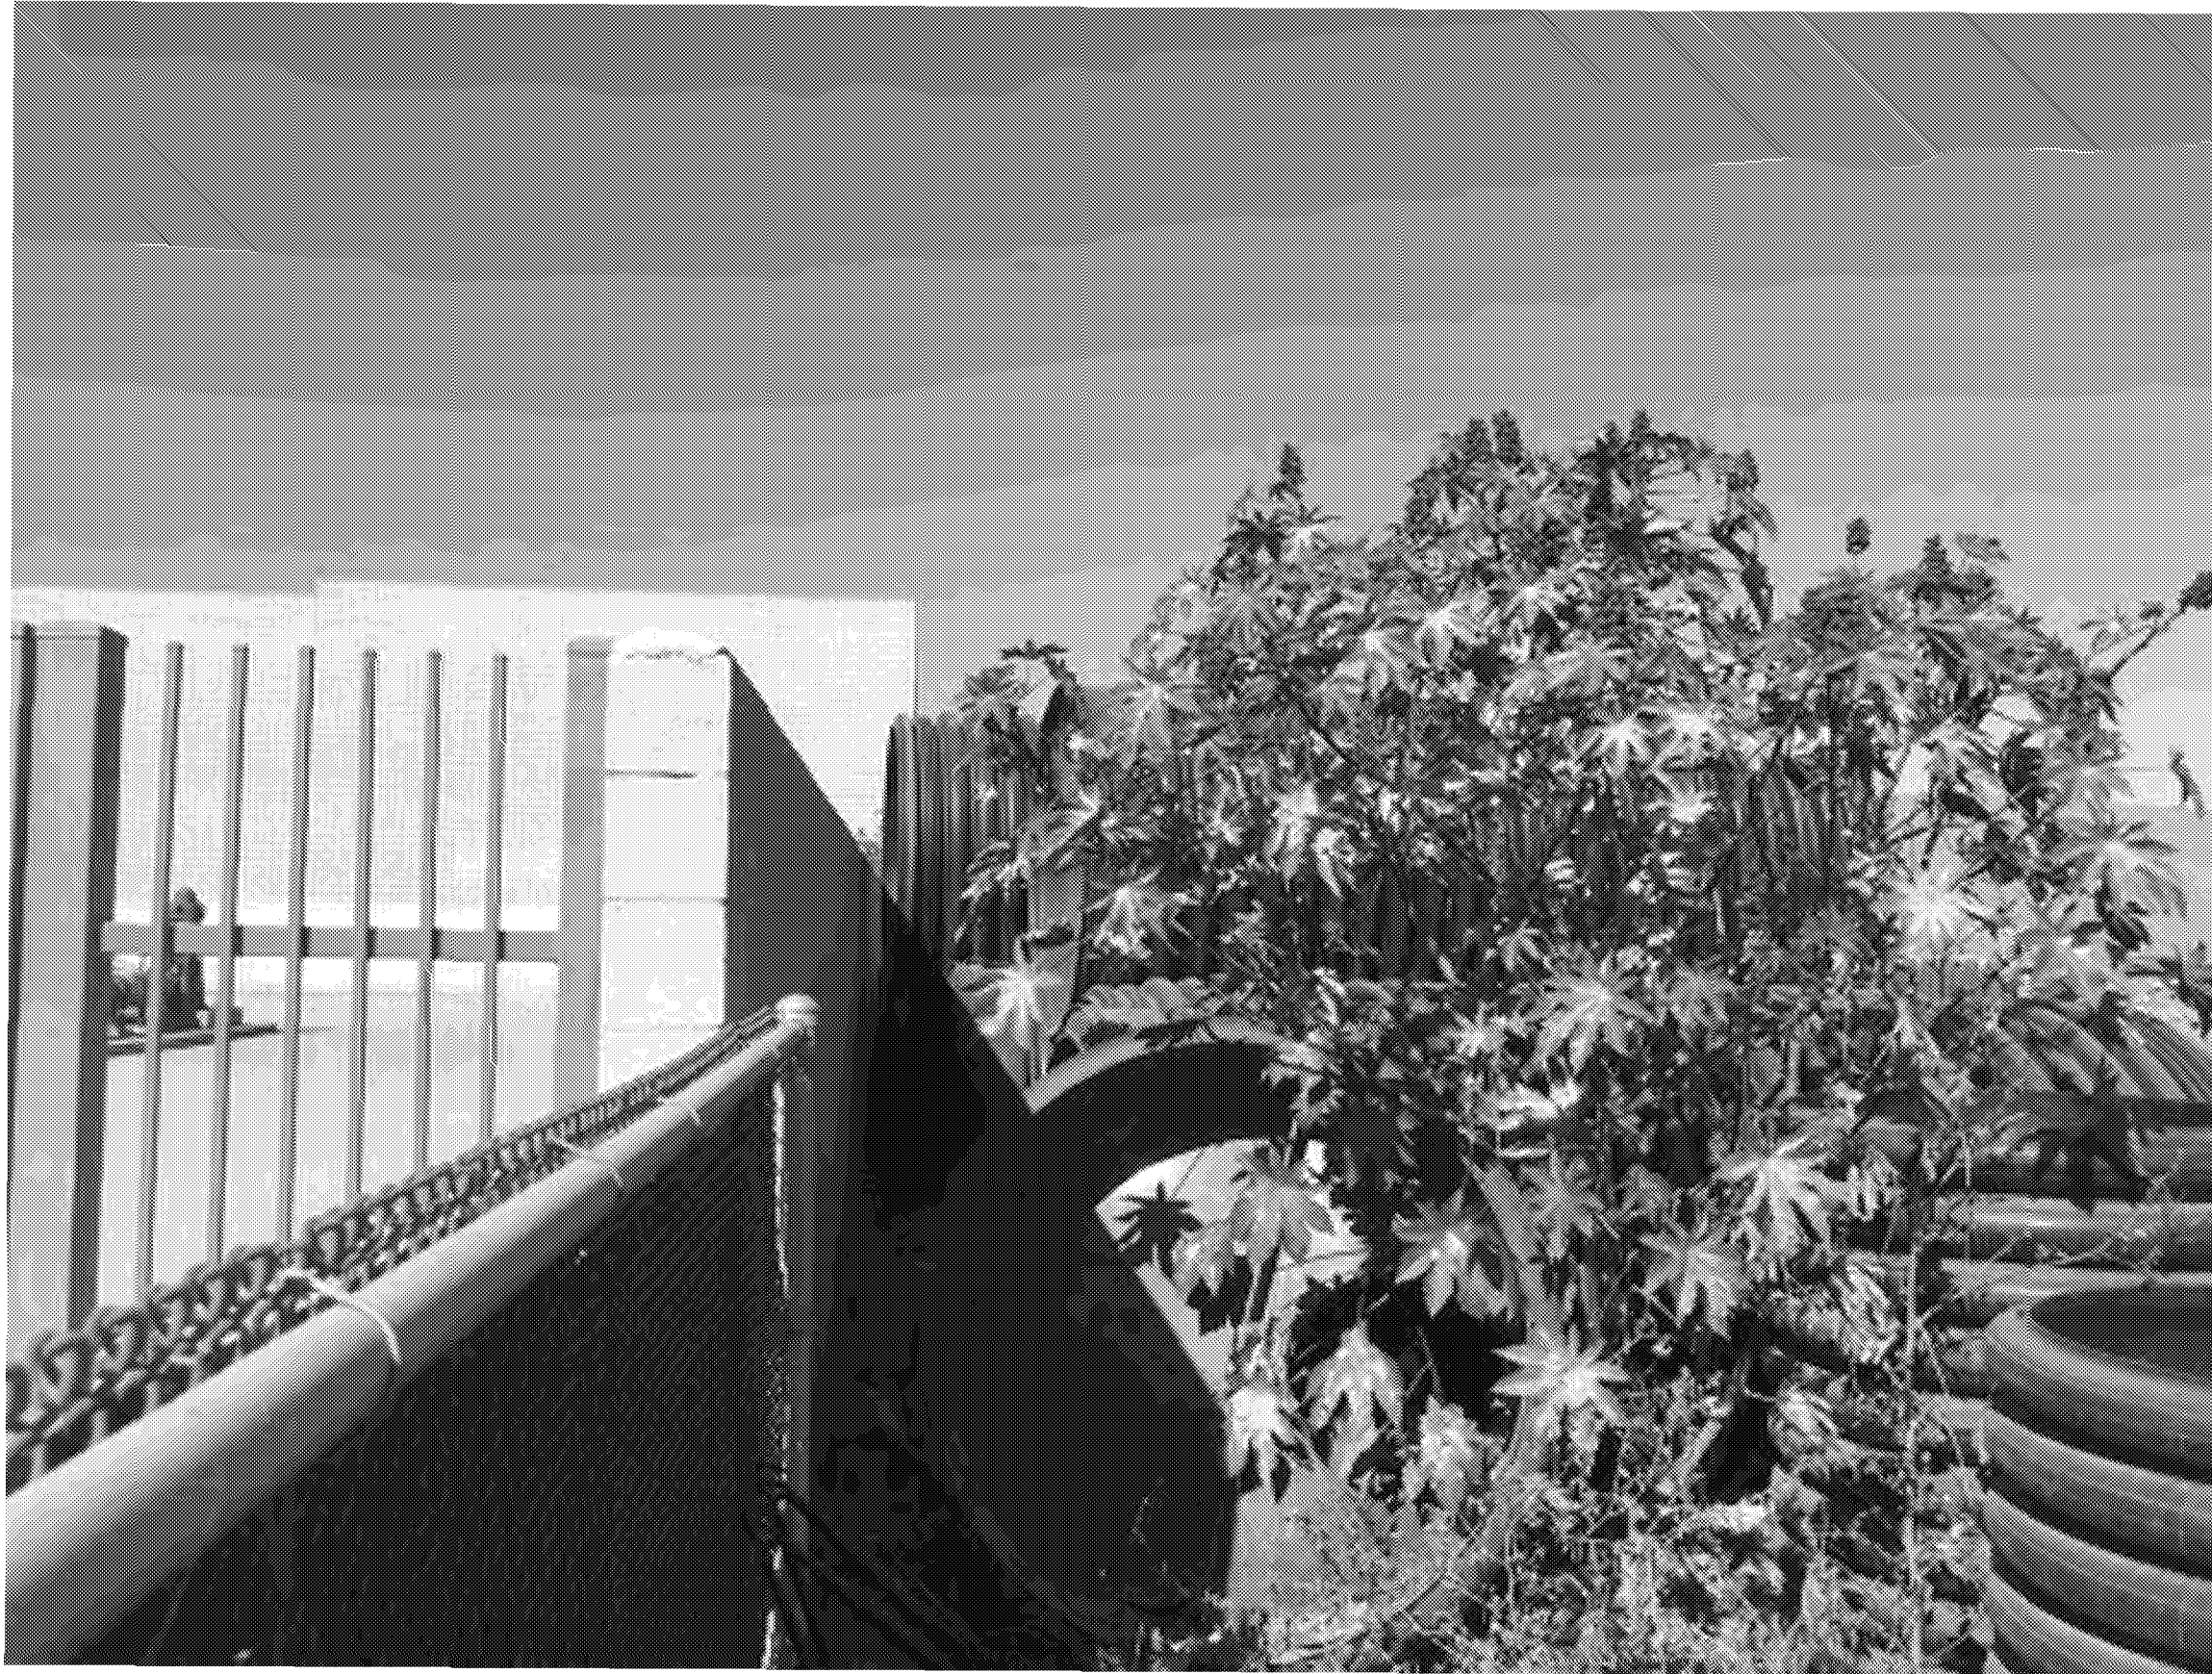
20

NORTHBOUND VIEW FROM SOUTHWEST
CORNER OF PARCEL, ALONG 102ND

SITE SURROUNDED BY CHAIN LINK
FENCE, CMU WALLS AND A WROUGHT
IRON FENCE WITH PILASTERS

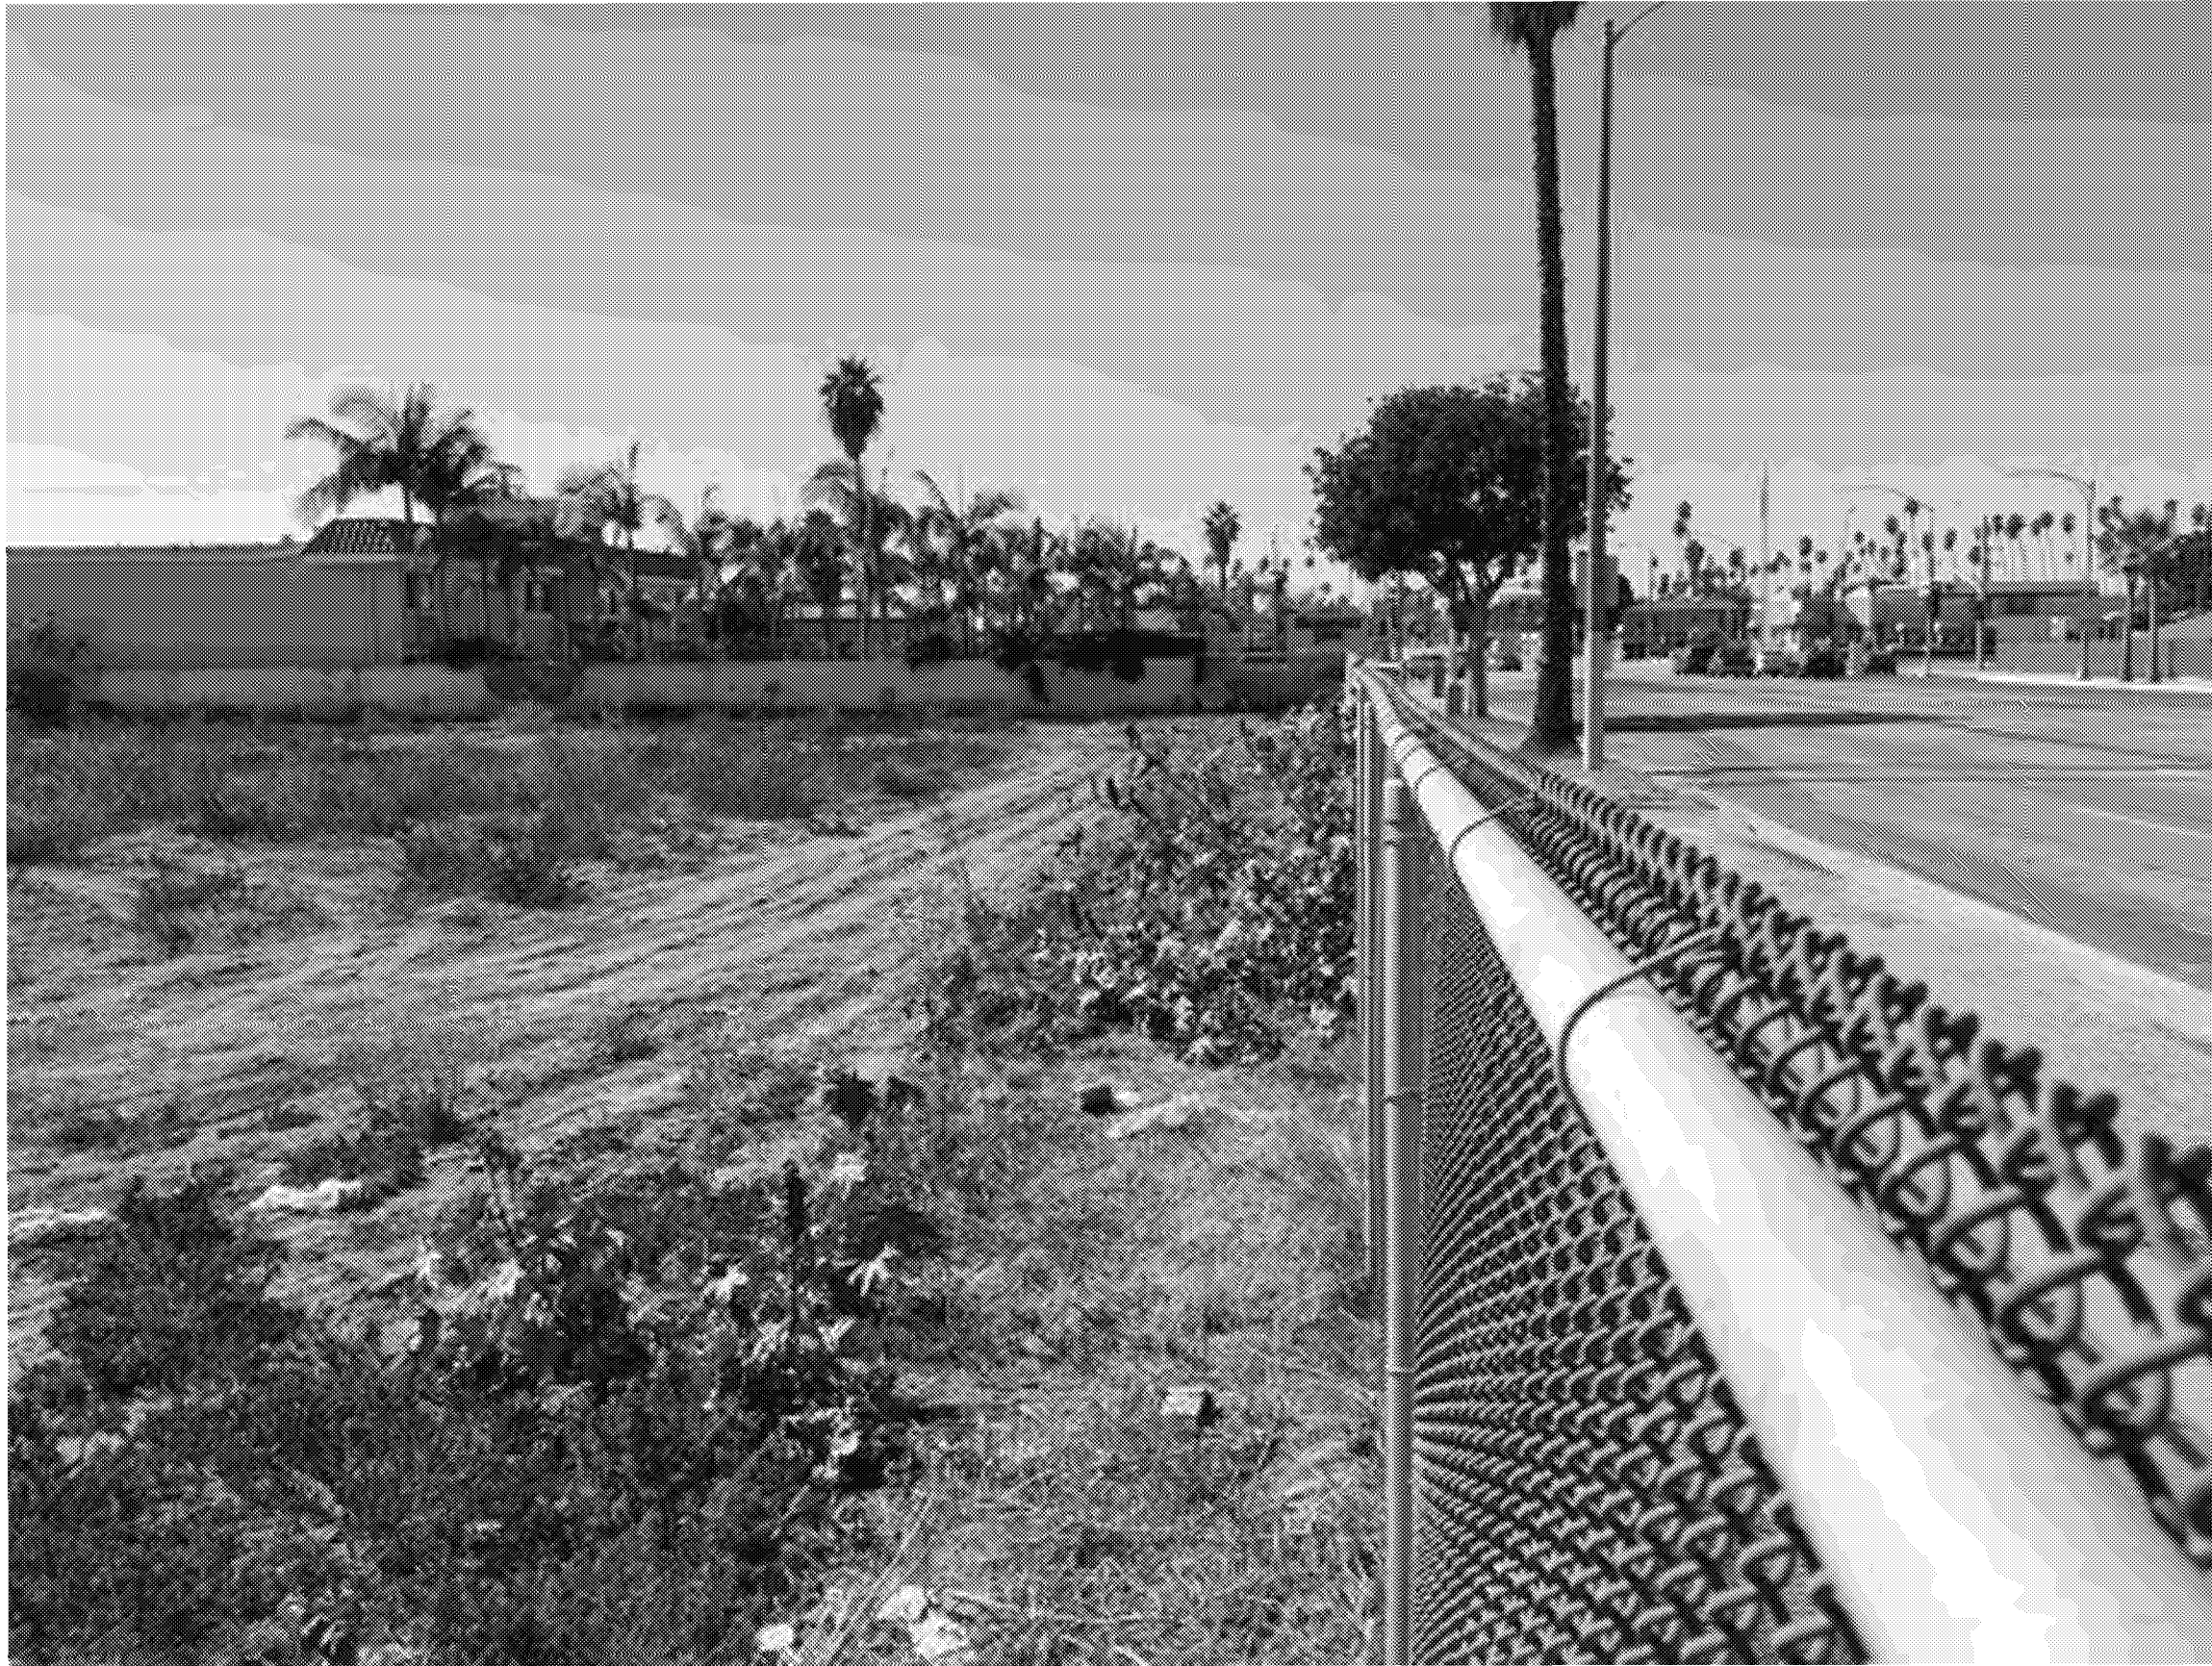
WESTBOUND VIEW FROM NORTHEAST
CORNER OF PARCEL, ALONG CENTURY

SITE SURROUNDED BY CHAIN LINK
FENCE, CMU WALLS AND A WROUGHT
IRON FENCE WITH PILASTERS

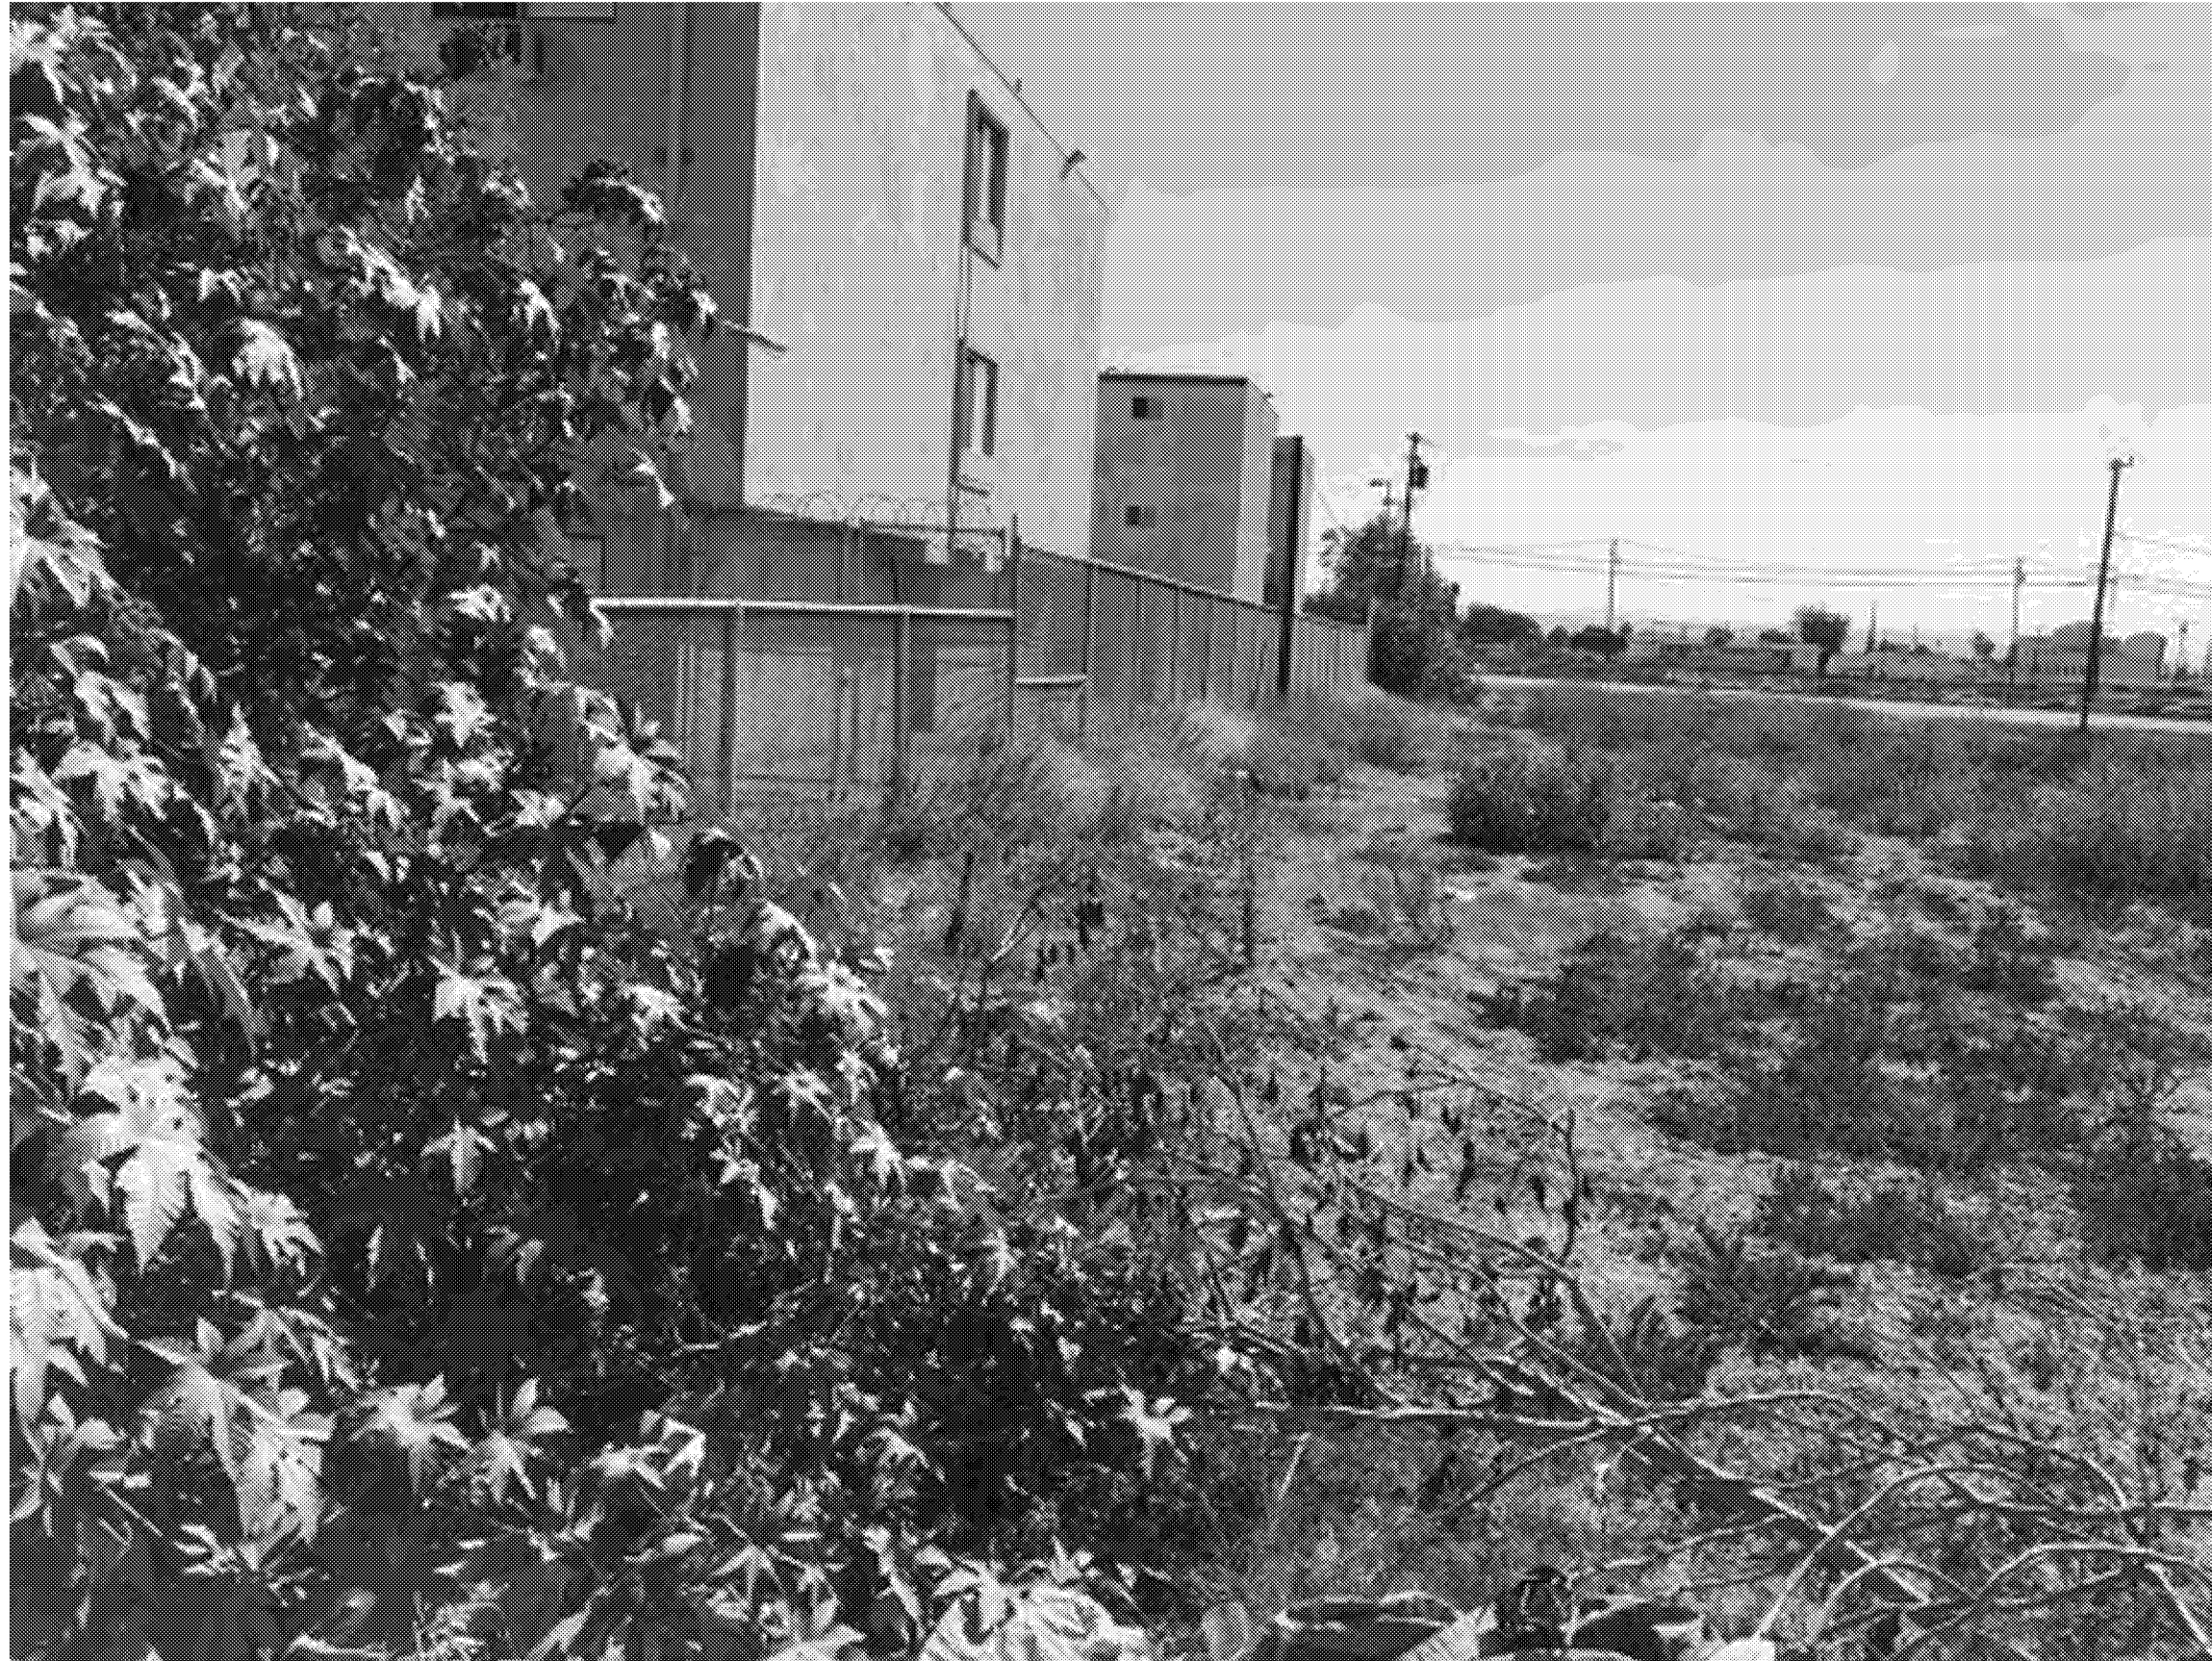
22

SOUTHBOUND VIEW FROM NORTHEAST
CORNER OF PARCEL, ALONG CENTURY

SITE SURROUNDED BY CHAIN LINK
FENCE, CMU WALLS AND A WROUGHT
IRON FENCE WITH PILASTERS

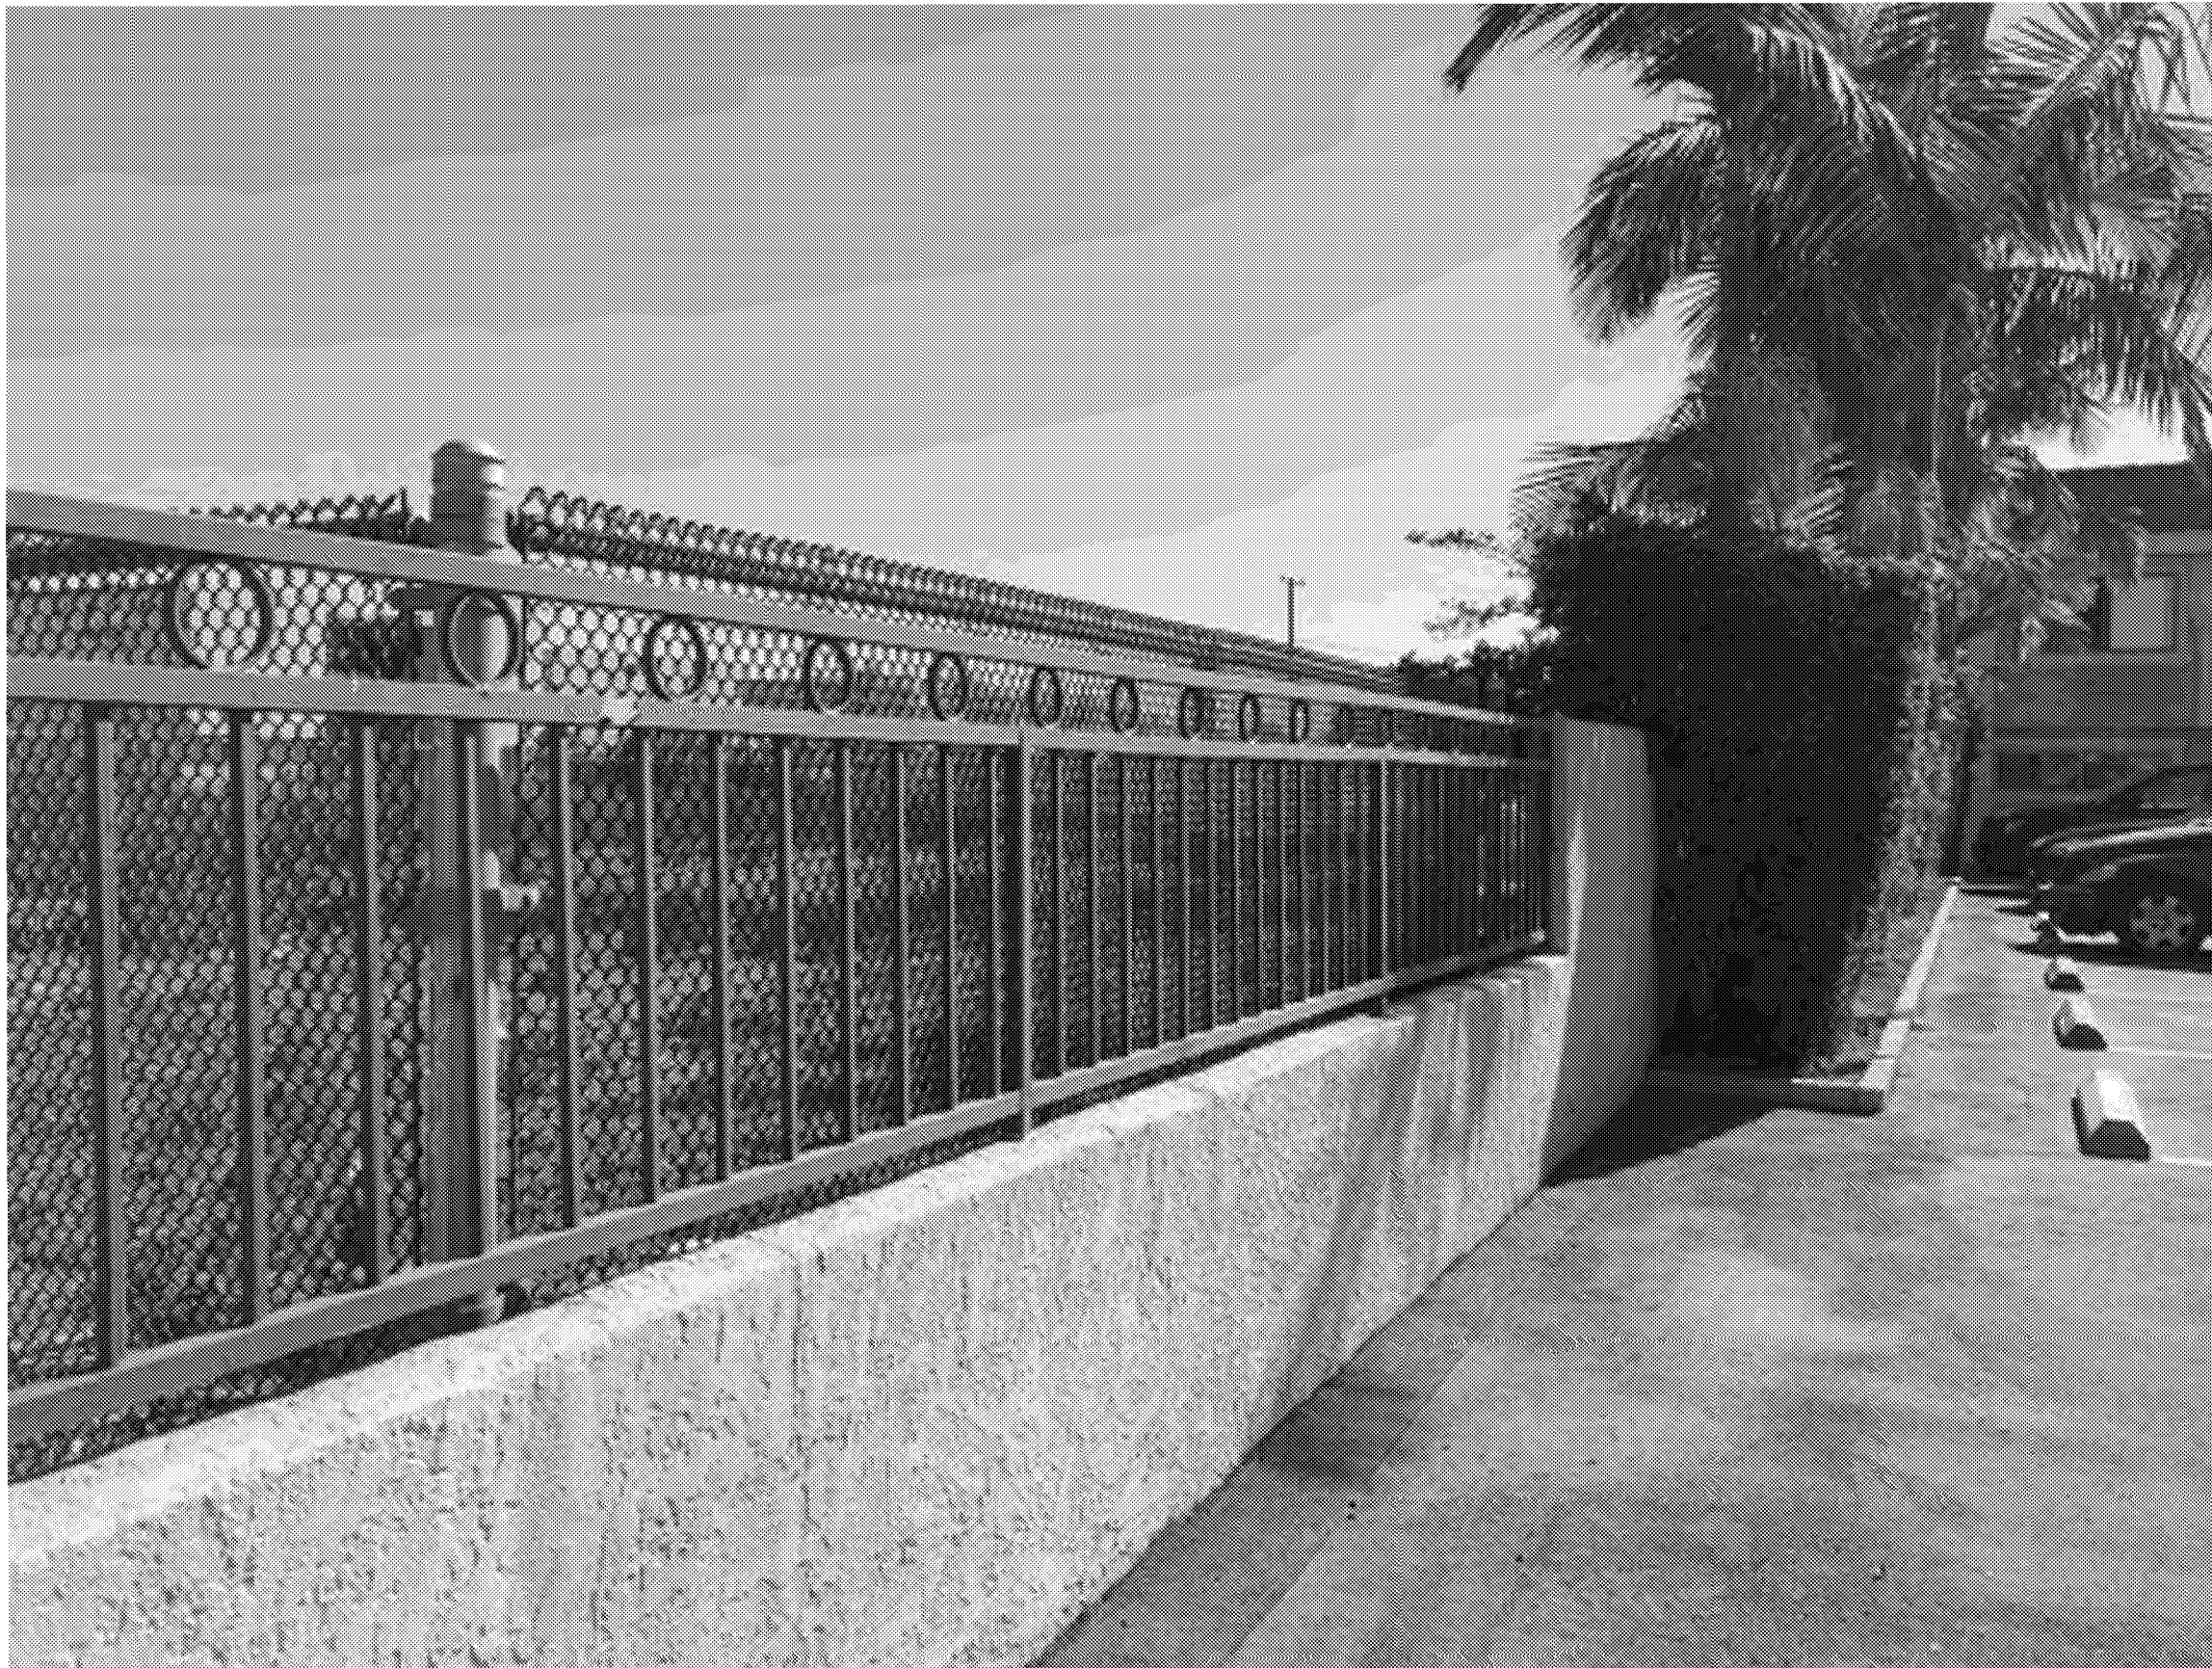
23

SOUTHBOUND VIEW FROM NORTHWEST
CORNER OF PARCEL, ALONG CENTURY

SITE SURROUNDED BY CHAIN LINK
FENCE, CMU WALLS AND A WROUGHT
IRON FENCE WITH PILASTERS

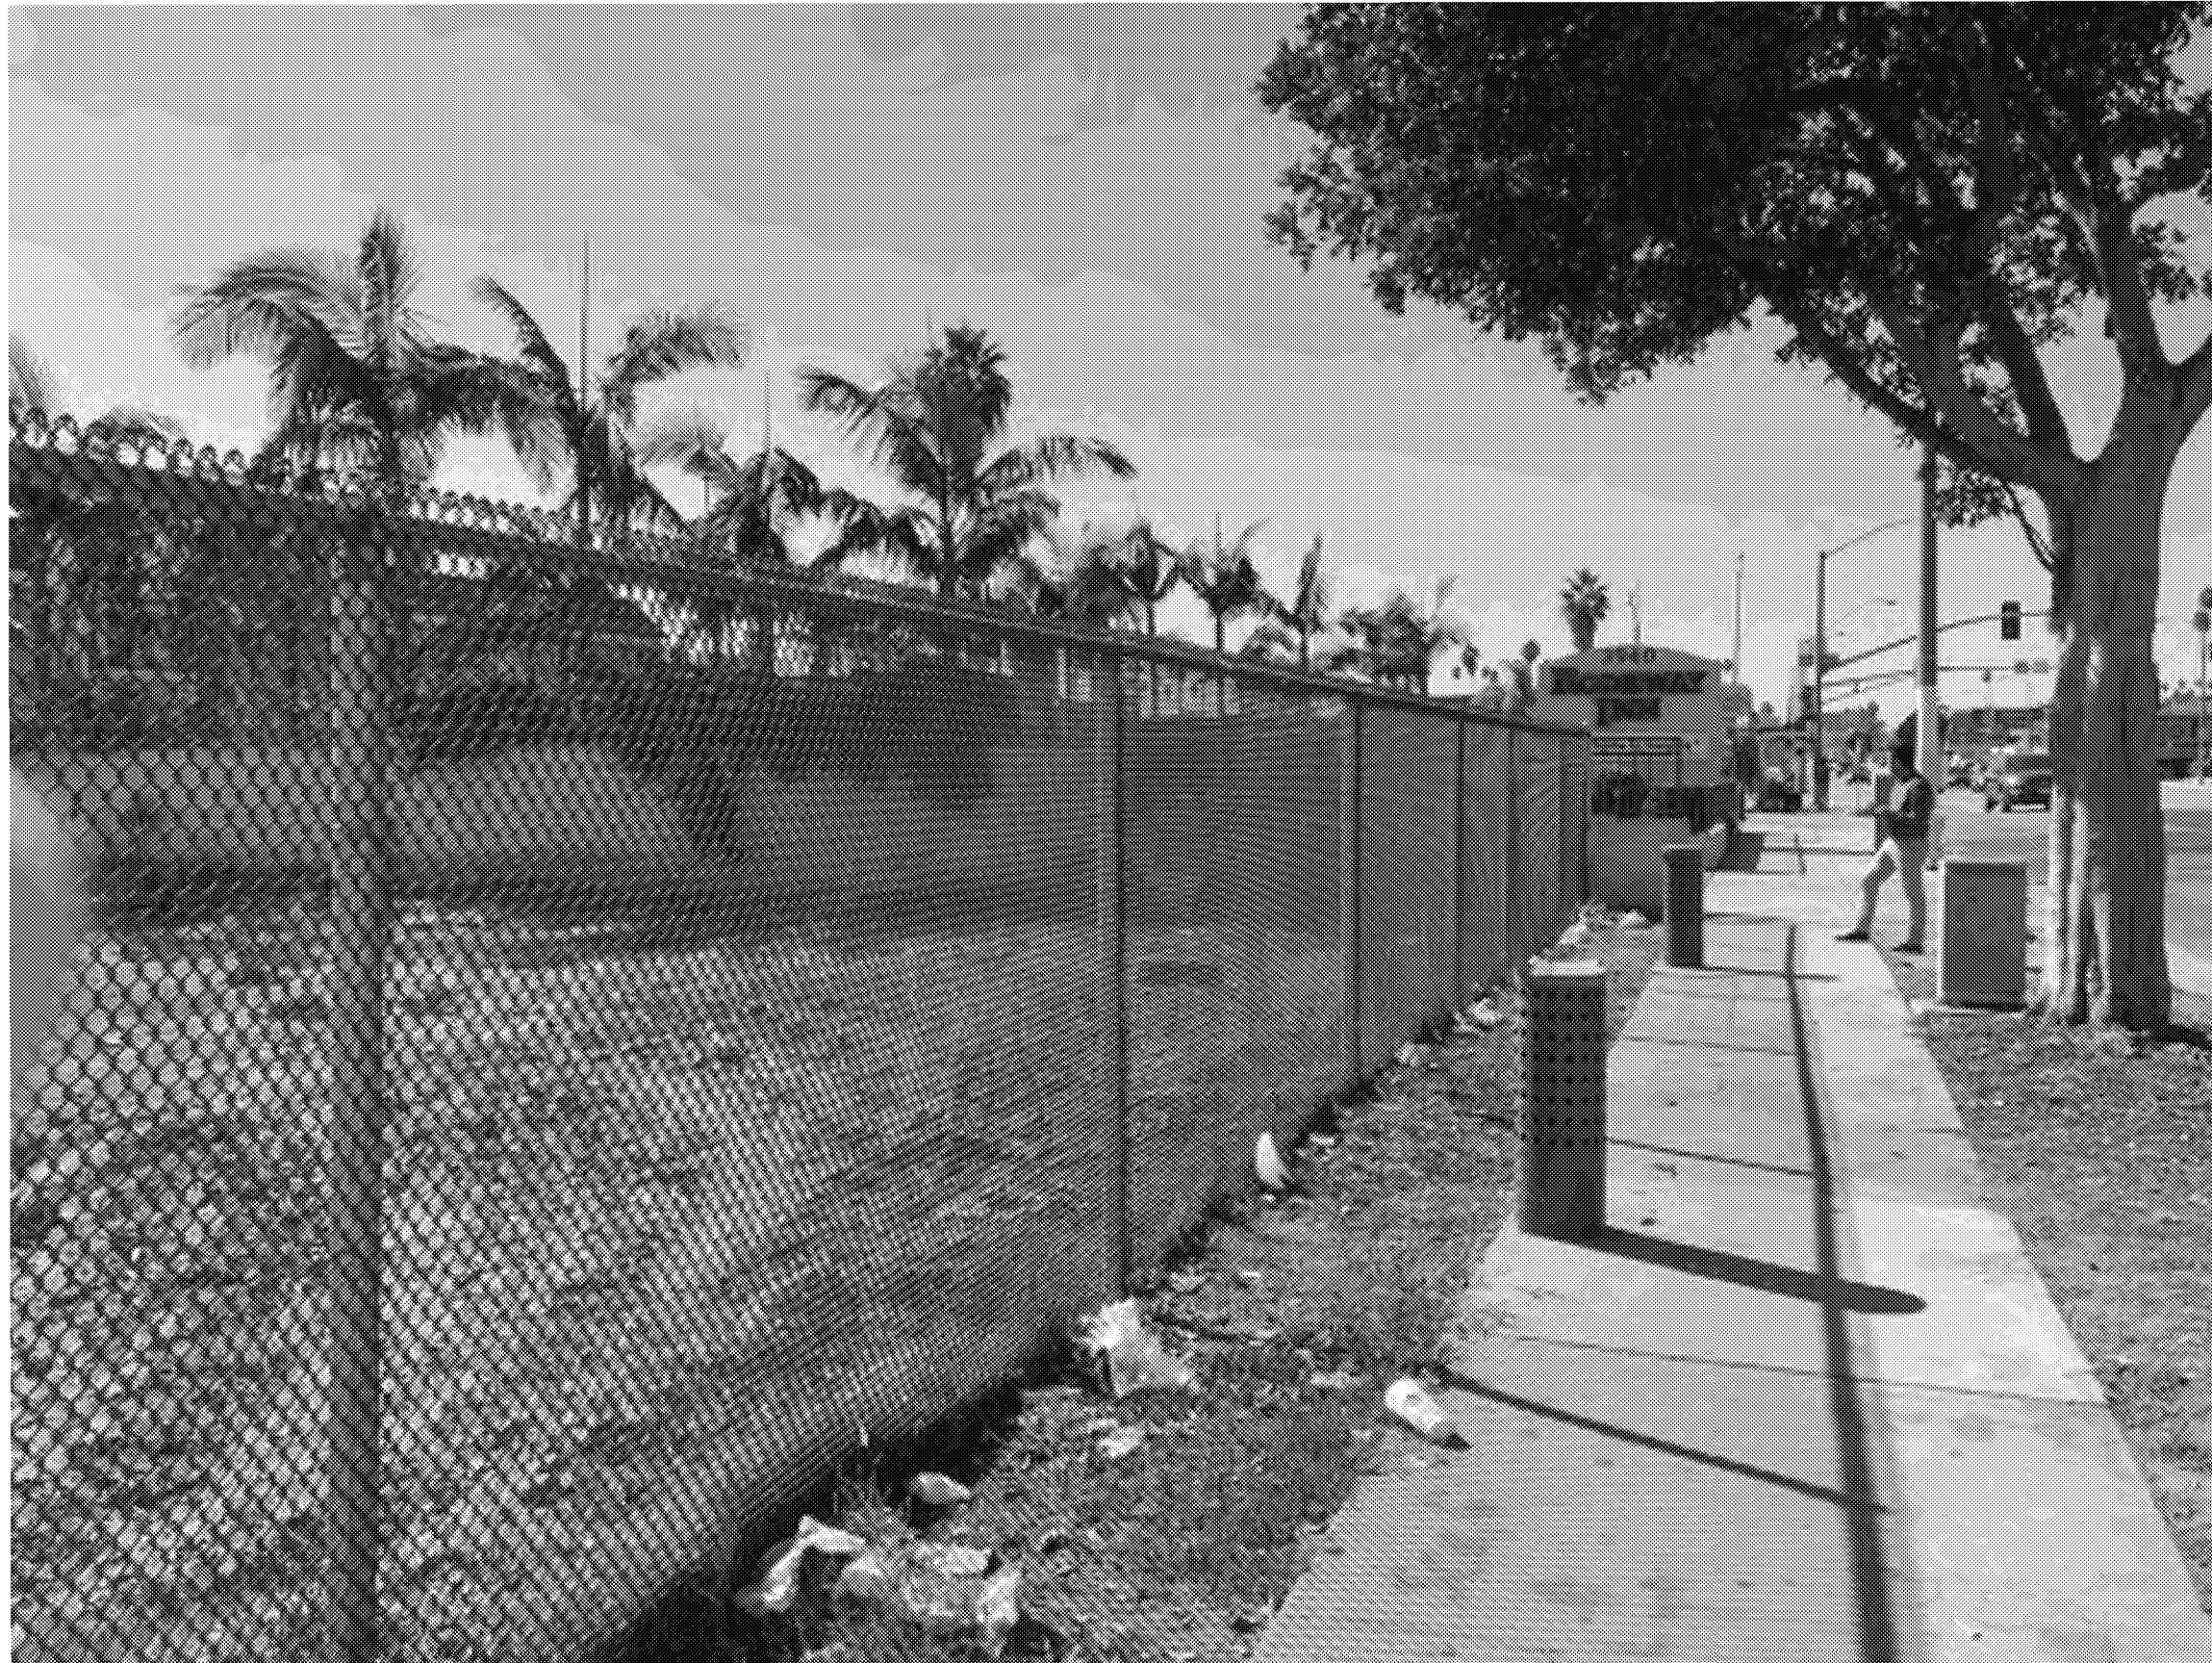
24

WESTBOUND VIEW FROM MIDDLE OF
PARCEL ON NORTH END, ALONG
CENTURY

SITE SURROUNDED BY CHAIN LINK
FENCE, CMU WALLS AND A WROUGHT
IRON FENCE WITH PILASTERS
