<p>D & D ENGINEERING, INC. 8901 S. LA CIENEGA BLVD, SUITE 106 INGLEWOOD, CA 90301 Phone: 424-393-4122</p>	PROJECT CONDOR	SCALE: AS SHOWN
	PERIMETER CONDITIONS EXHIBIT	DATE: 2017/10/24
		SHT NO.: 01 OF 01

PHOTO KEY MAP

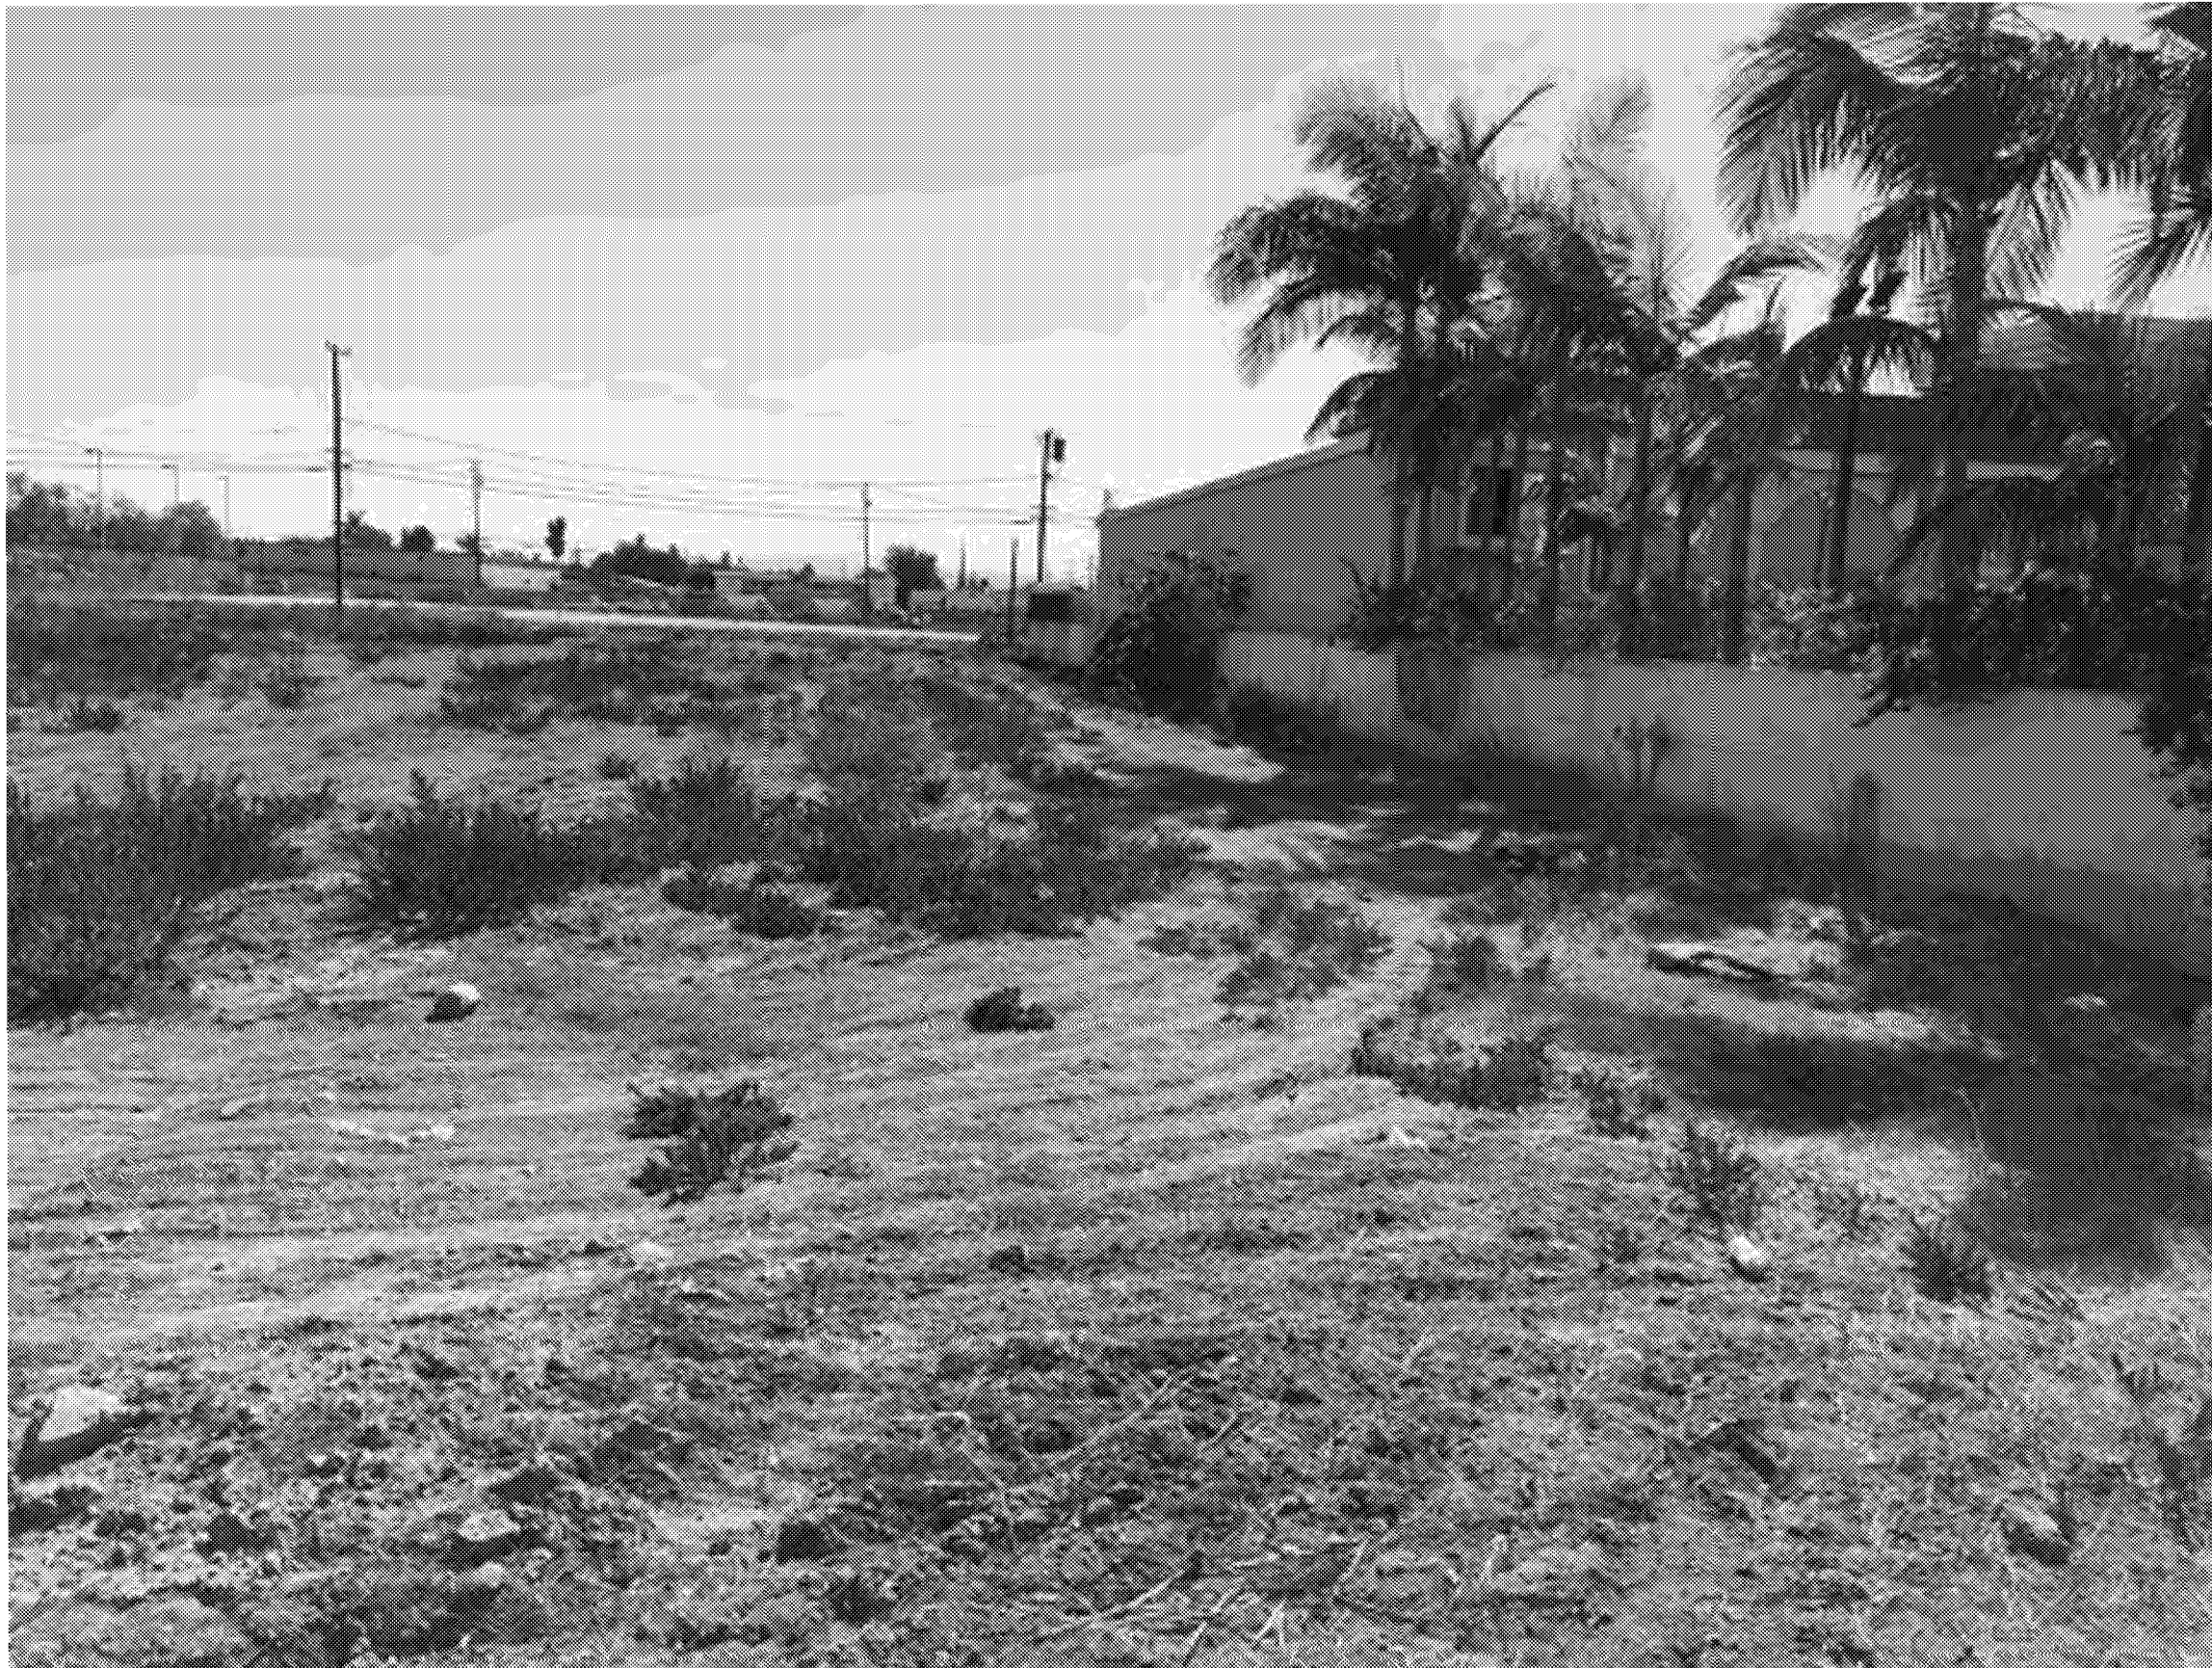
25

SOUTHWESTBOUND VIEW FROM MIDDLE
PARCEL ON NORTH END, ALONG
CENTURY

SITE SURROUNDED BY CHAIN LINK
FENCE, CMU WALLS AND A WROUGHT
IRON FENCE WITH PILASTERS

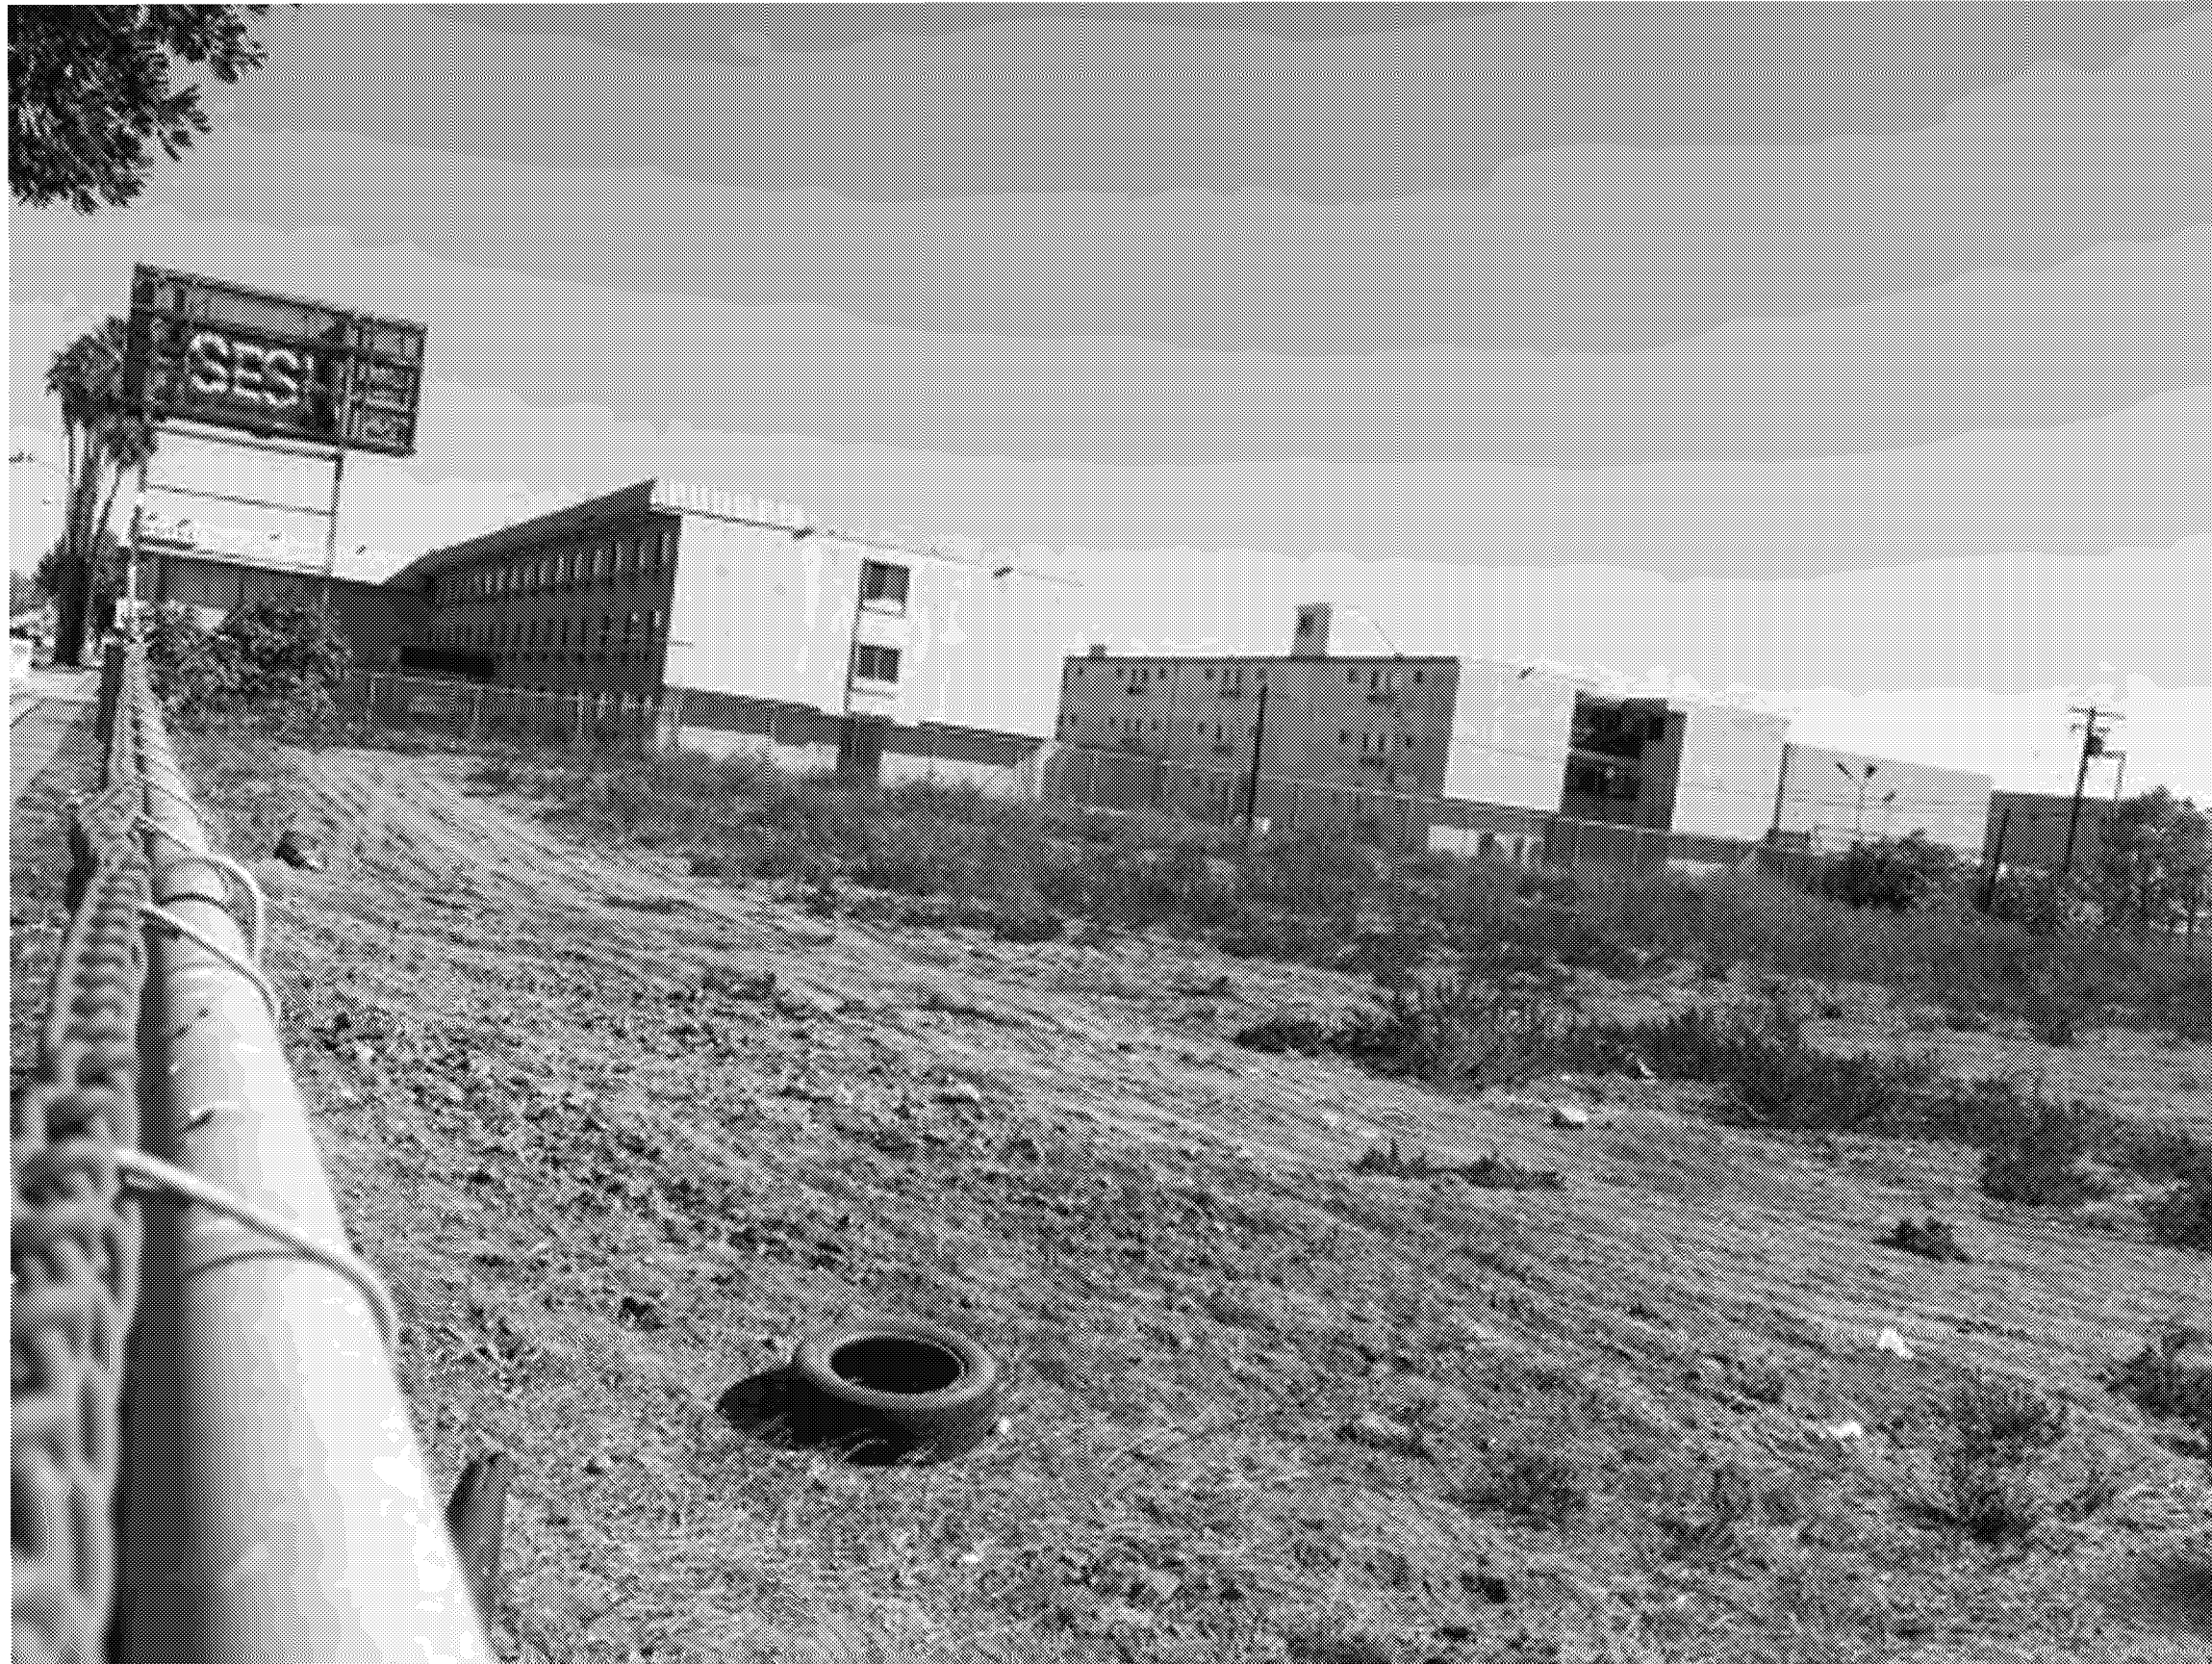
26

SOUTHEASTBOUND VIEW FROM MIDDLE OF PARCLE ON NORTH END, ALONG CENTURY

SITE SURREOUNDED BY CHAIN LINK FENCE, CMU WALLS AND A WROUGHT IRON FENCE WITH PILASTERS

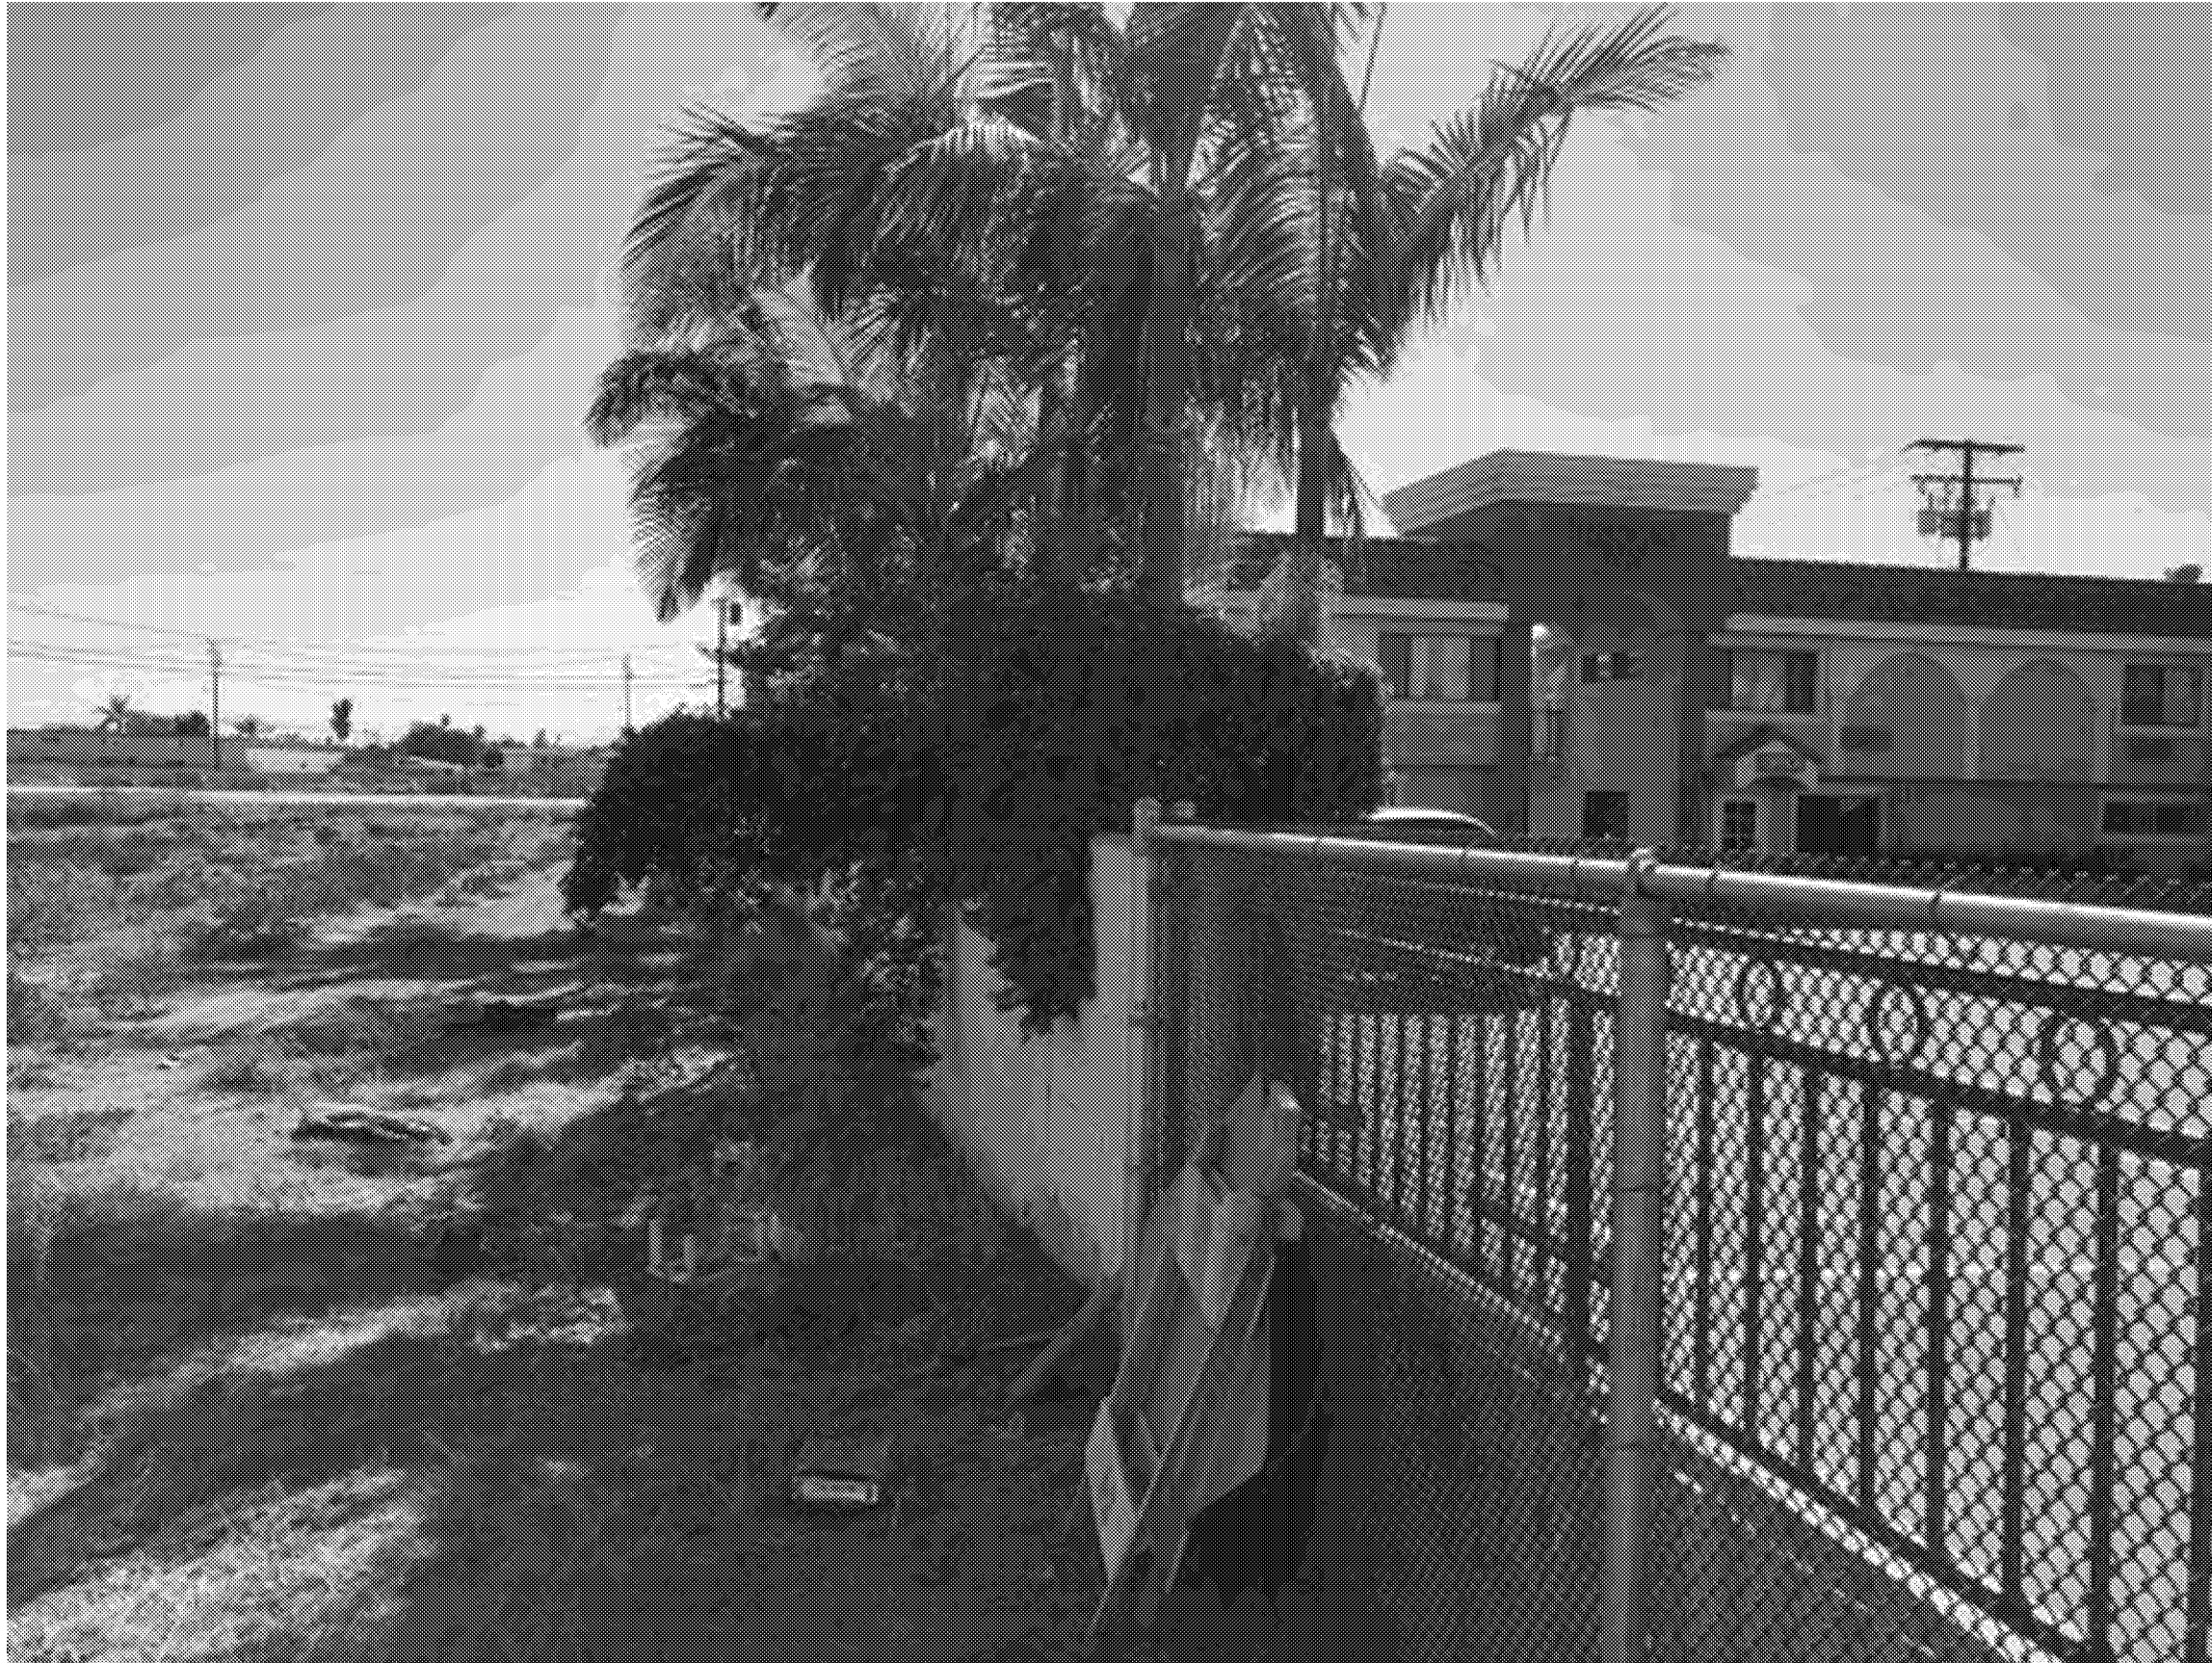
27

SOUTHBOUND VIEW FROM NORTHWEST
CORNER OF PARCEL, ALONG CENTURY

SITE SURROUNDED BY CHAIN LINK
FENCE, CMU WALLS AND A WROUGHT
IRON FENCE WITH PILASTERS

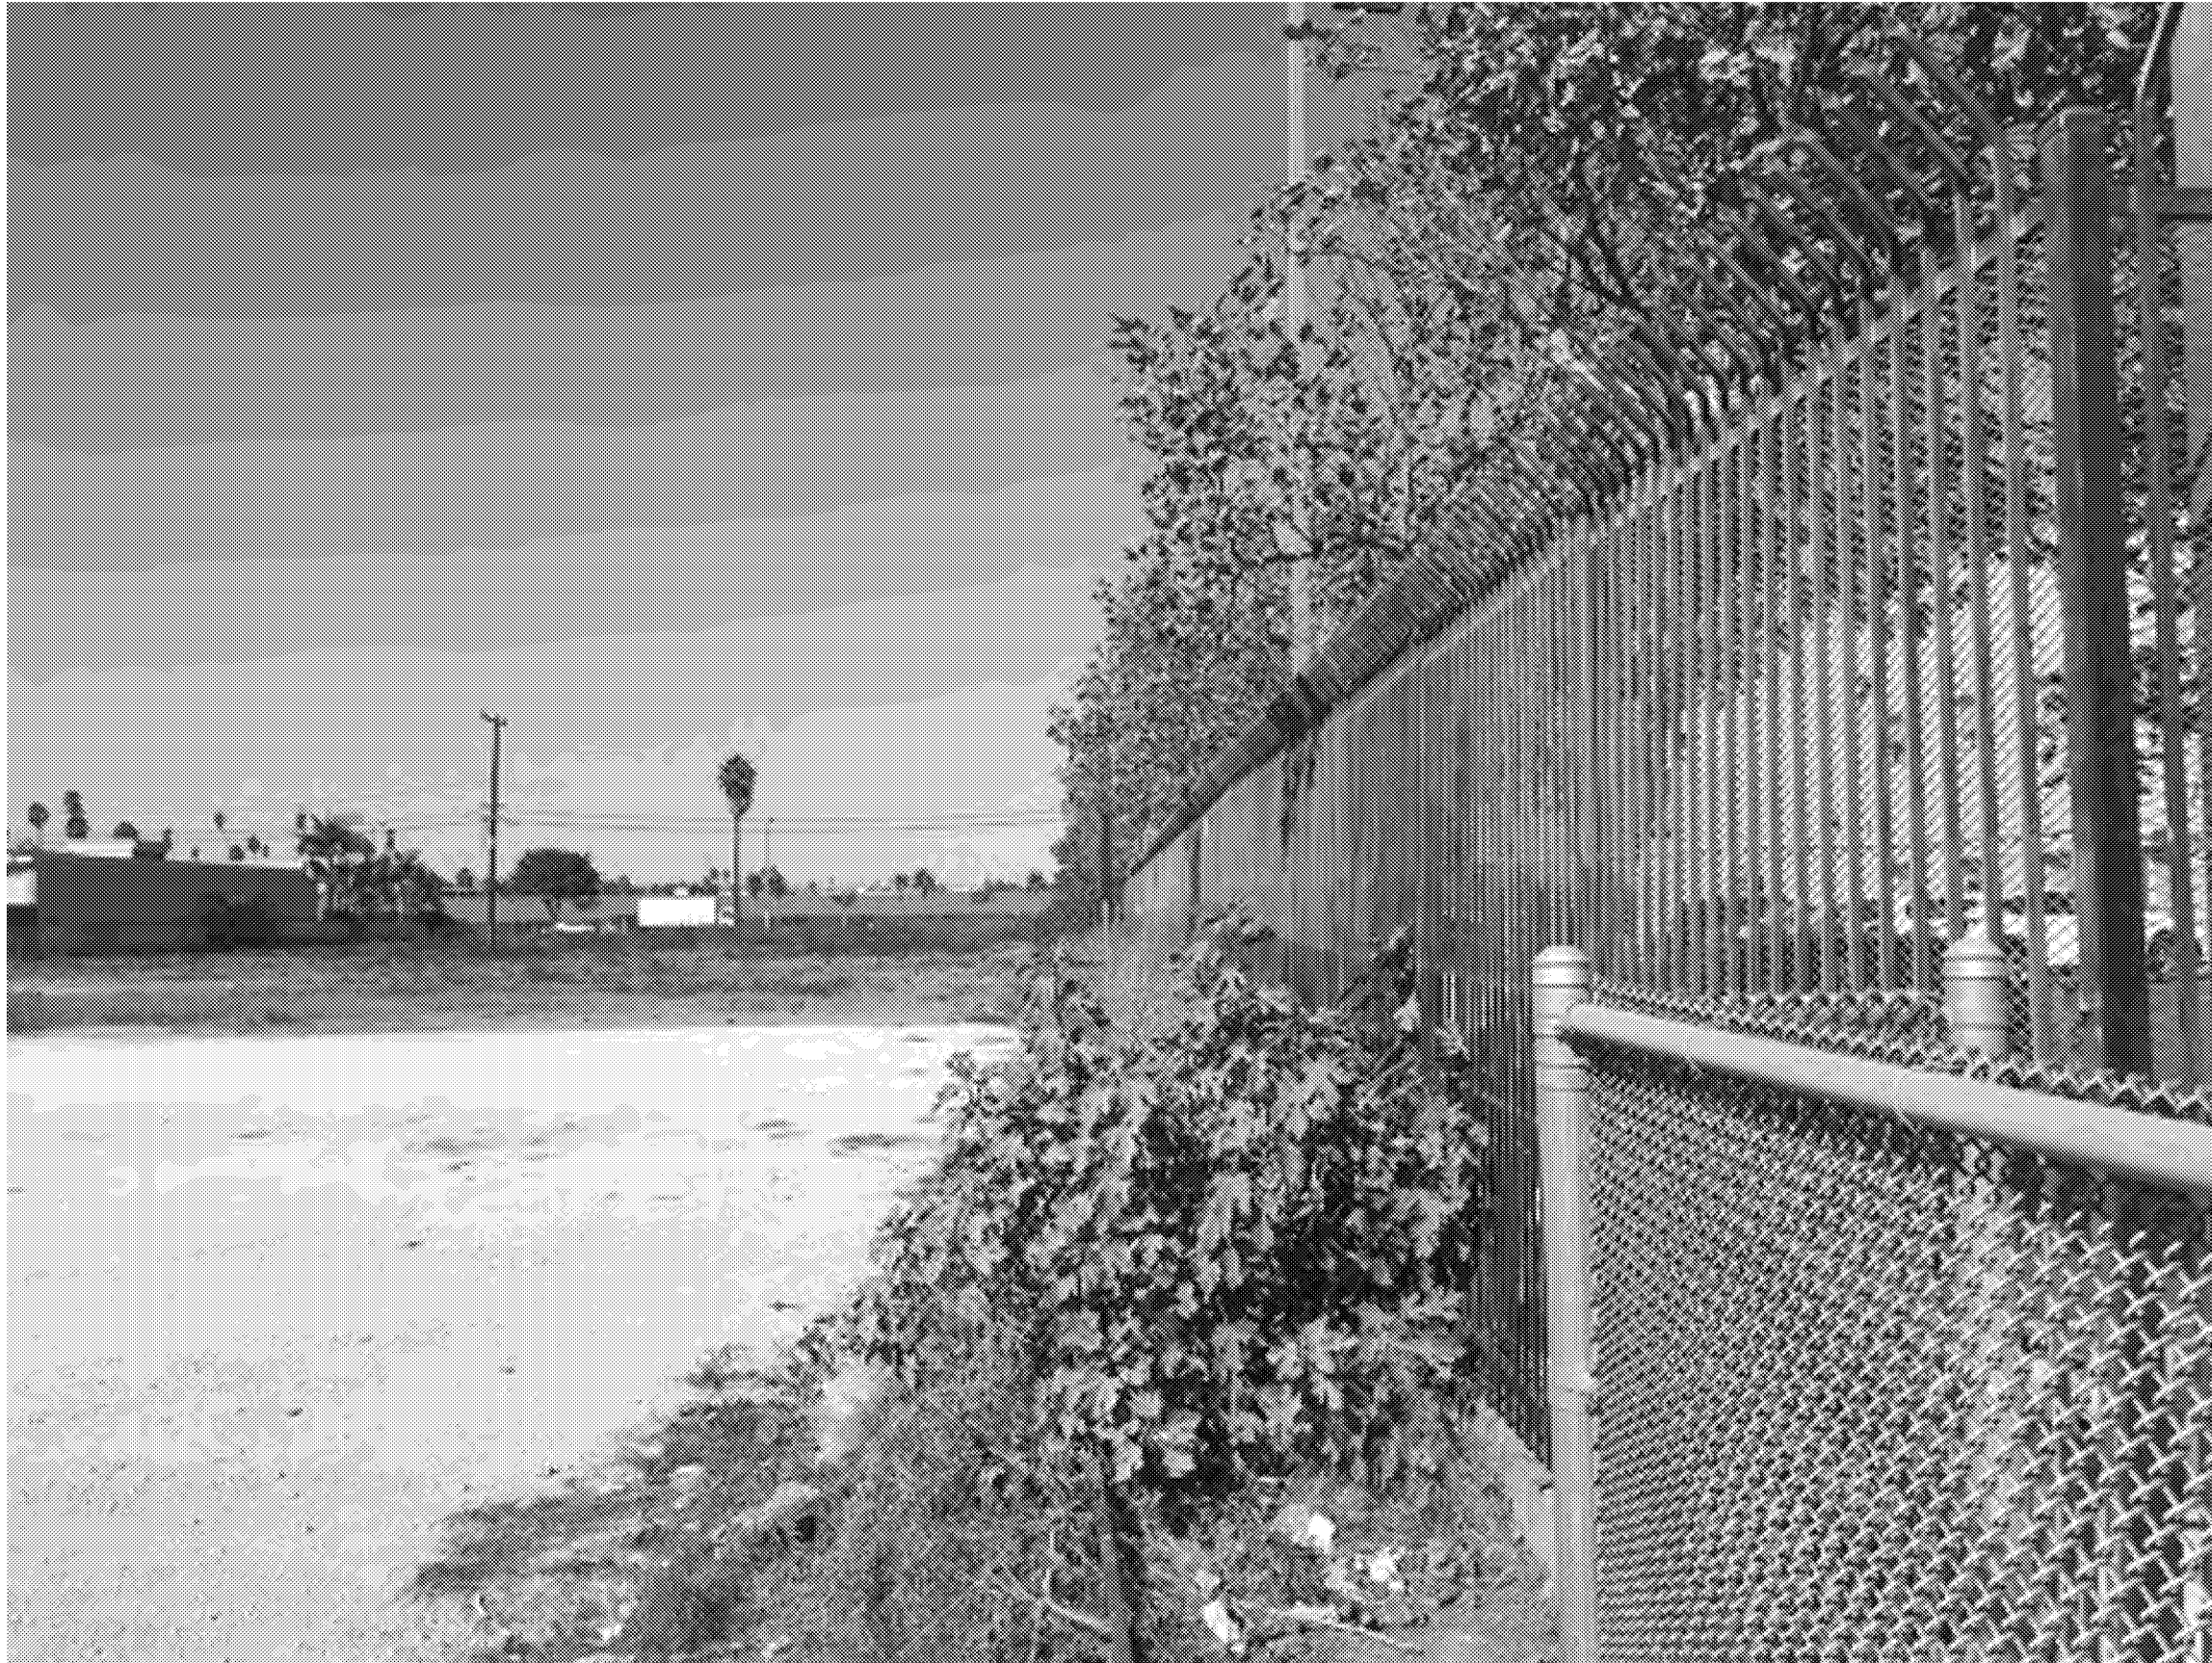
28

NORTHBOUND VIEW FROM SOUTHEAST
CORNER OF PARCEL, ALONG 102ND

SITE SURROUNDED BY CHAIN LINK
FENCE, CMU WALLS AND A WROUGHT
IRON FENCE WITH PILASTERS

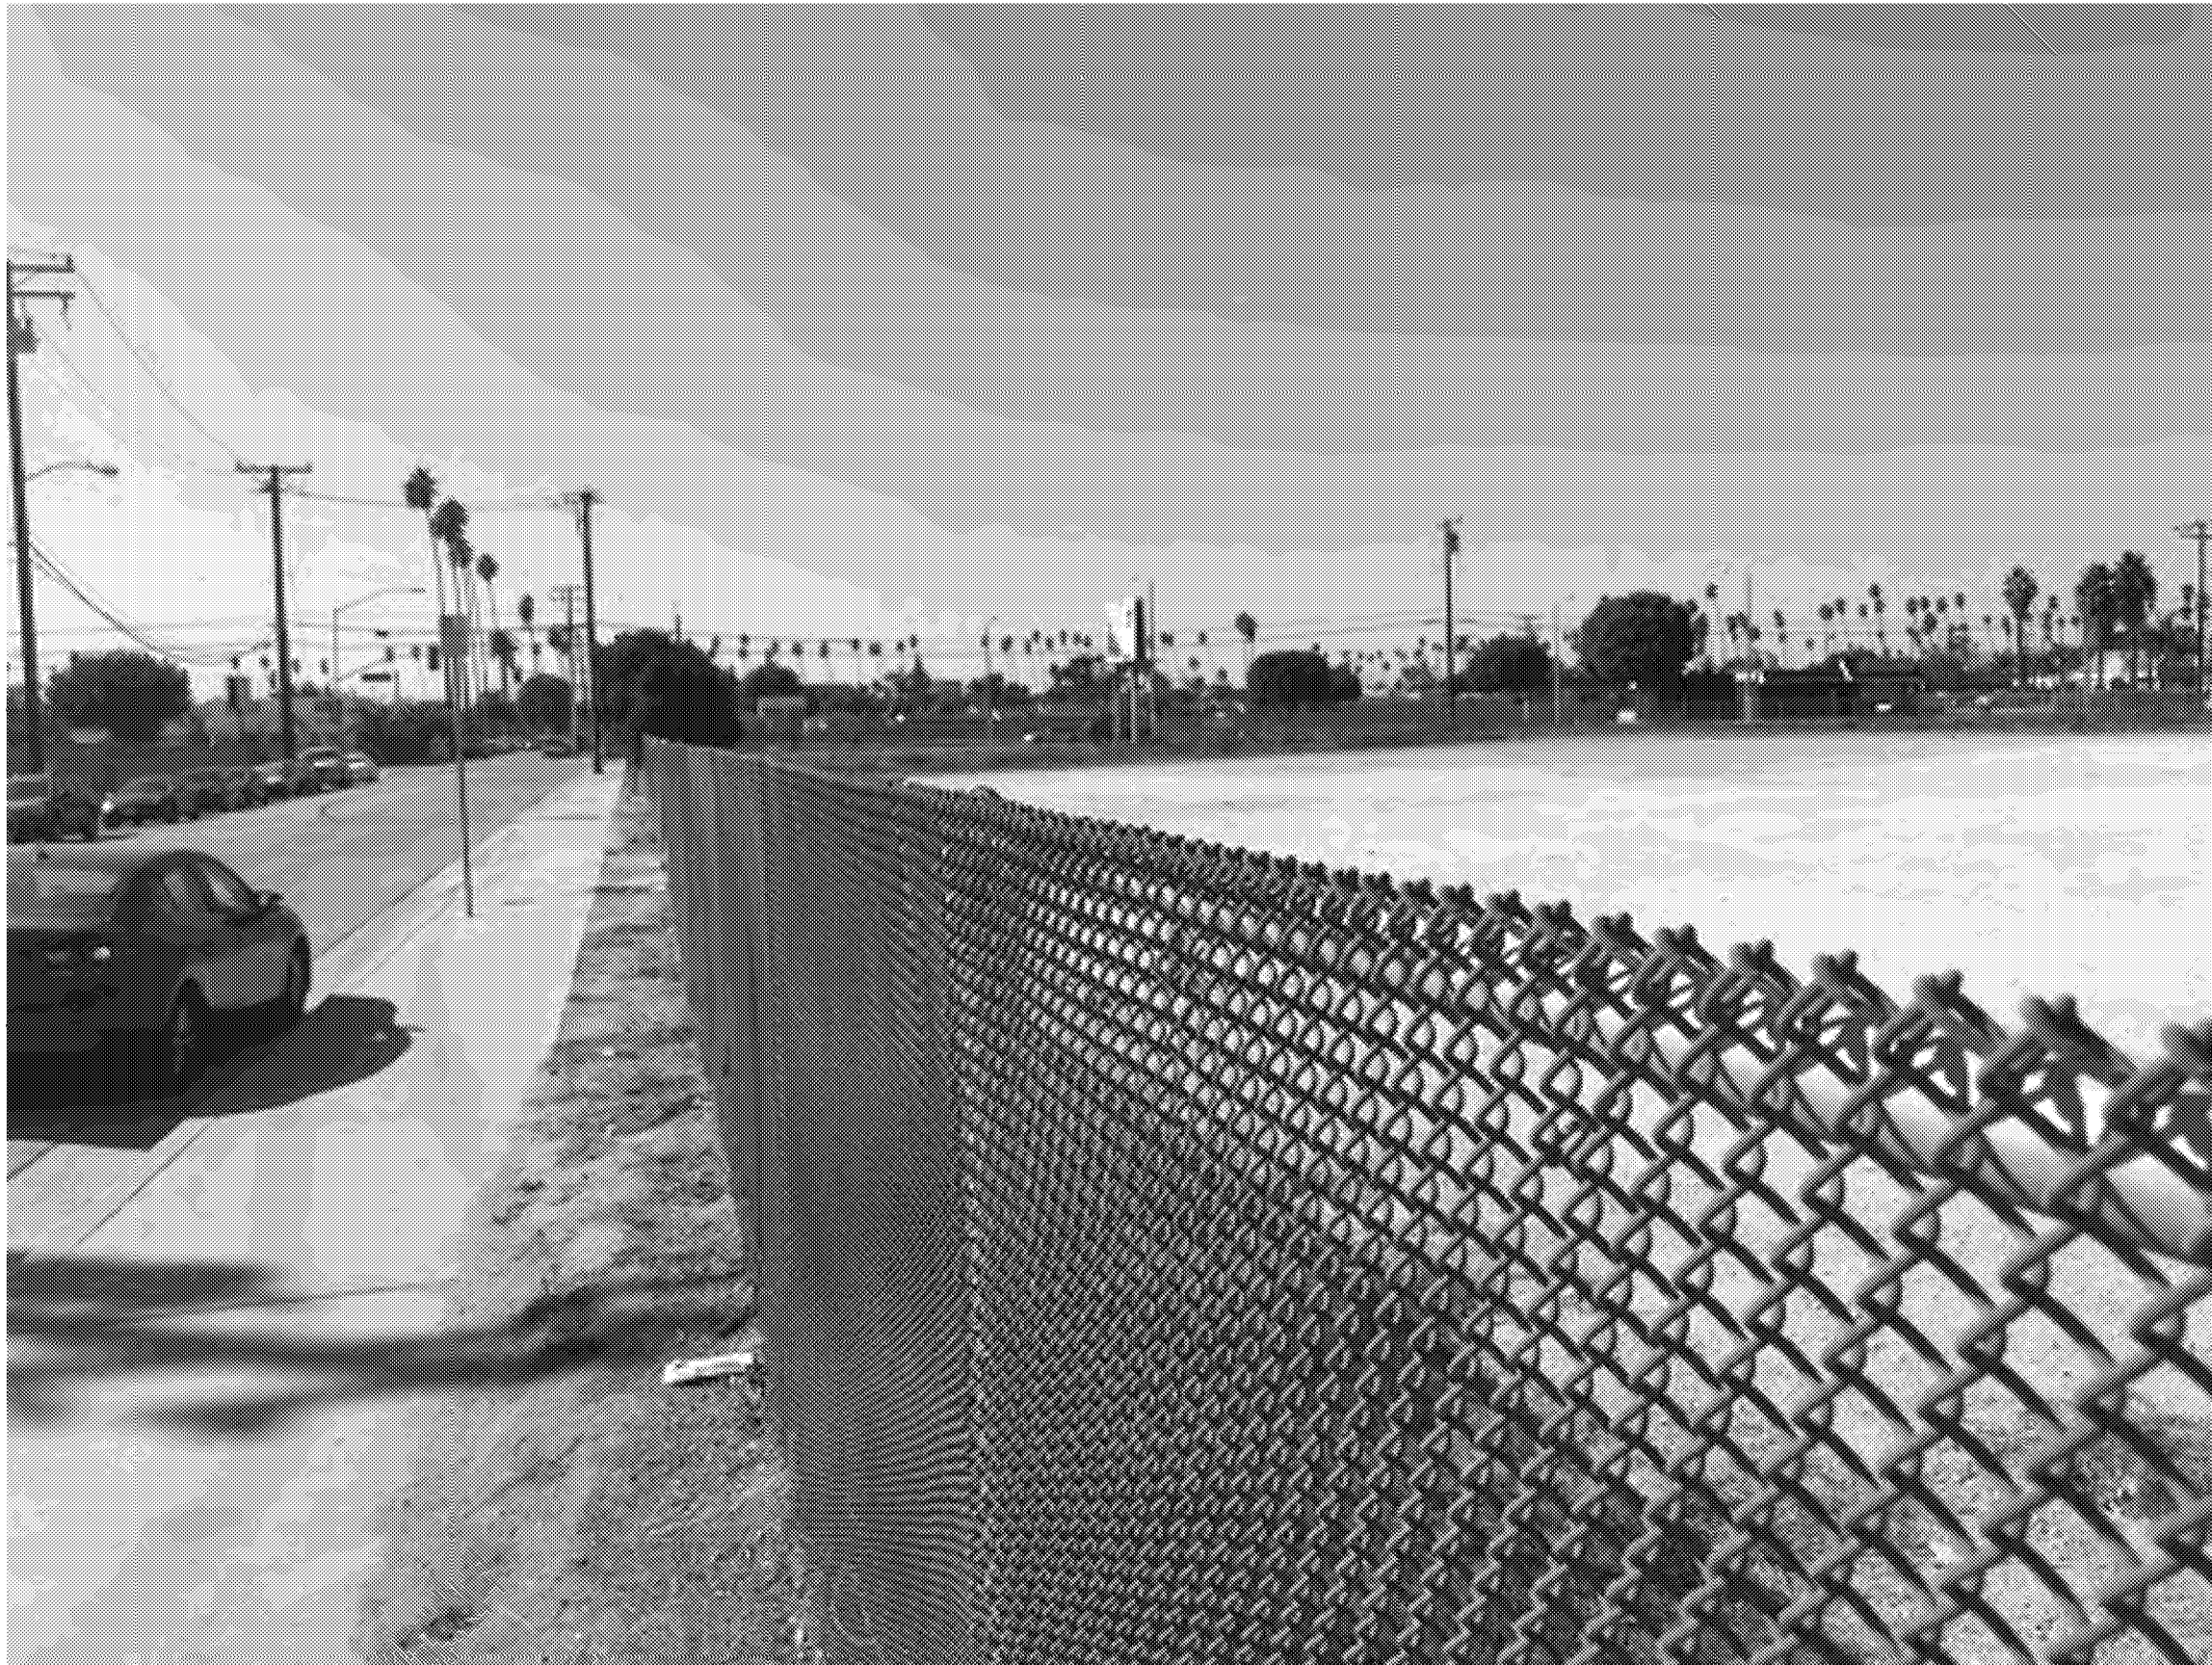
WESTBOUND VIEW FROM SOUTHEAST
CORNER OF PARCEL, ALONG 102ND

SITE SURROUNDED BY CHAIN LINK
FENCE, CMU WALLS AND A WROUGHT
IRON FENCE WITH PILASTERS

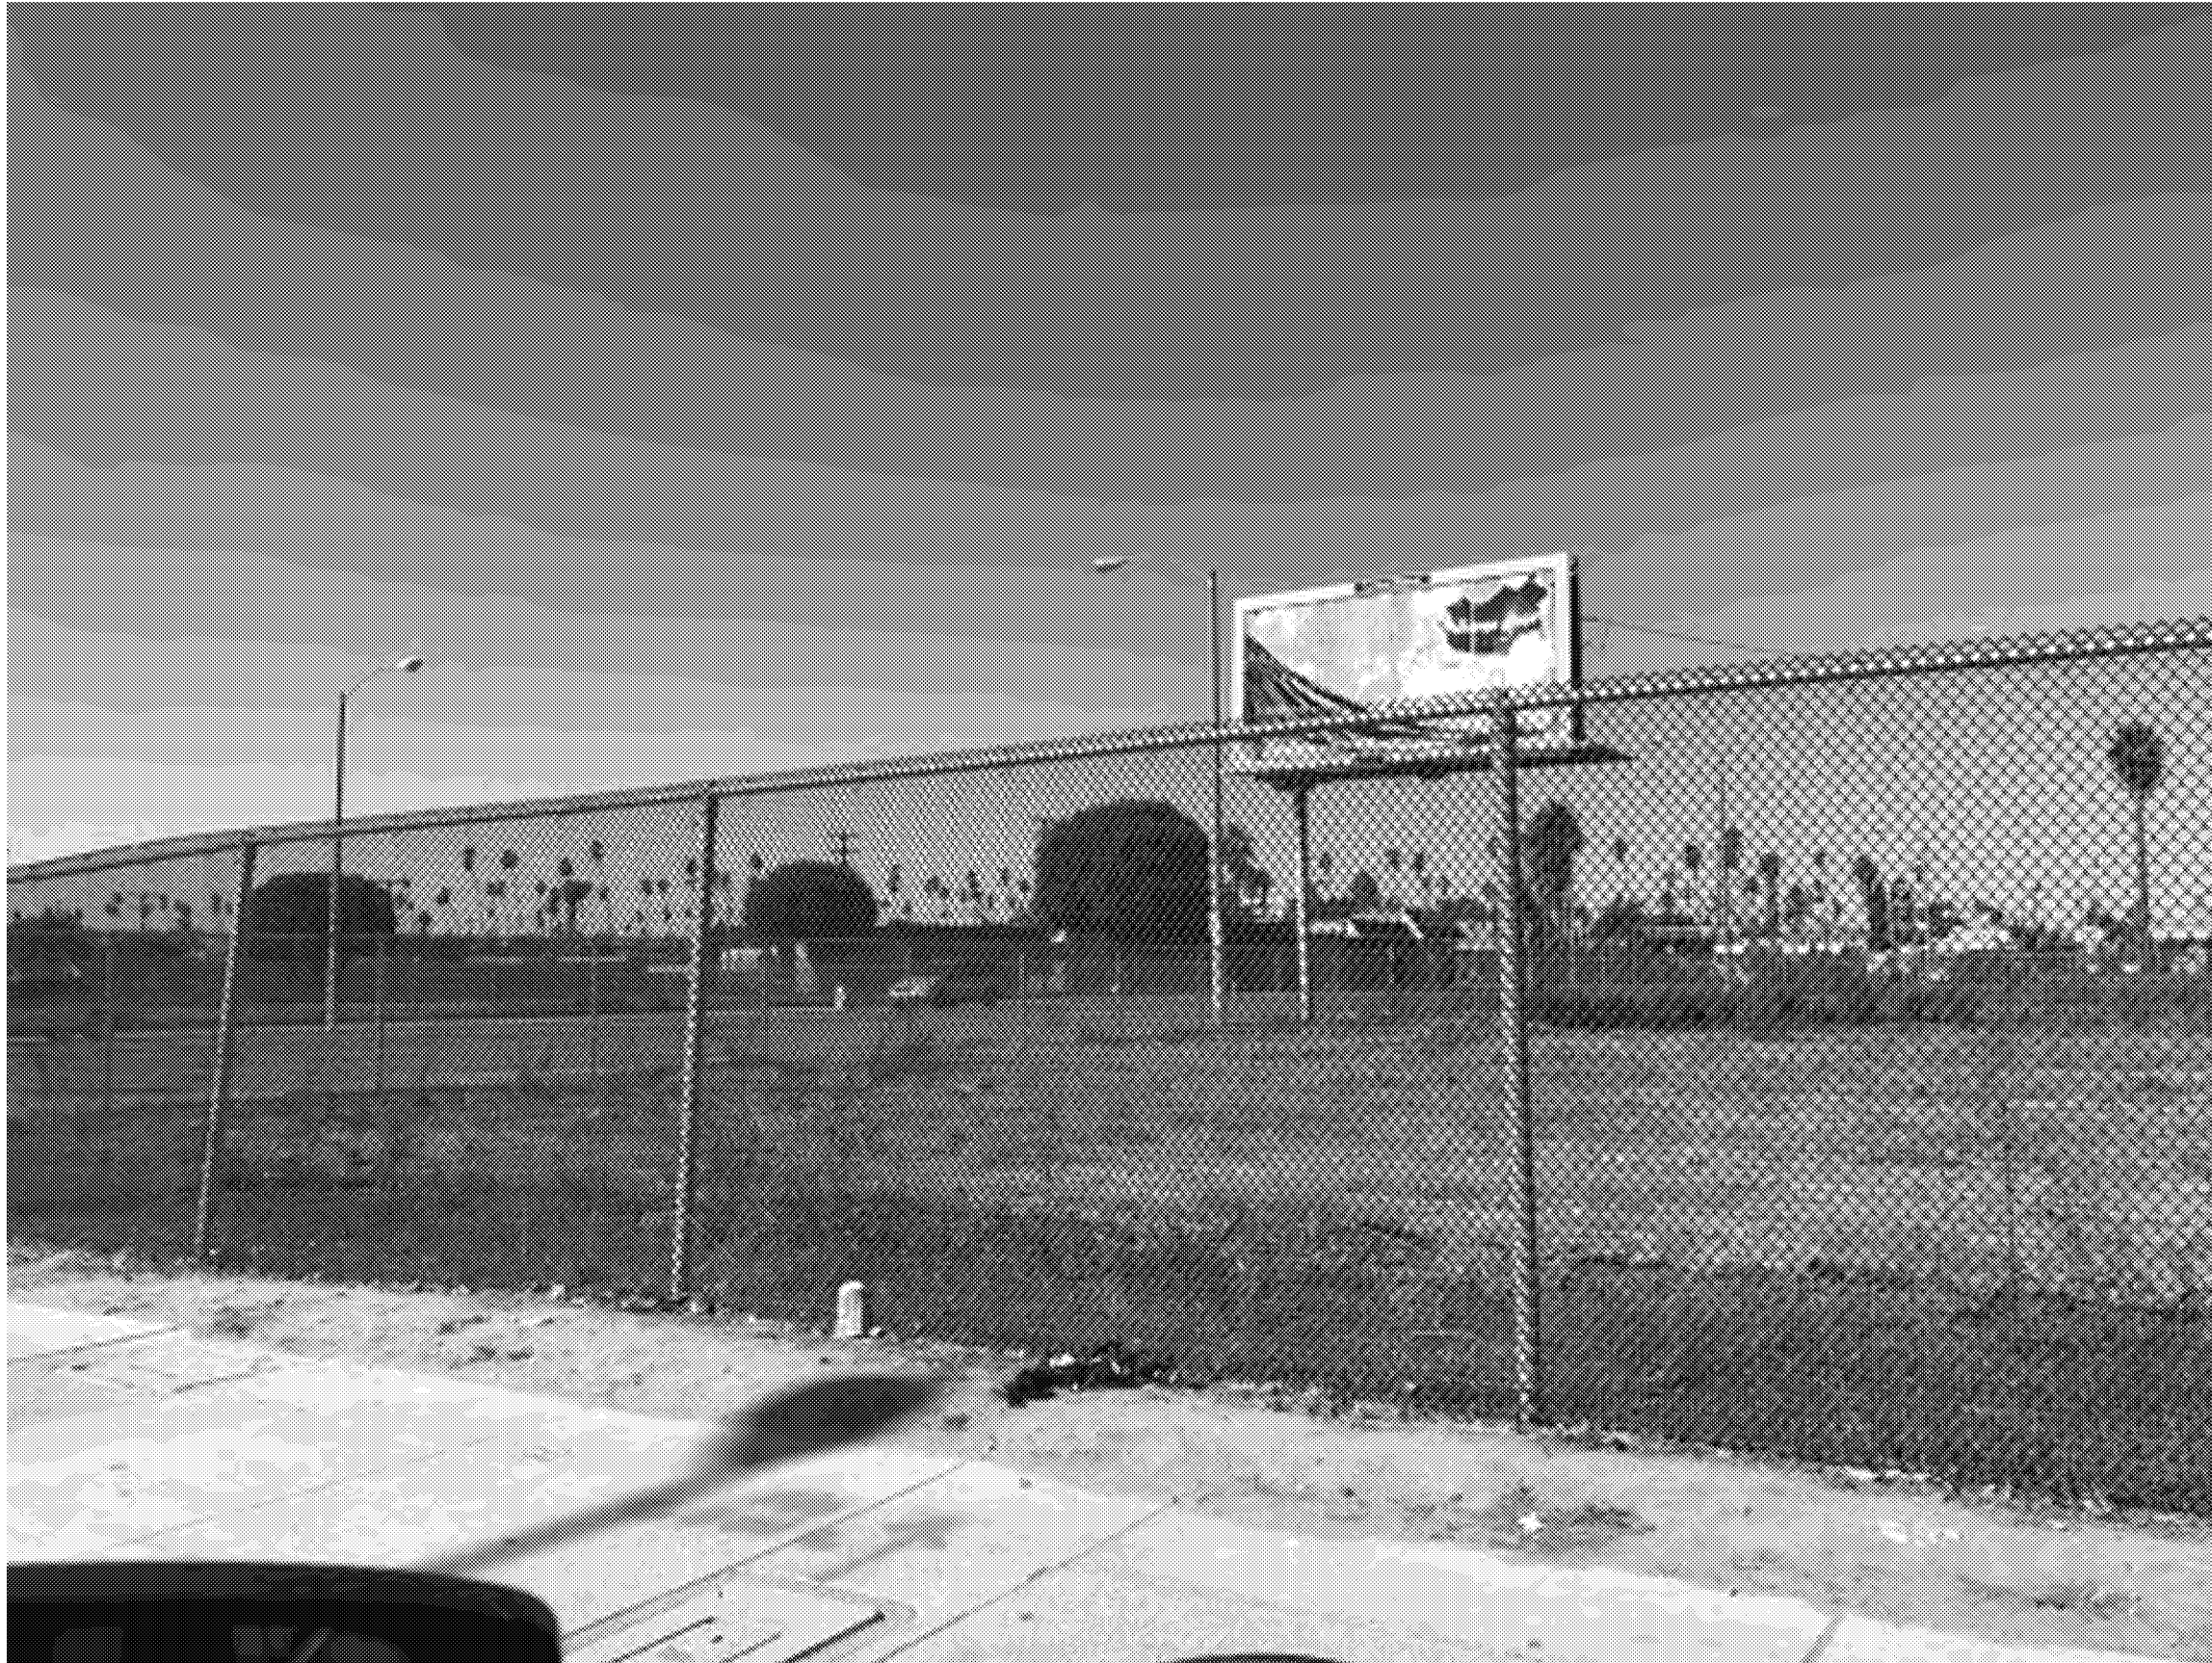
30

NORTHWESTBOUND VIEW FROM SOUTH
CORNER OF PARCEL, ALONG 102ND

SITE SURROUNDED BY CHAIN LINK
FENCE, CMU WALLS AND A WROUGHT
IRON FENCE WITH PILASTERS
