<p>D & D ENGINEERING, INC. 8901 S. LA CIENEGA BLVD, SUITE 106 INGLEWOOD, CA 90301 Phone: 424-393-4122</p>	PROJECT CONDOR	SCALE: AS SHOWN
	PERIMETER CONDITIONS EXHIBIT	DATE: 2017/10/24
		SHT NO.: 01 OF 01

PHOTO KEY MAP

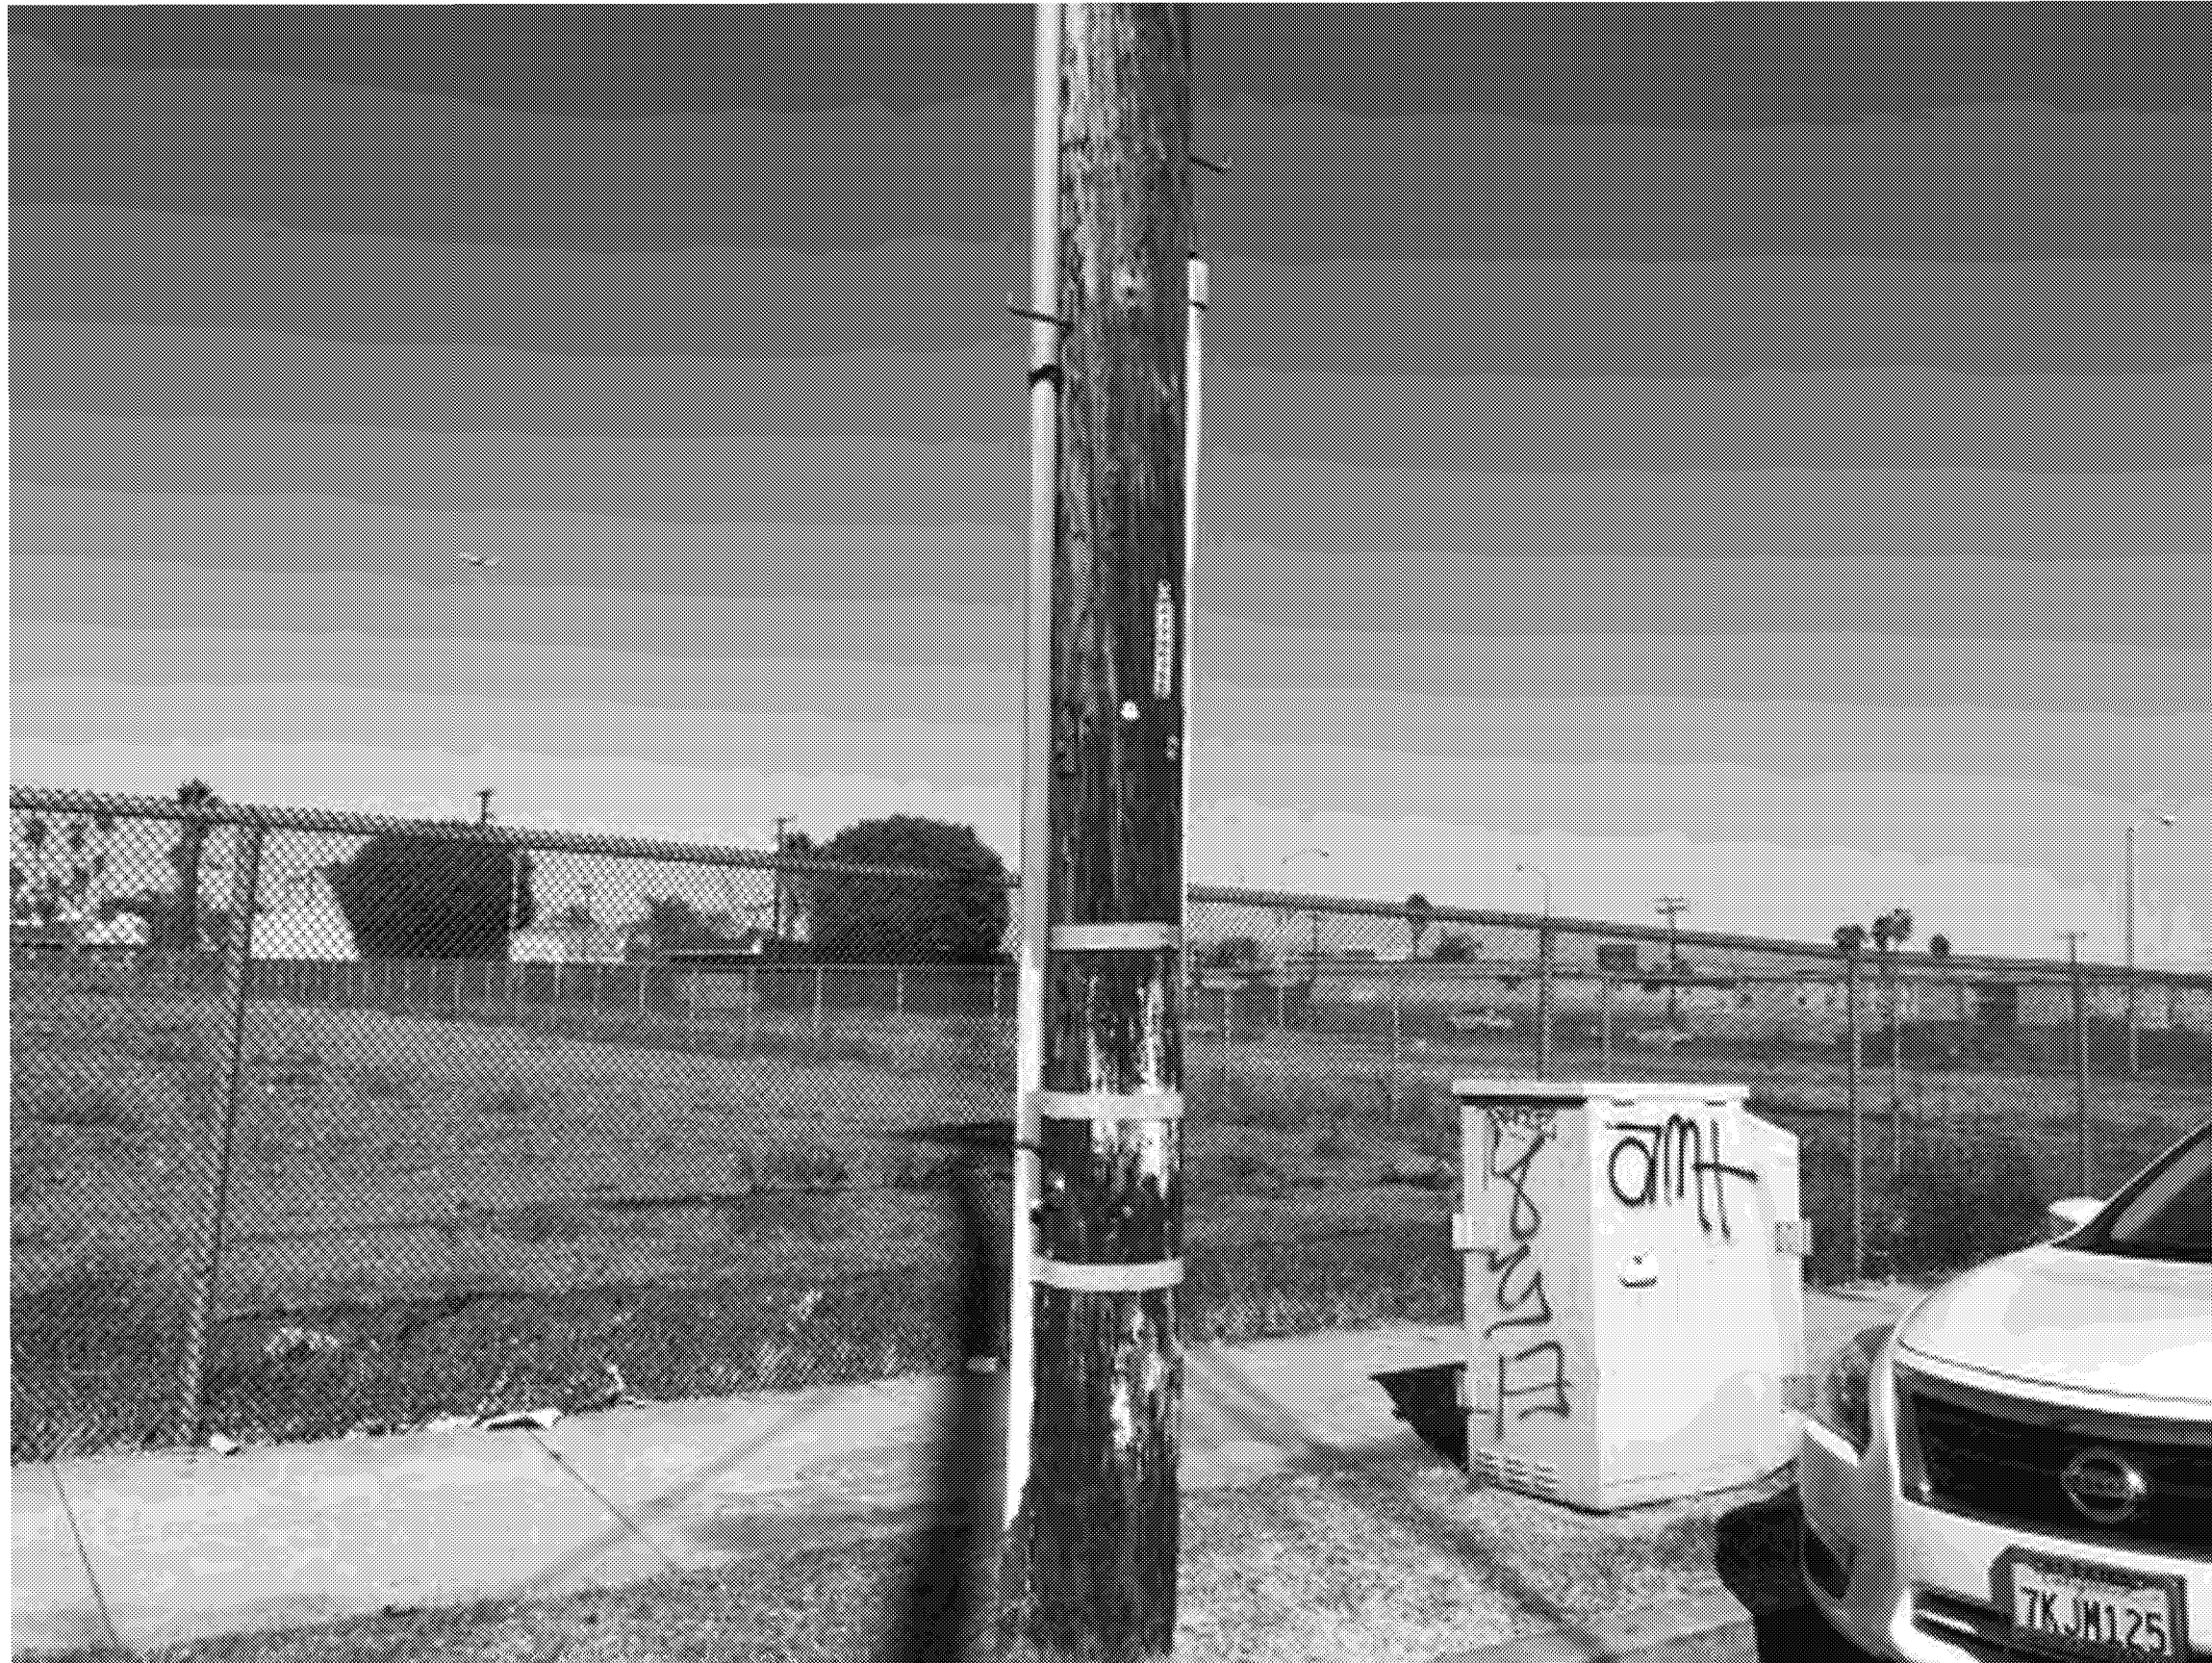
31

NORTHEAST VIEW FROM SOUTHWEST
CORNER OF PARCEL, ALONG 102ND

SITE SURROUNDED BY CHAIN LINK
FENCE, CMU WALLS AND A WROUGHT
IRON FENCE WITH PILASTERS

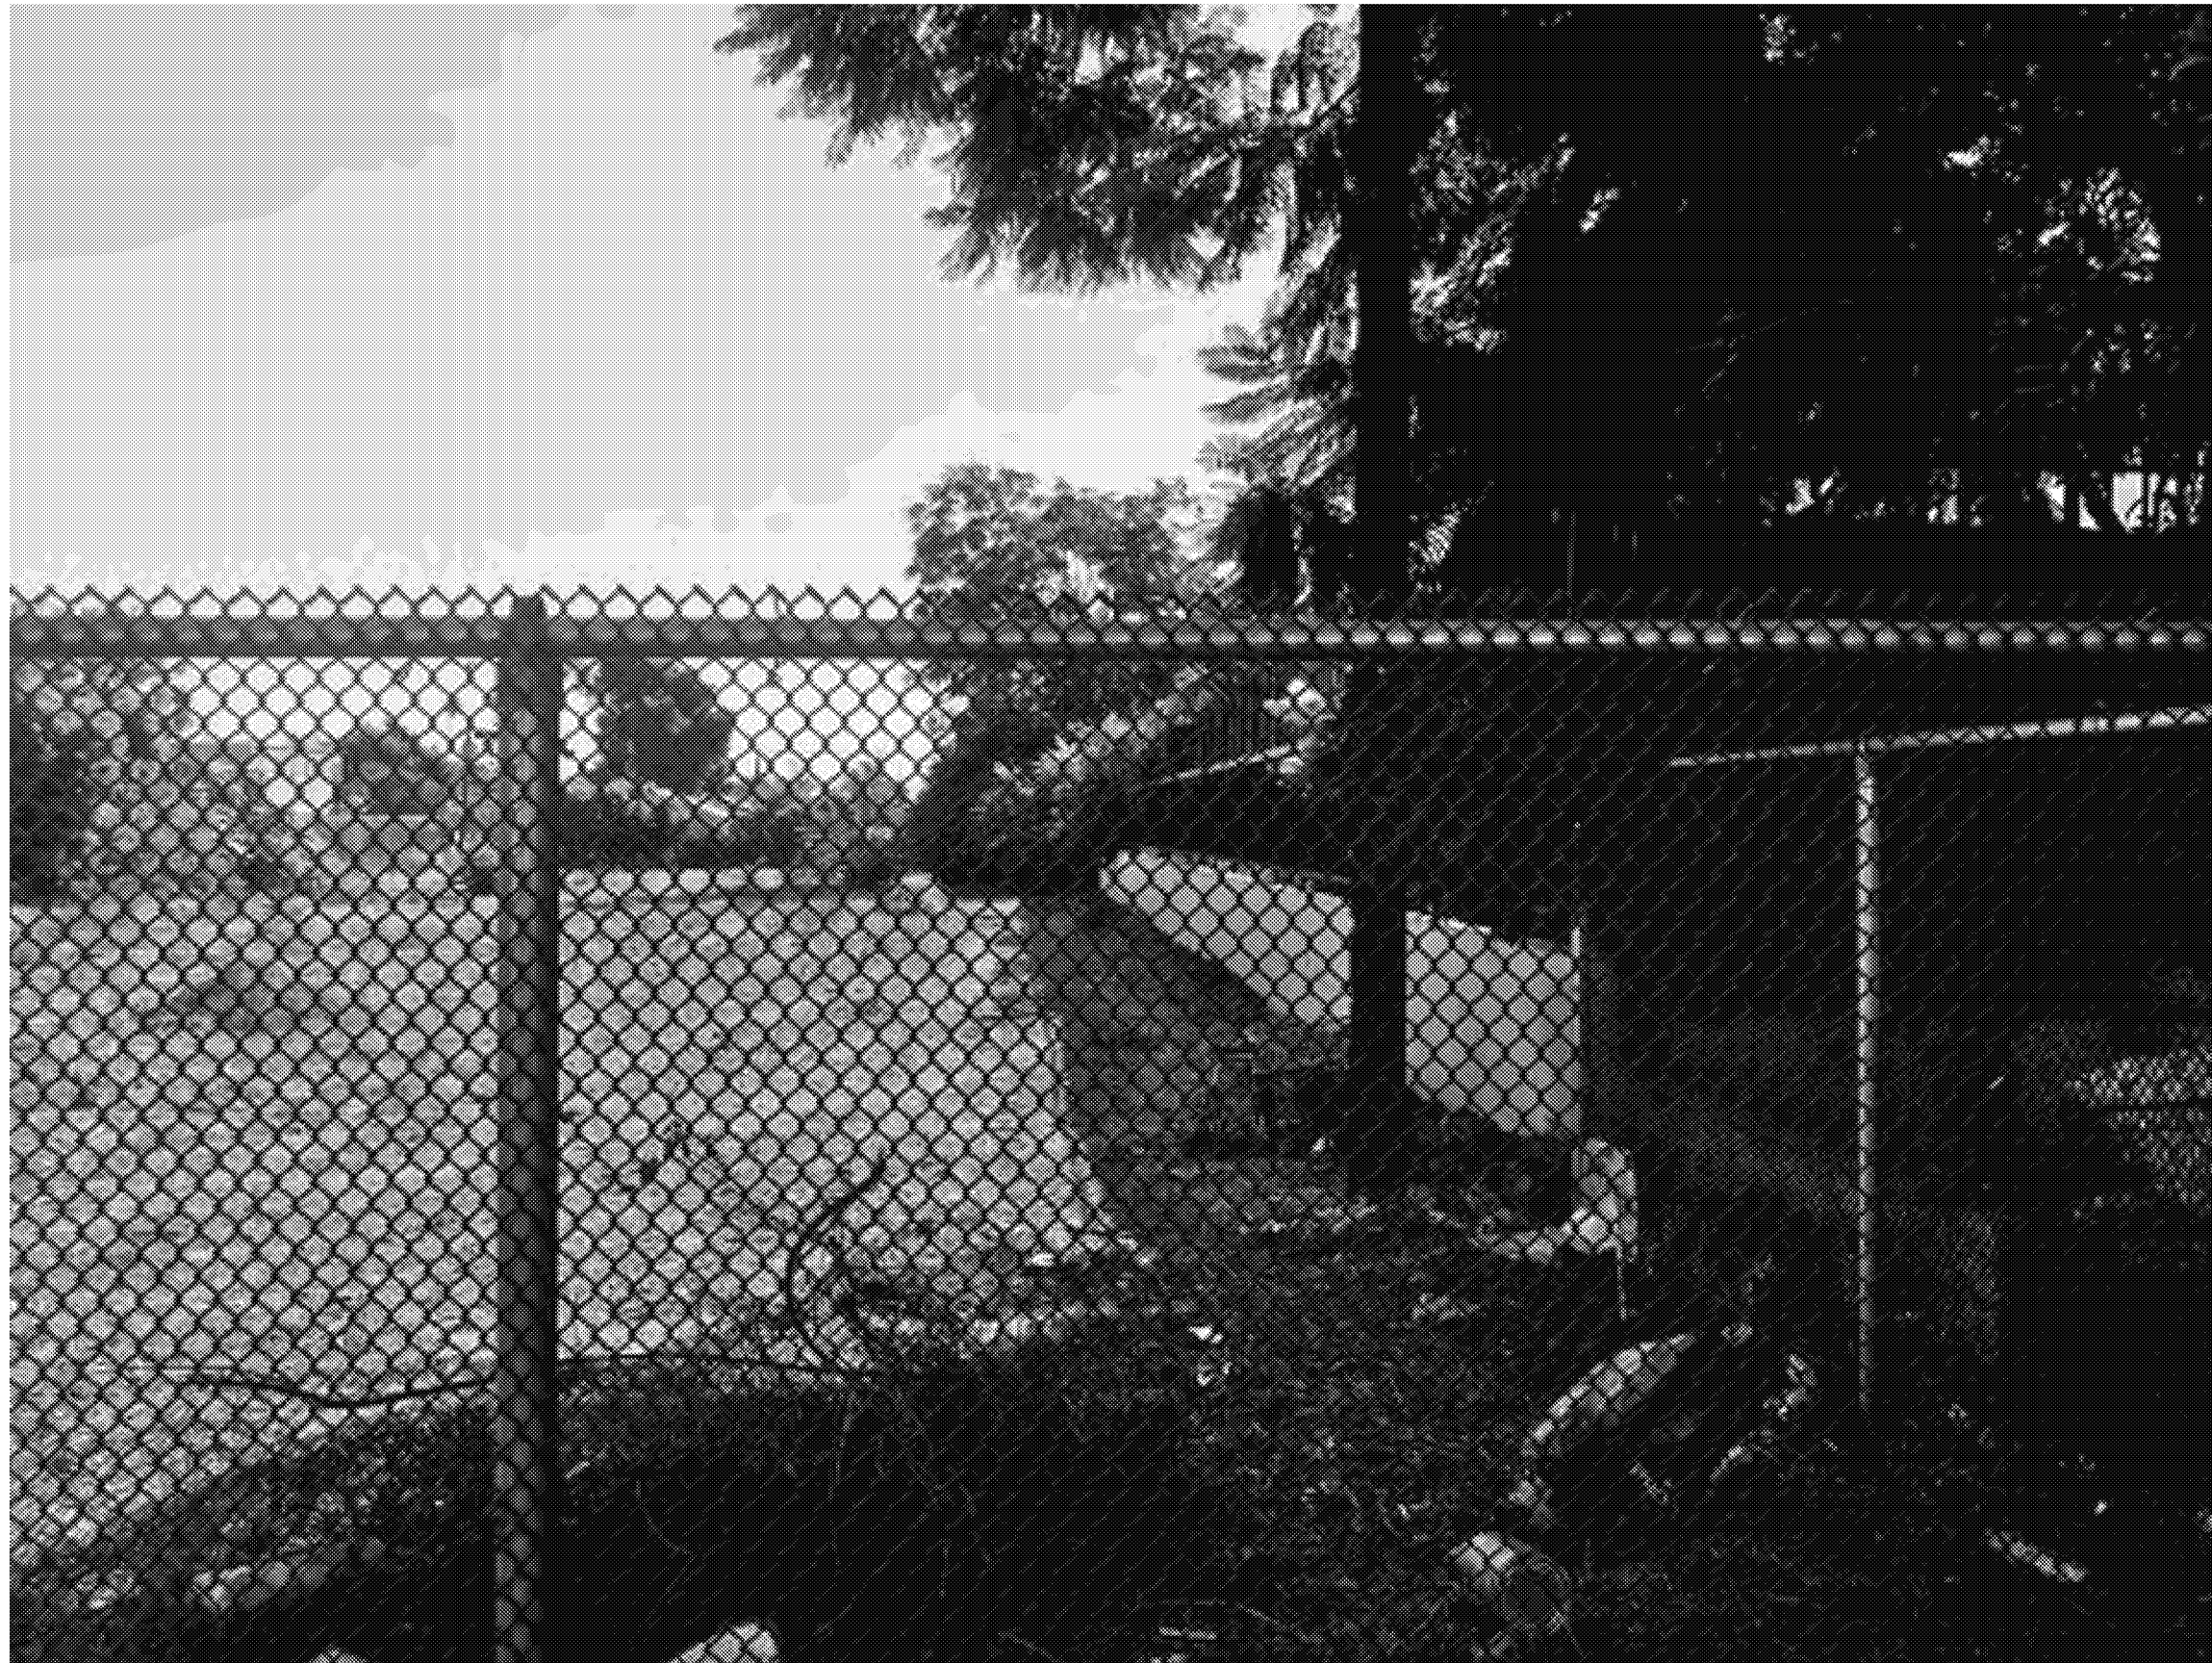
32

SOUTHBOUND VIEW FROM NORTHWEST
CORNER OF PARCEL, ALONG 102ND

SITE SURROUNDED BY CHAIN LINK
FENCE, CMU WALLS AND A WROUGHT
IRON FENCE WITH PILASTERS

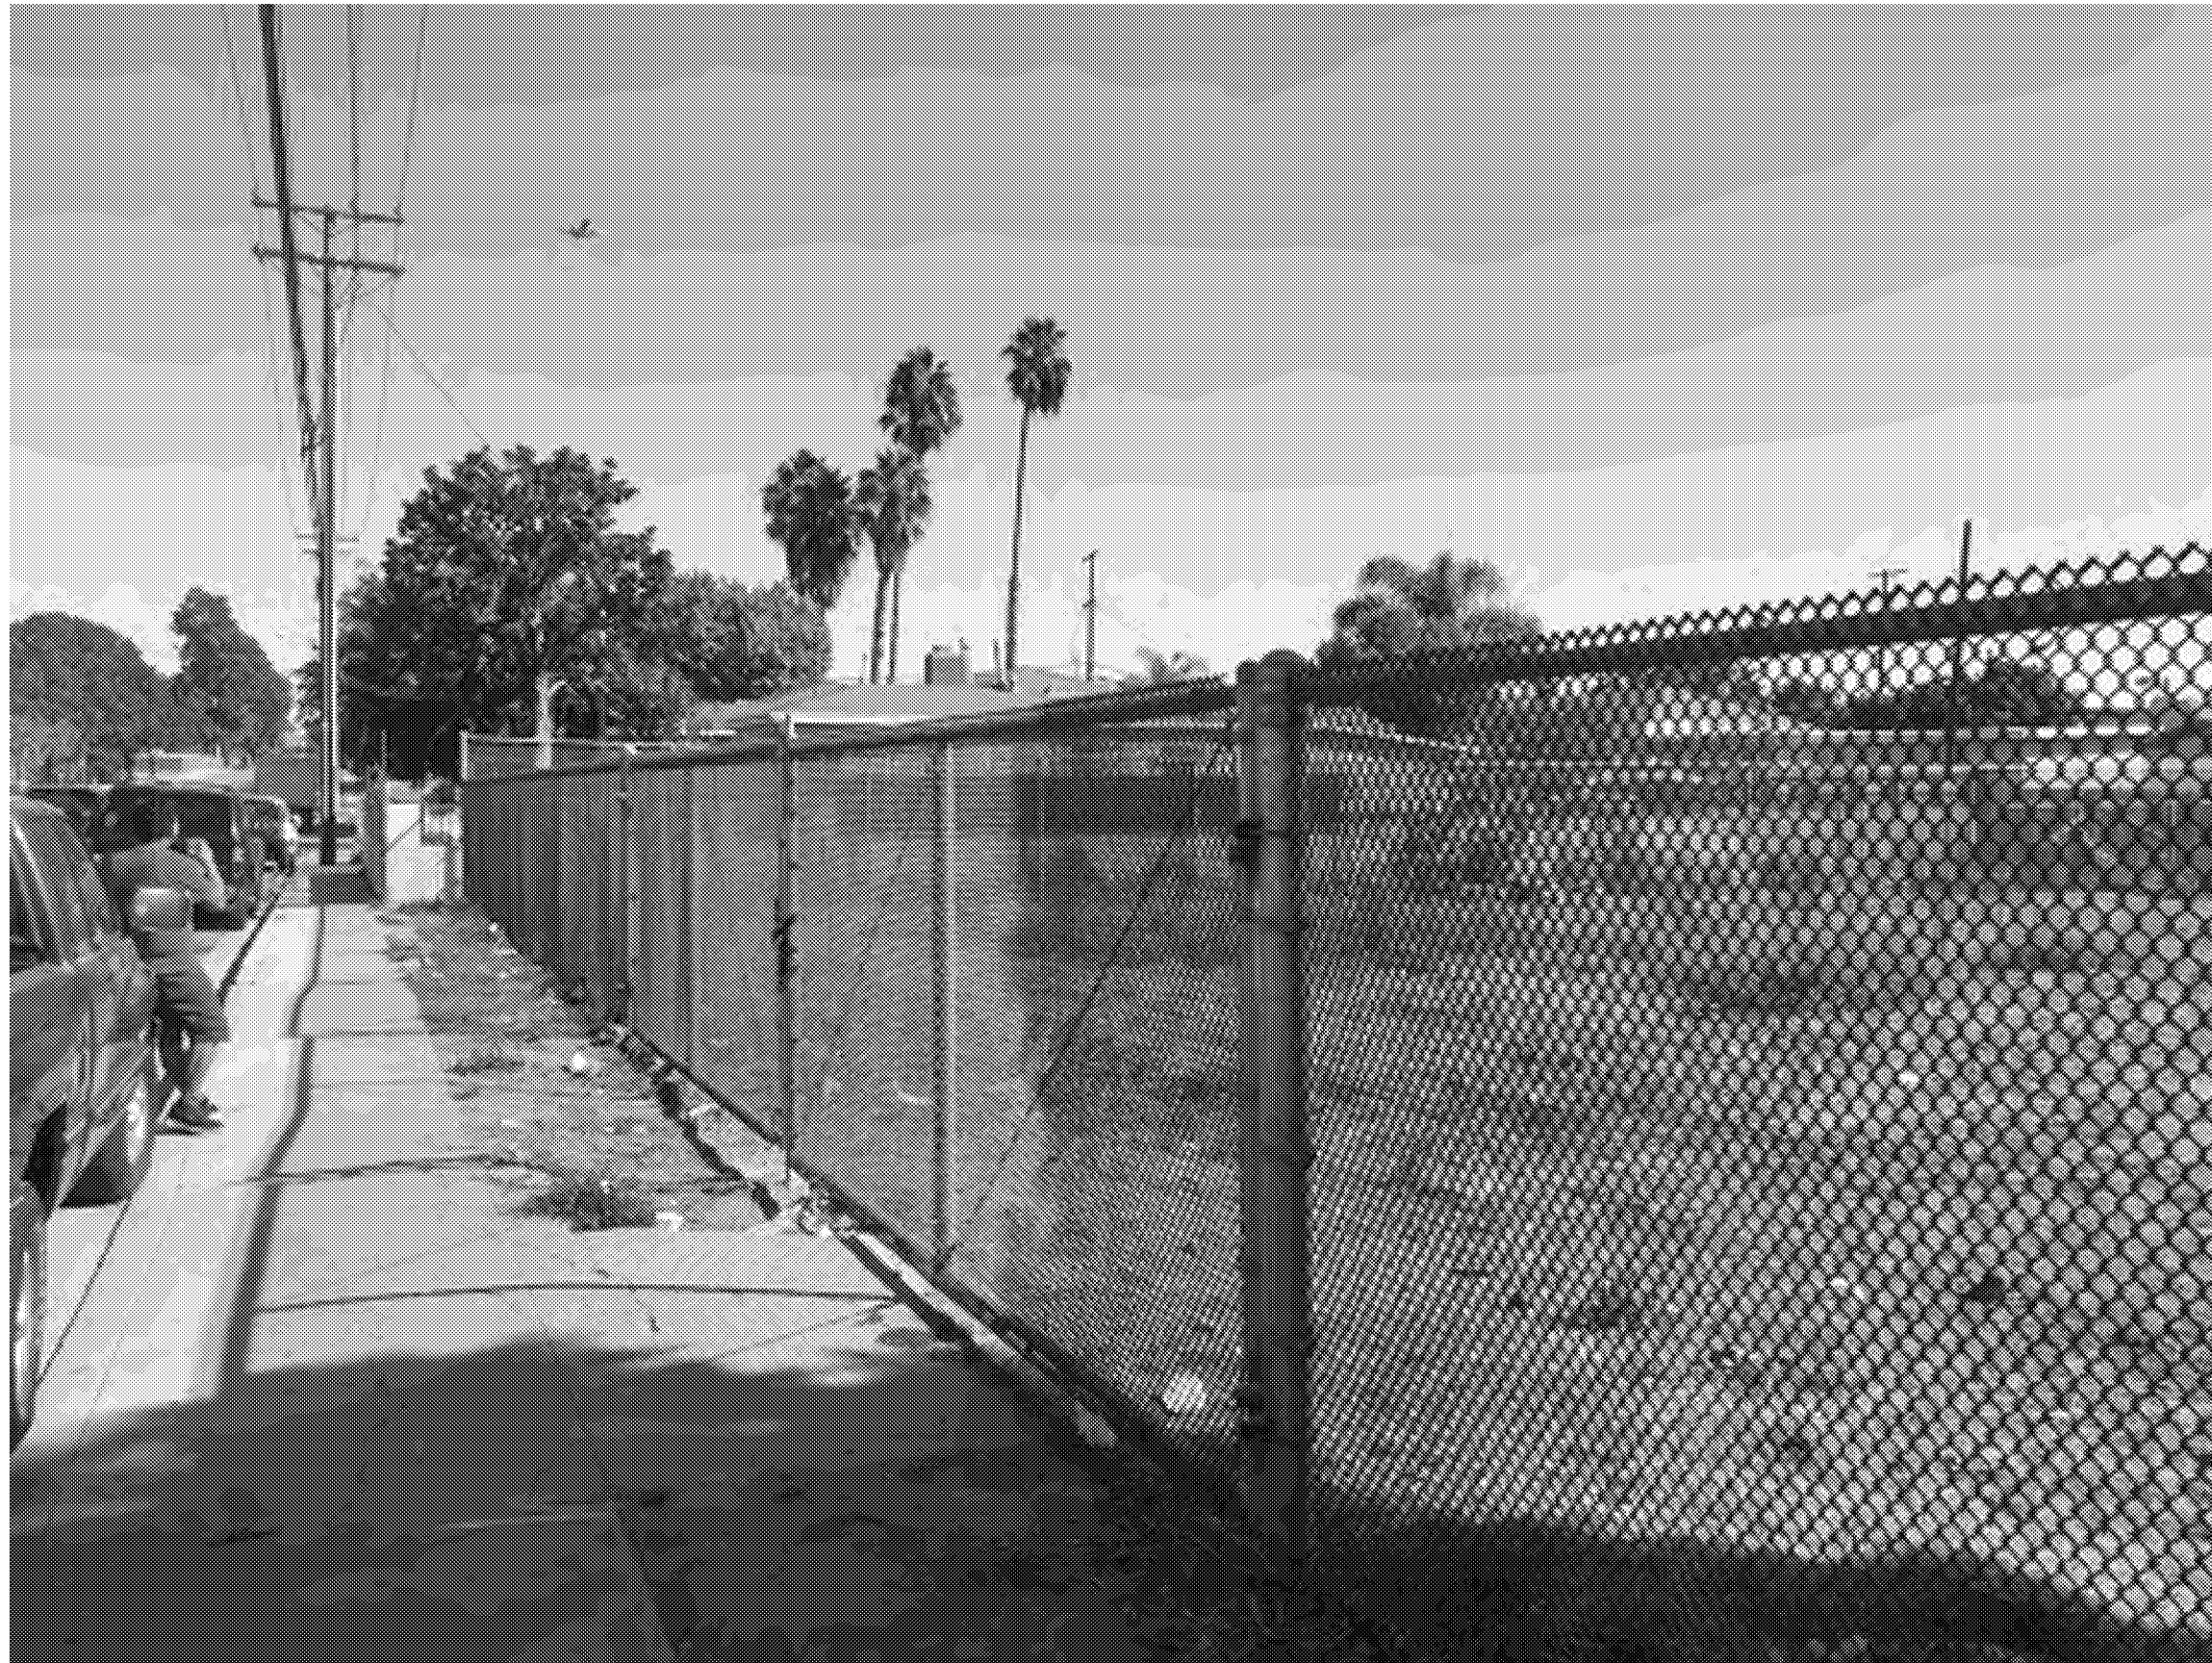
33

SOUTHEASTBOUND VIEW FROM
NORTHWEST CORNER OF PARCEL, ALONG
102ND

SITE SURROUNDED BY CHAIN LINK
FENCE, CMU WALLS AND A WROUGHT
IRON FENCE WITH PILASTERS

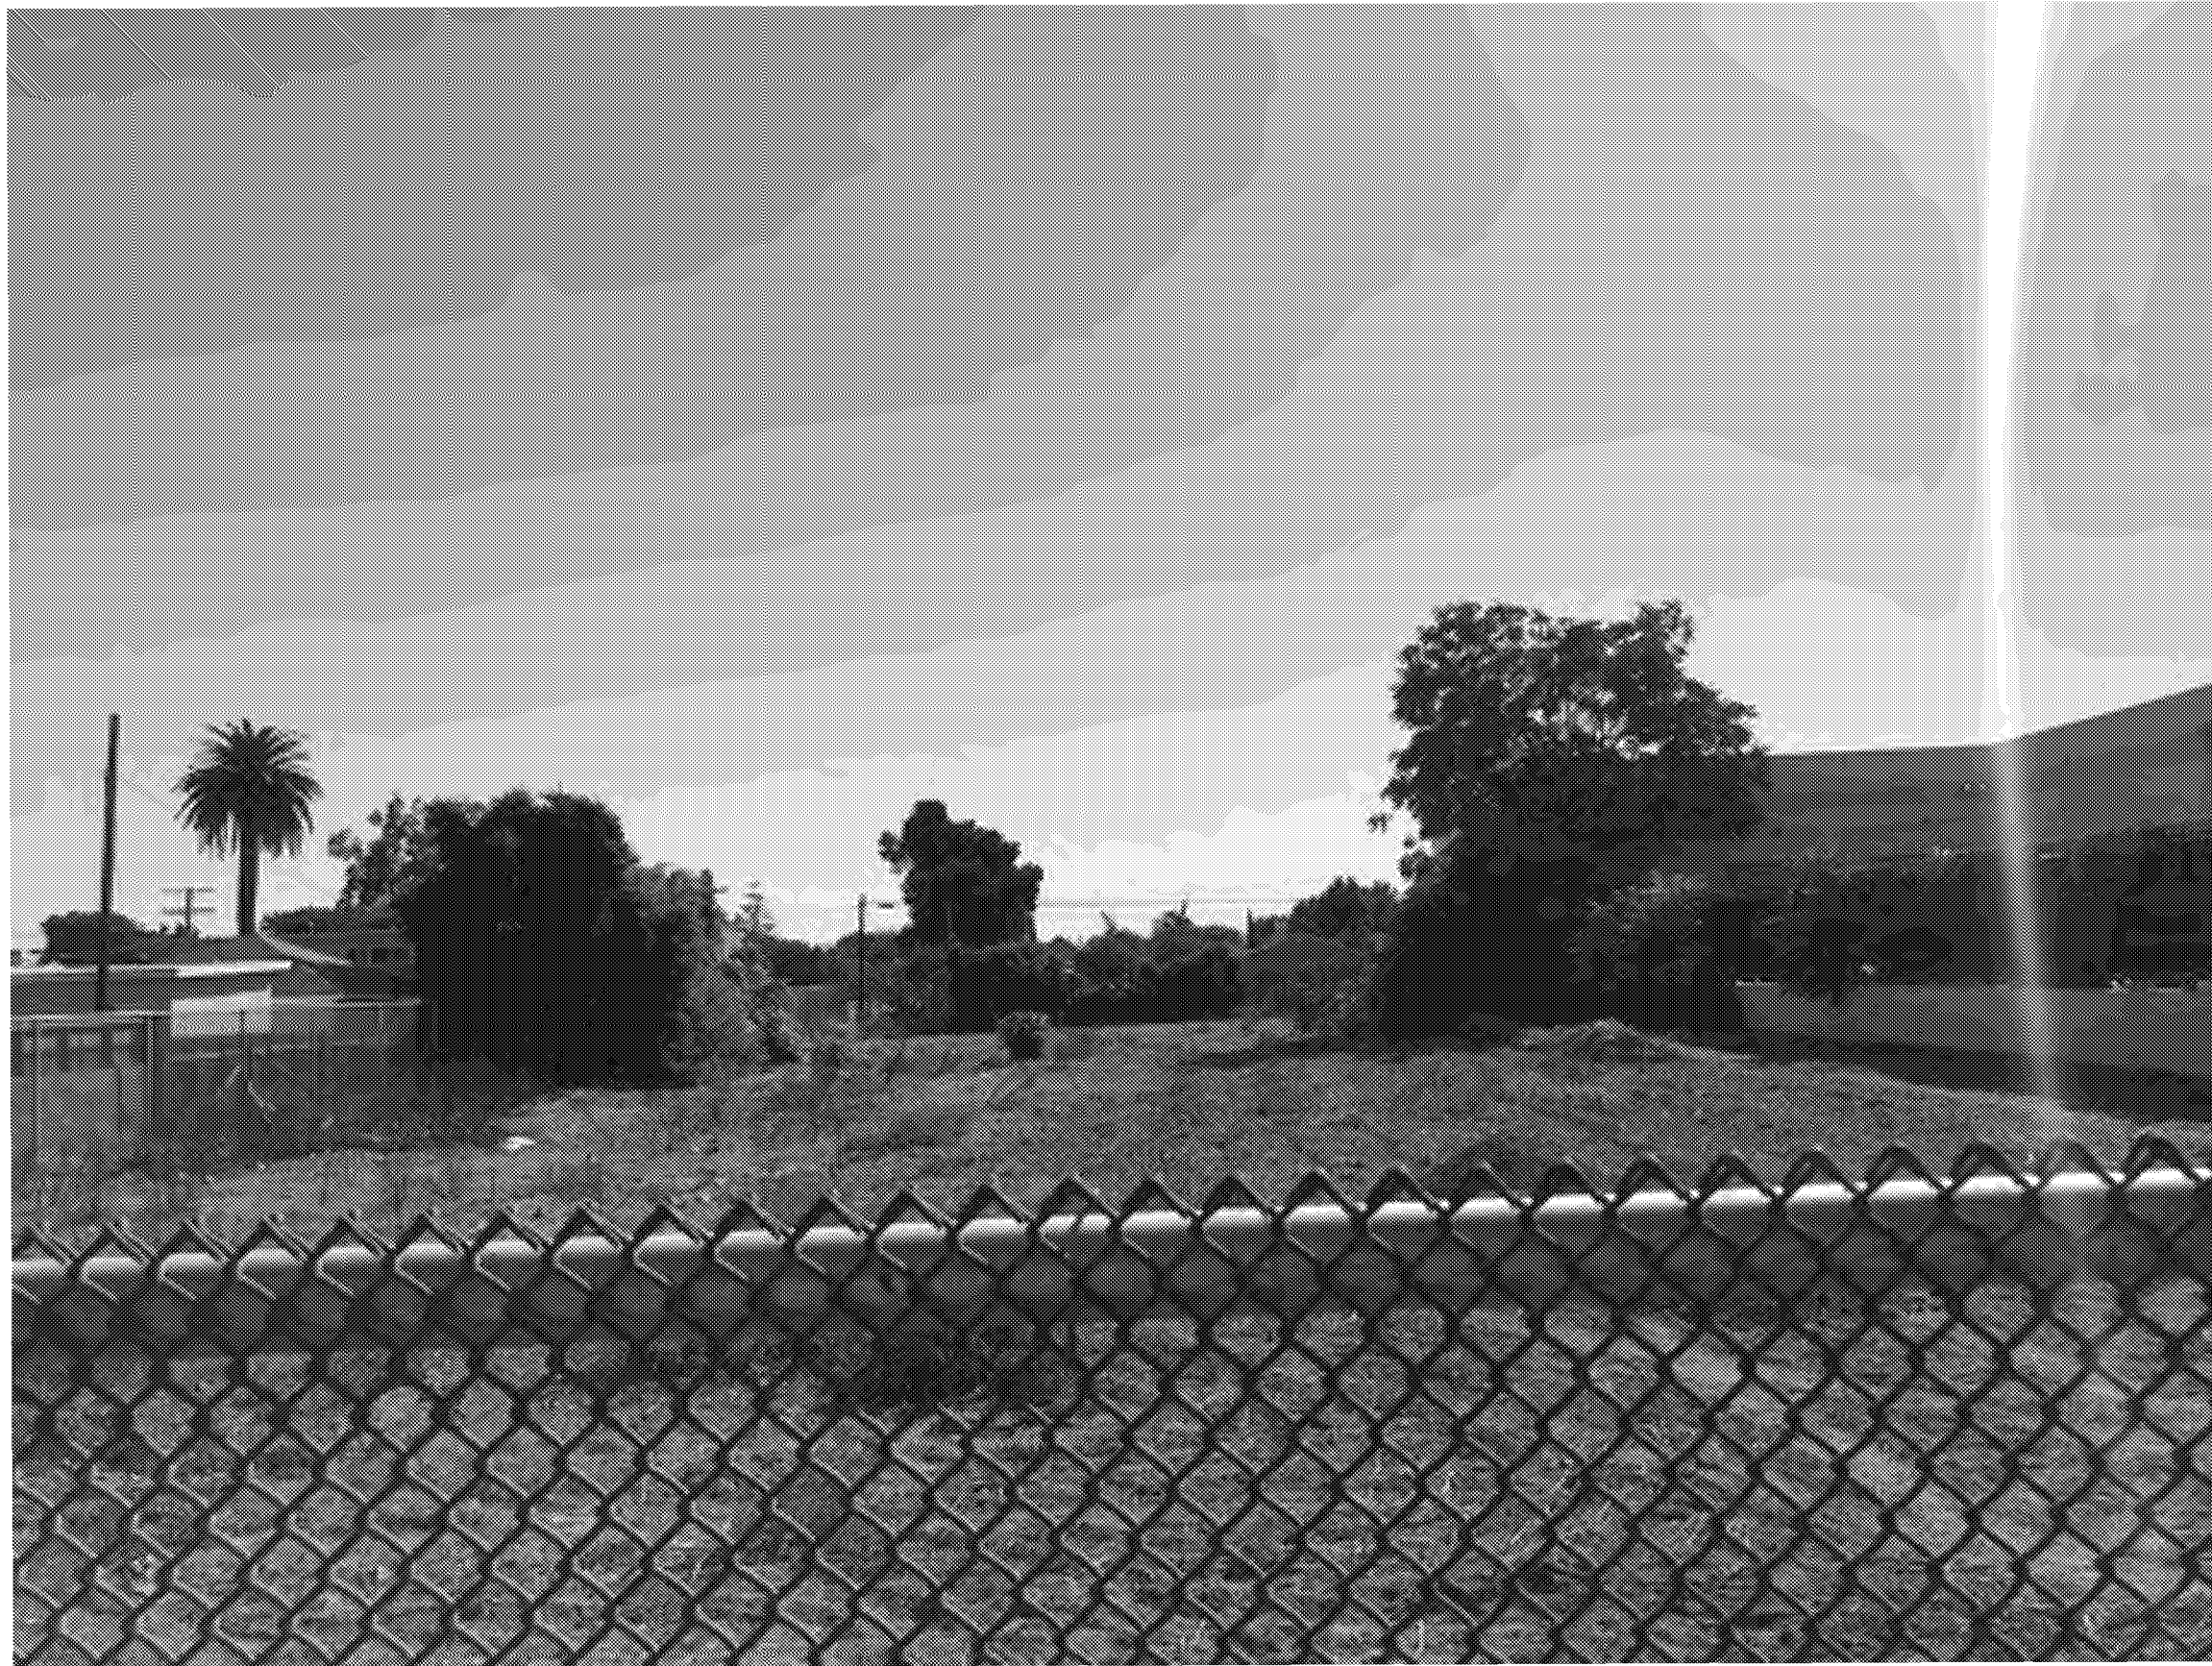
SOUTHBOUND VIEW FROM MIDDLE OF
PARCEL, ALONG 102ND

SITE SURROUNDED BY CHAIN LINK
FENCE, CMU WALLS AND A WROUGHT
IRON FENCE WITH PILASTERS

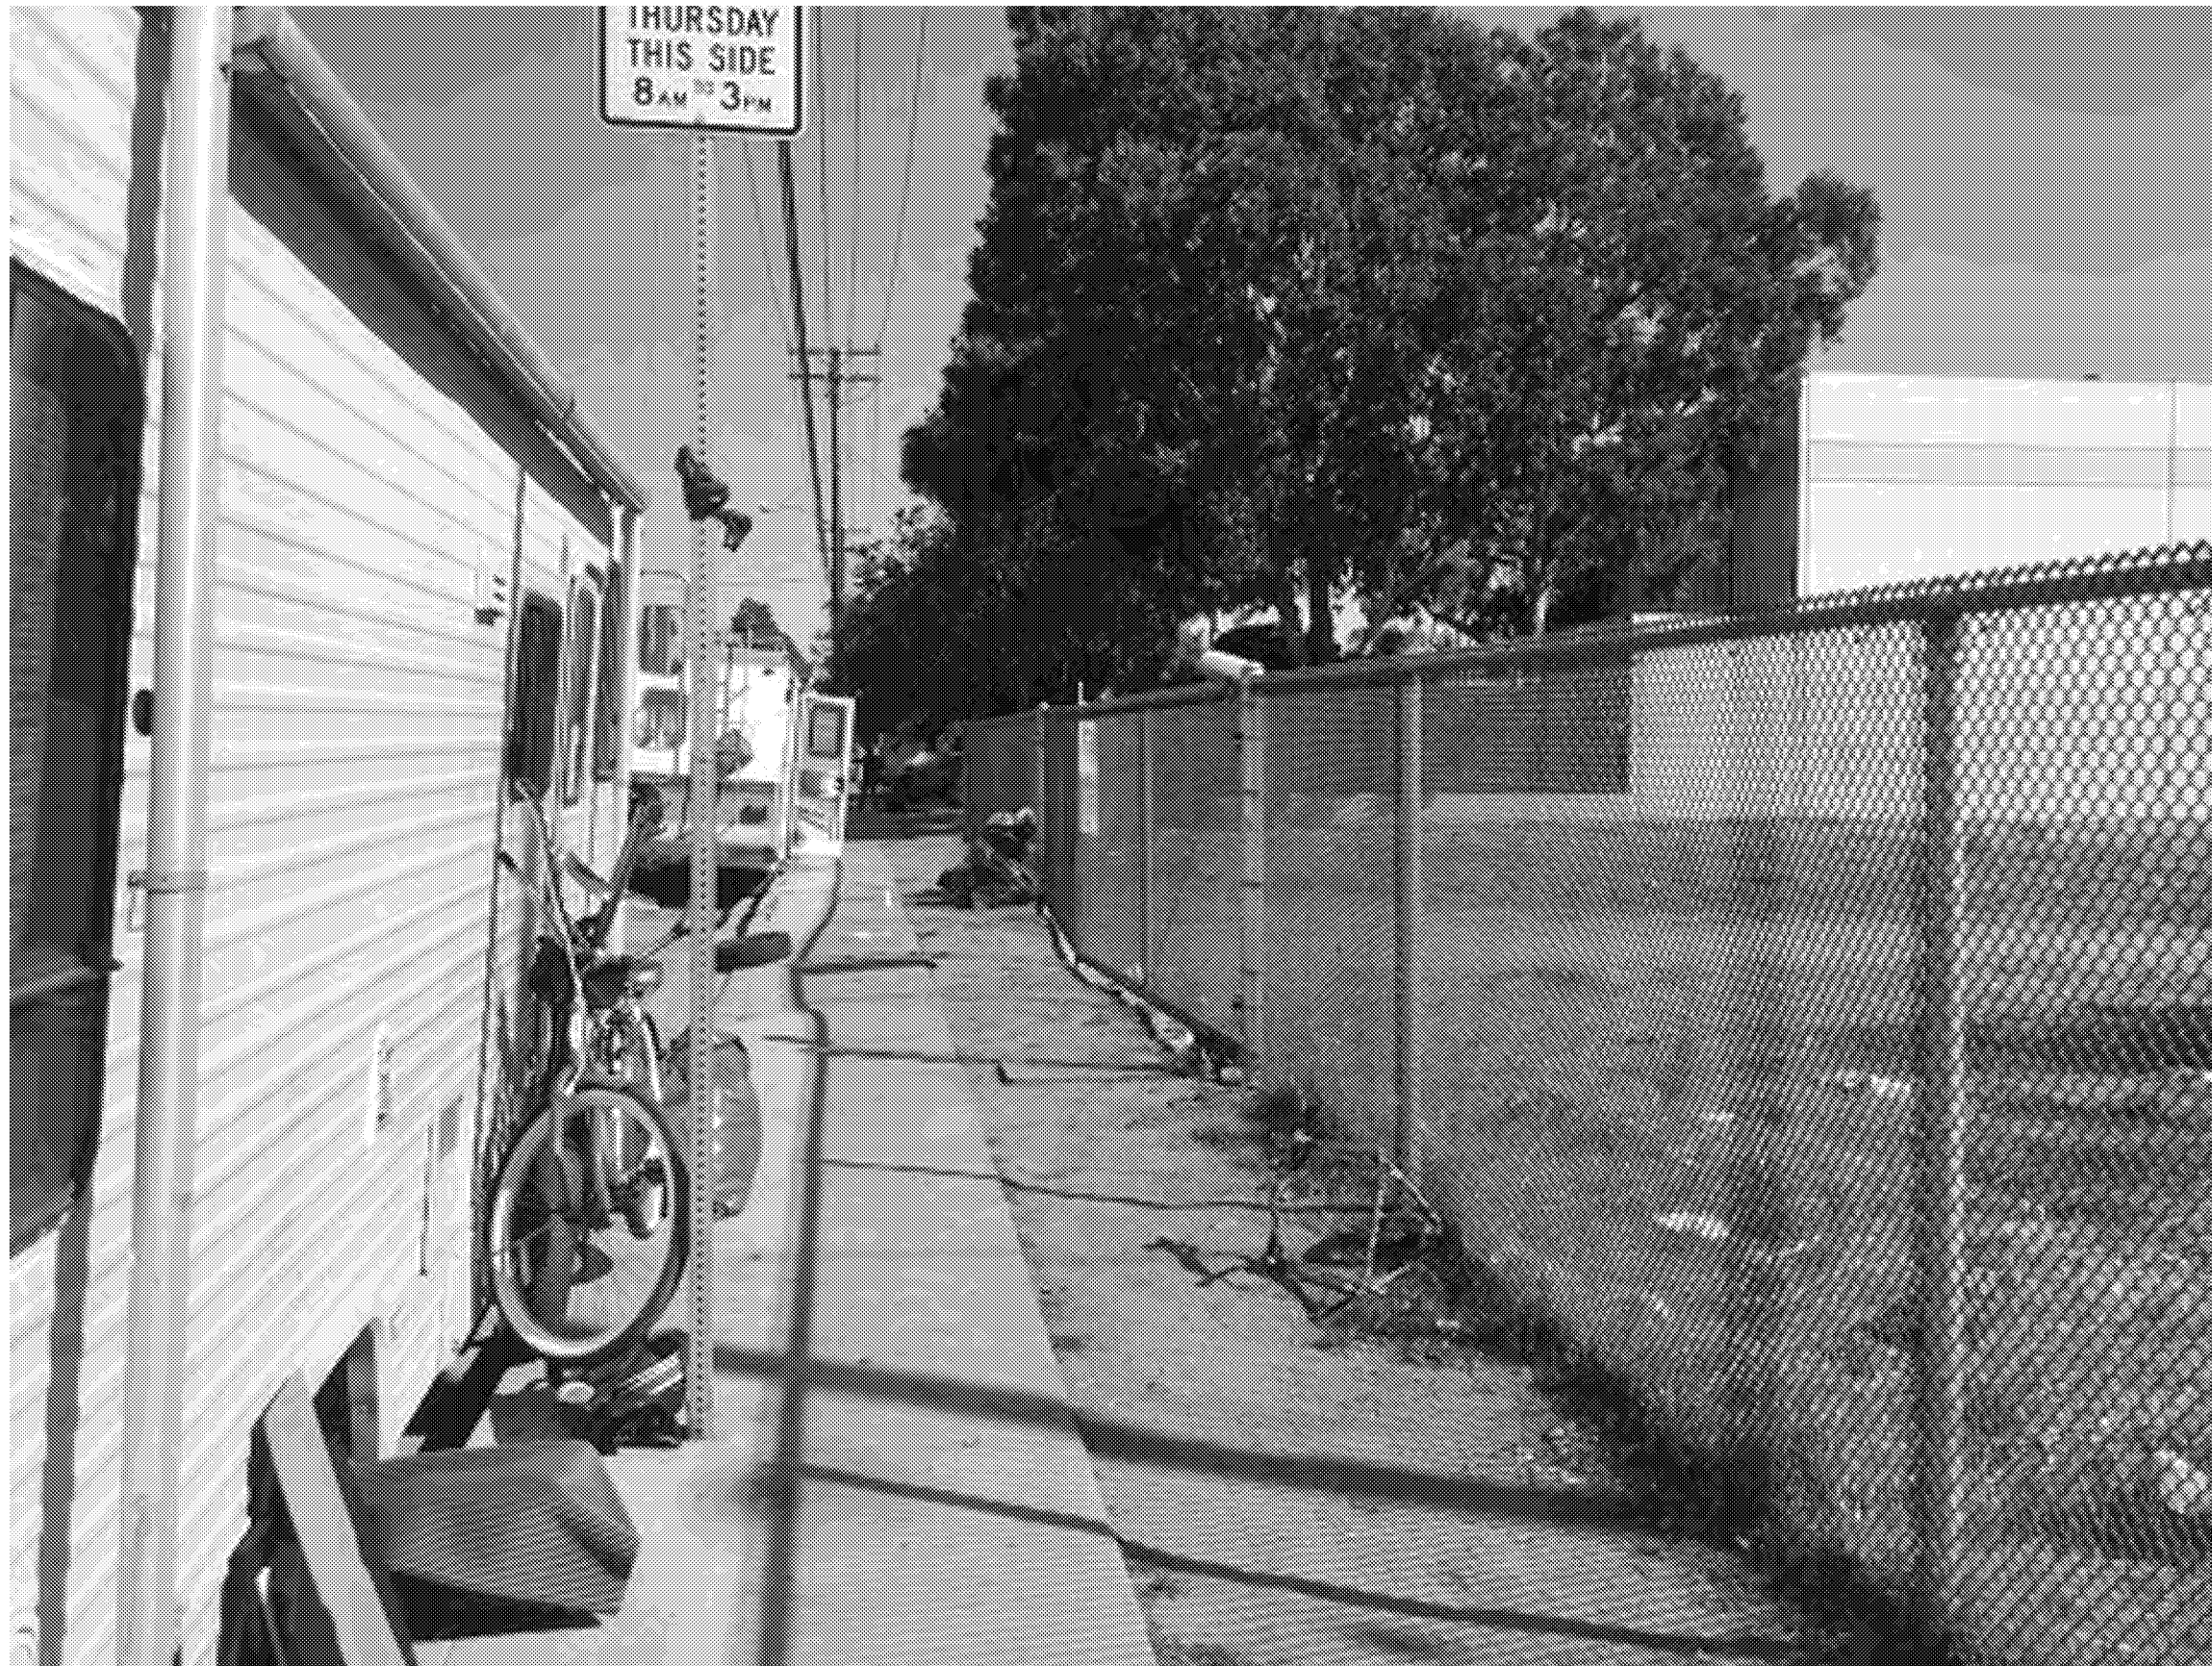
35

WESTBOUND VIEW FROM NORTHWEST CORNER OF PARCEL, ALONG 102ND

SITE SURROUNDED BY CHAIN LINK FENCE, CMU WALLS, BUILDINGS

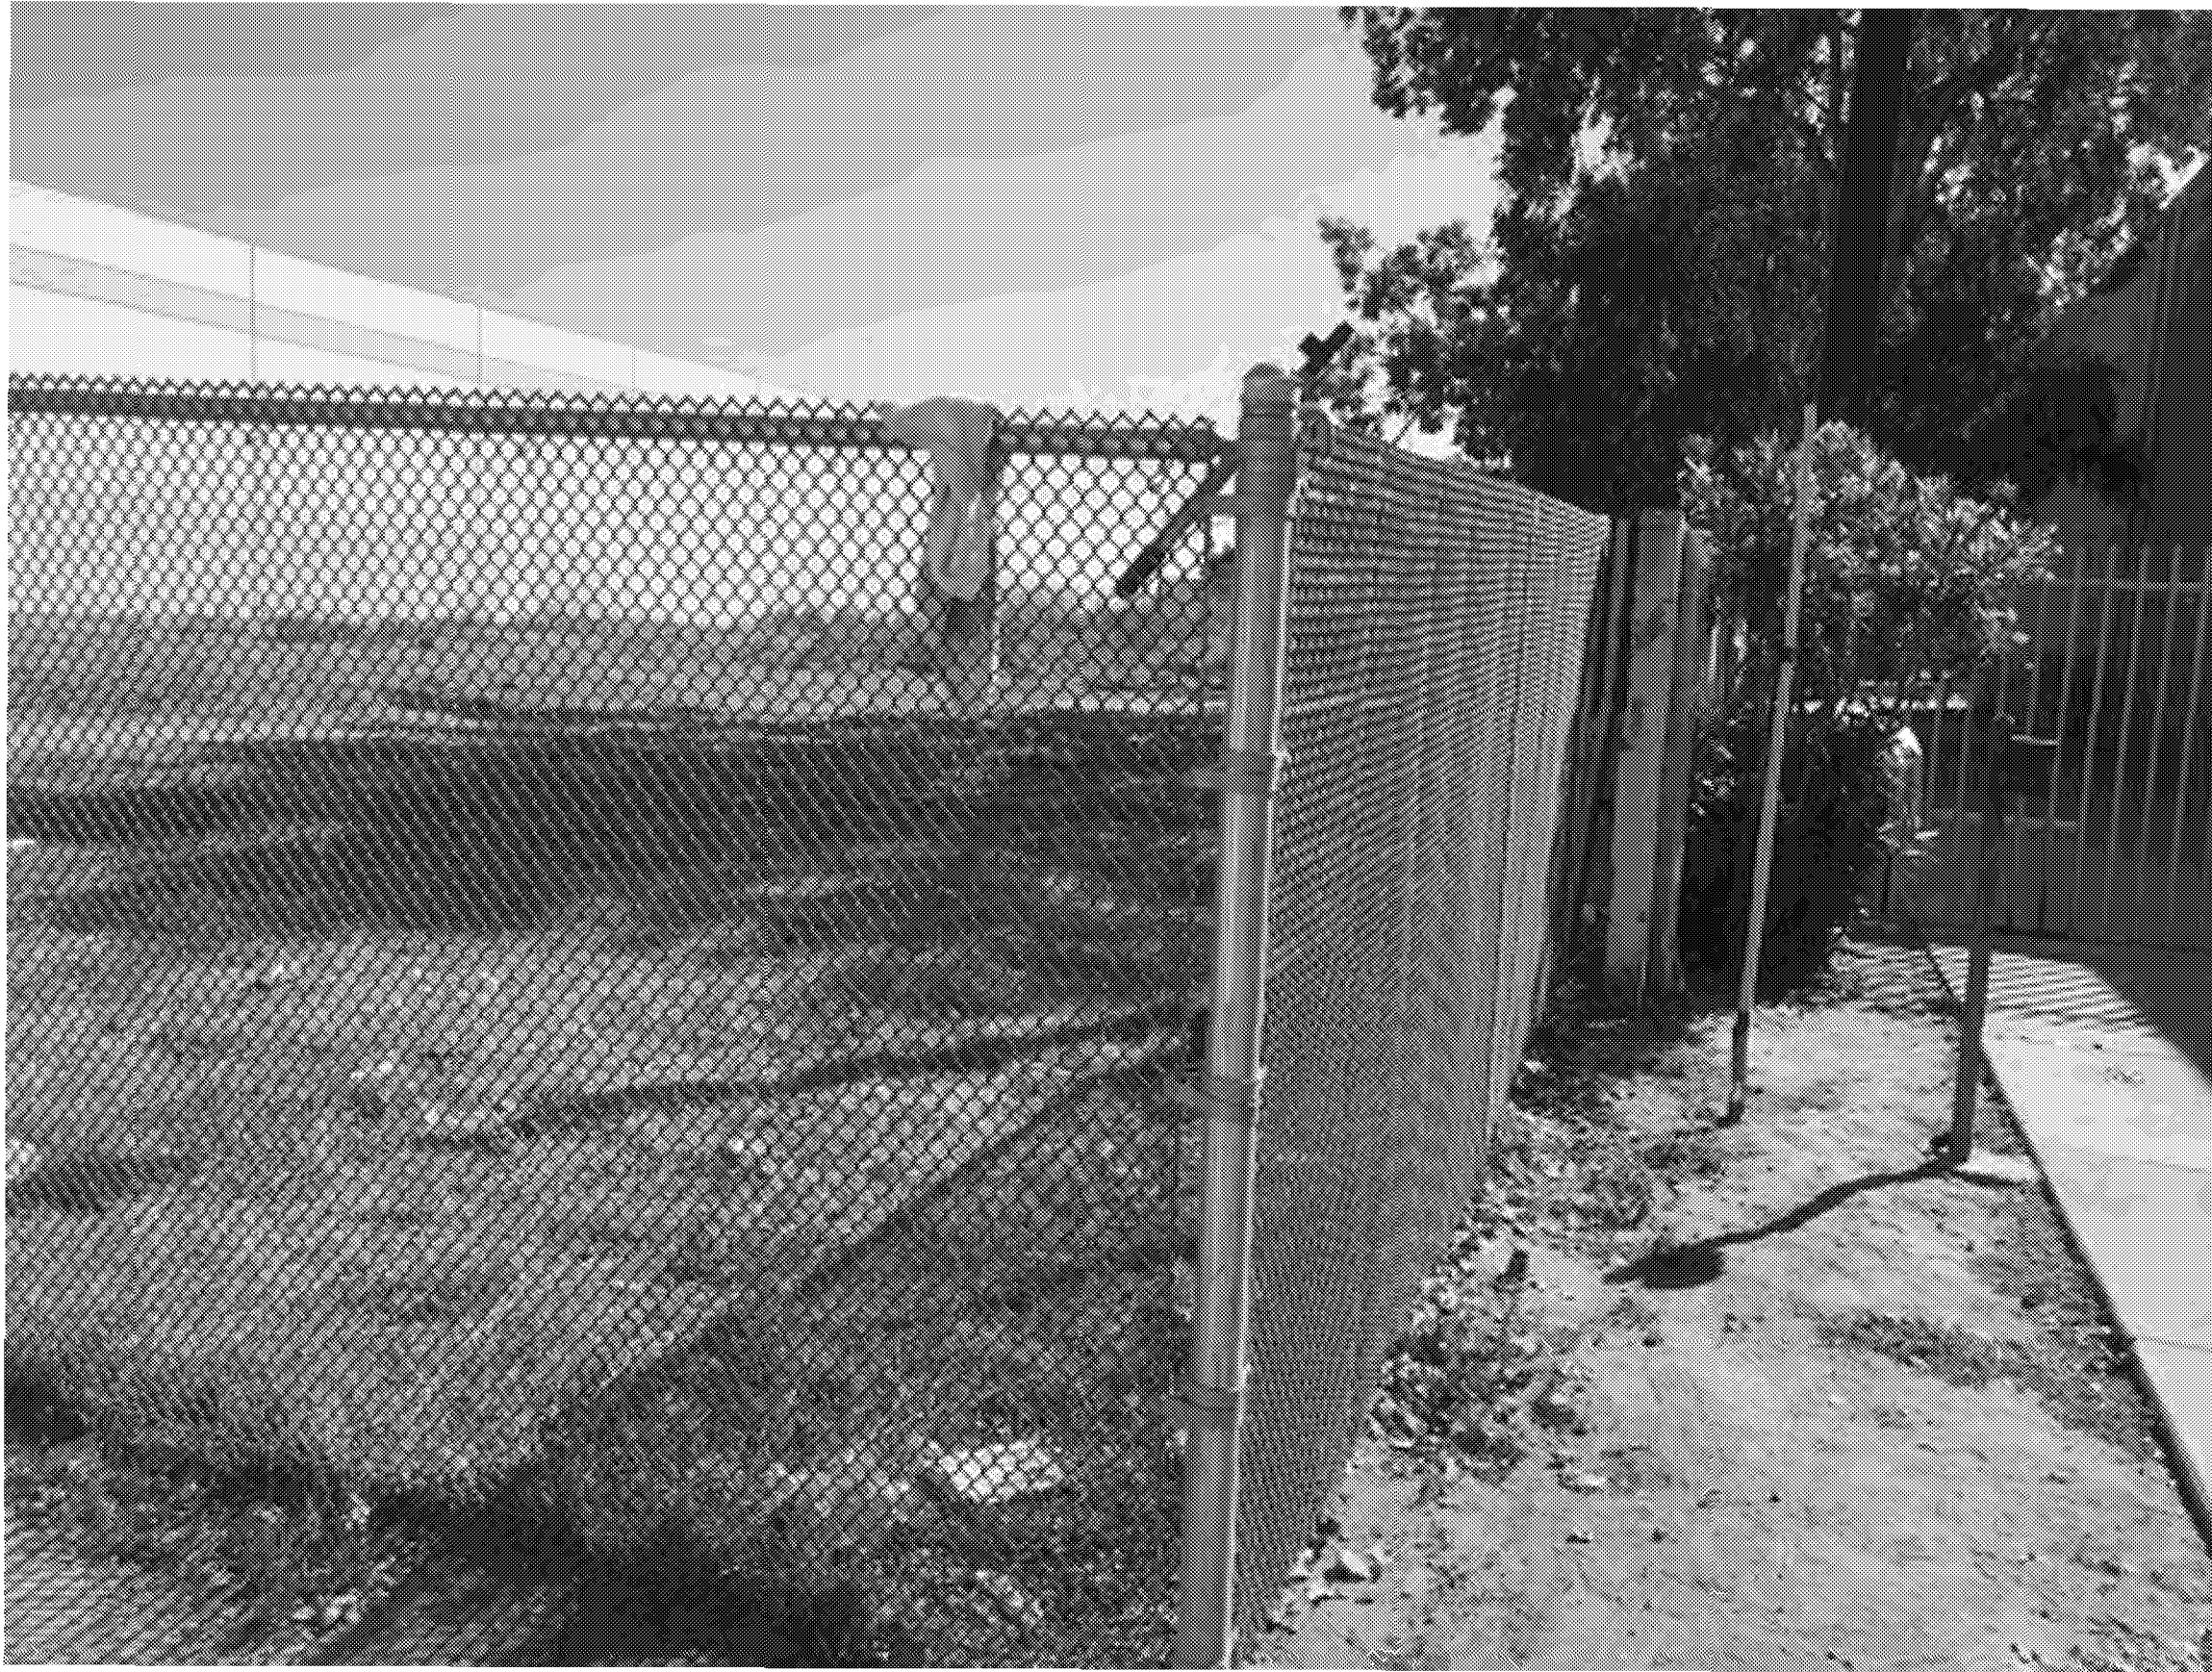
36

SOUTHWESTBOUND VIEW FROM
NORTHWEST CORNER OF PARCEL, ALONG
102ND

SITE SURROUNDED BY CHAIN LINK
FENCE, CMU WALLS, BUILDINGS
