<p>D & D ENGINEERING, INC. 8901 S. LA CIENEGA BLVD, SUITE 106 INGLEWOOD, CA 90301 Phone: 424-393-4122</p>	PROJECT CONDOR	SCALE: AS SHOWN
	PERIMETER CONDITIONS EXHIBIT	DATE: 2017/10/24
		SHT NO.: 01 OF 01

PHOTO KEY MAP

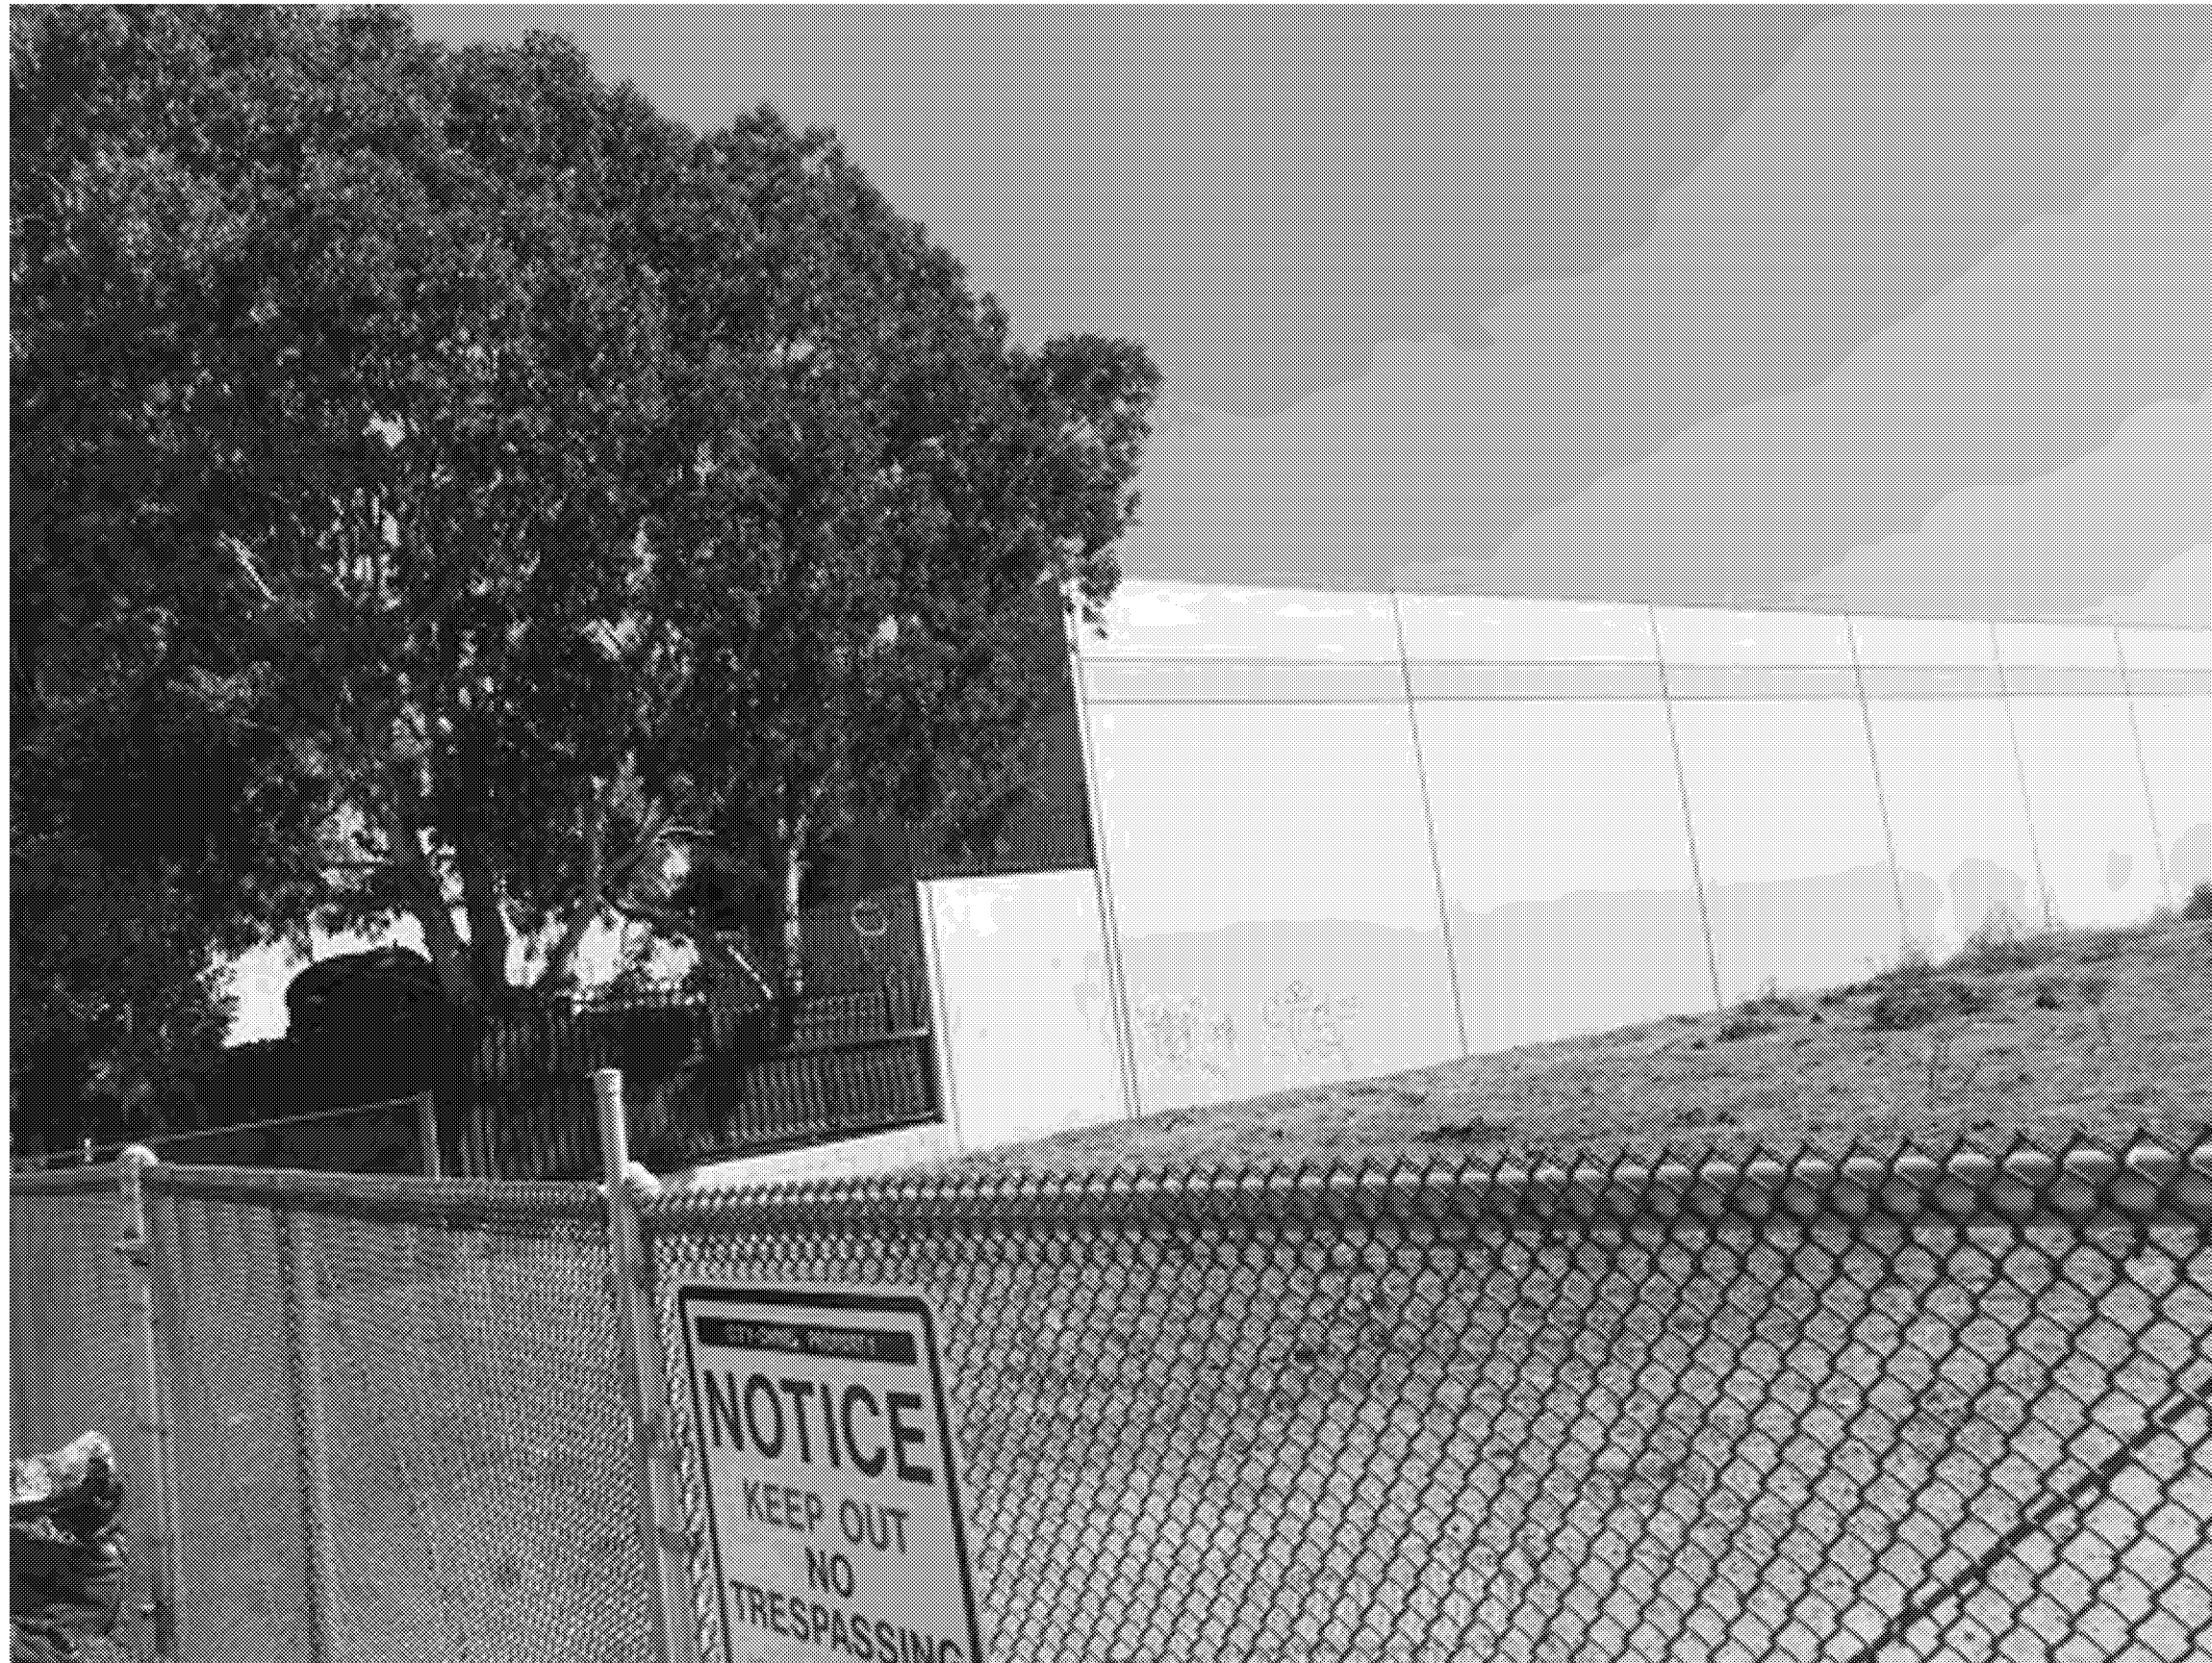
37

WESTBOUND VIEW FROM NORTHWEST
CORNER OF PARCEL, ALONG 102ND

SITE SURROUNDED BY CHAIN LINK
FENCE, CMU WALLS, BUILDINGS

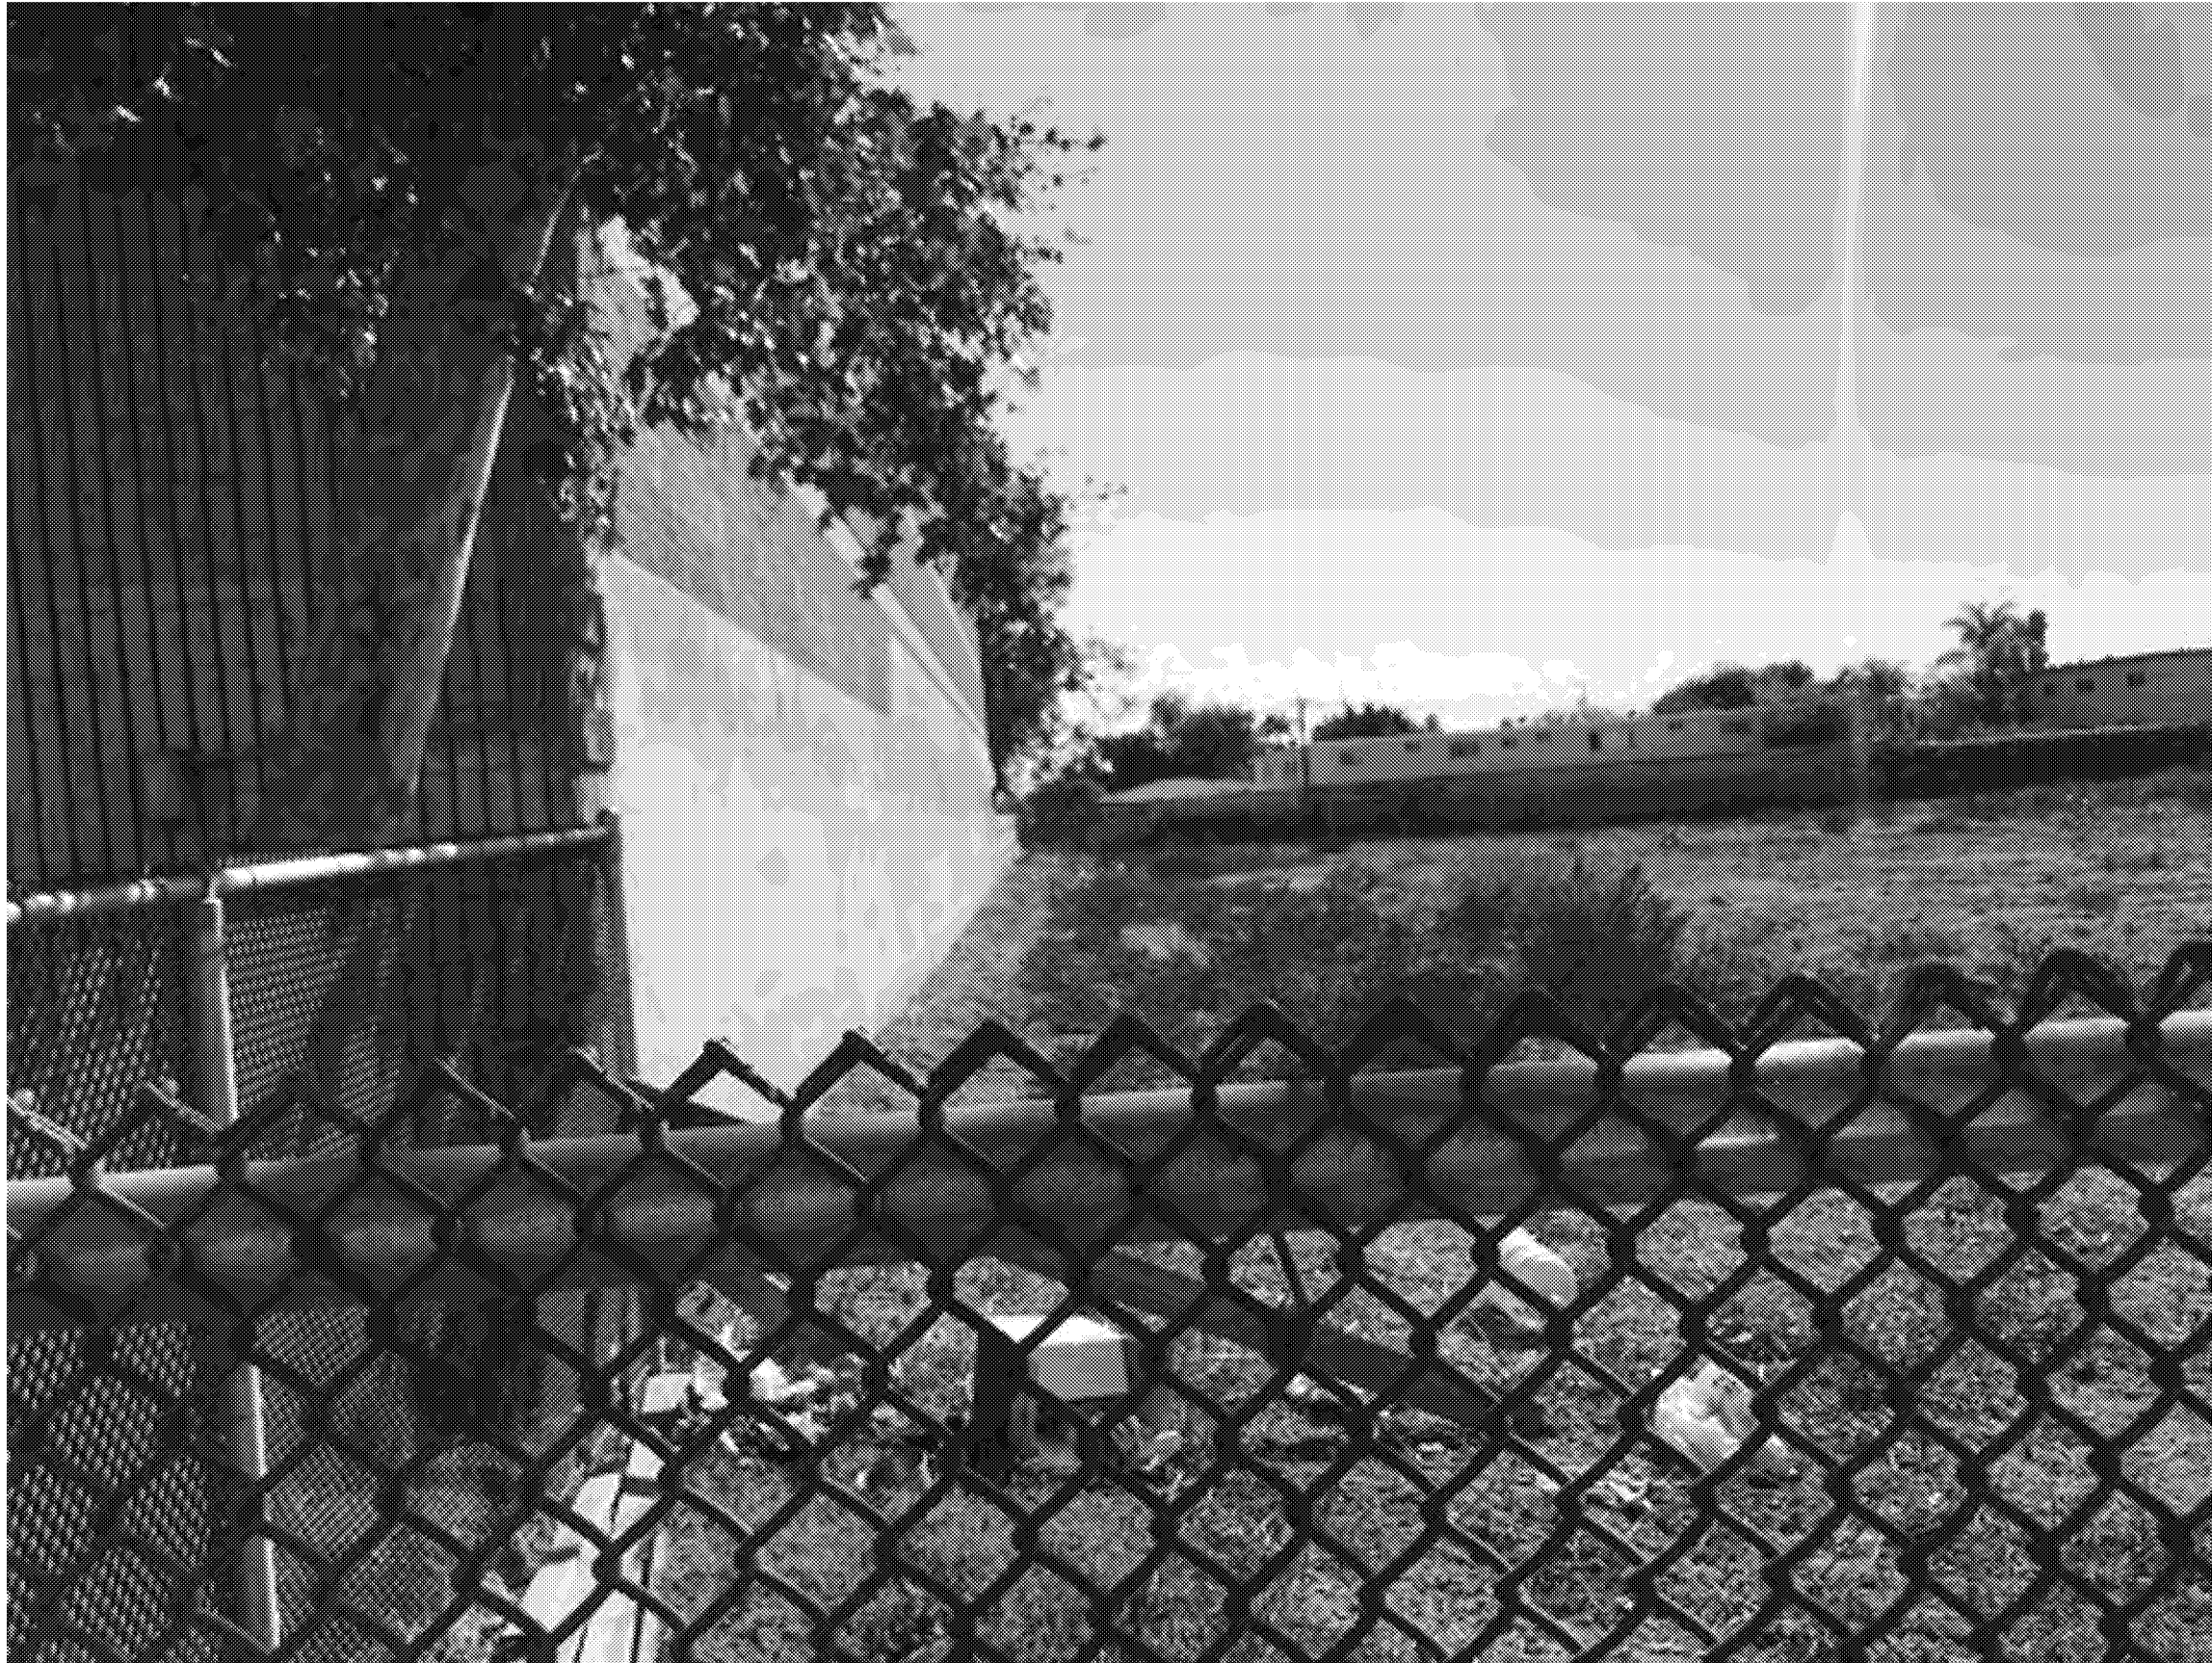
38

SOUTHBOUND VIEW FROM NORTHEAST
CORNER OF PARCEL, ALONG 102ND

SITE SURROUNDED BY CHAIN LINK
FENCE, CMU WALLS, BUILDINGS

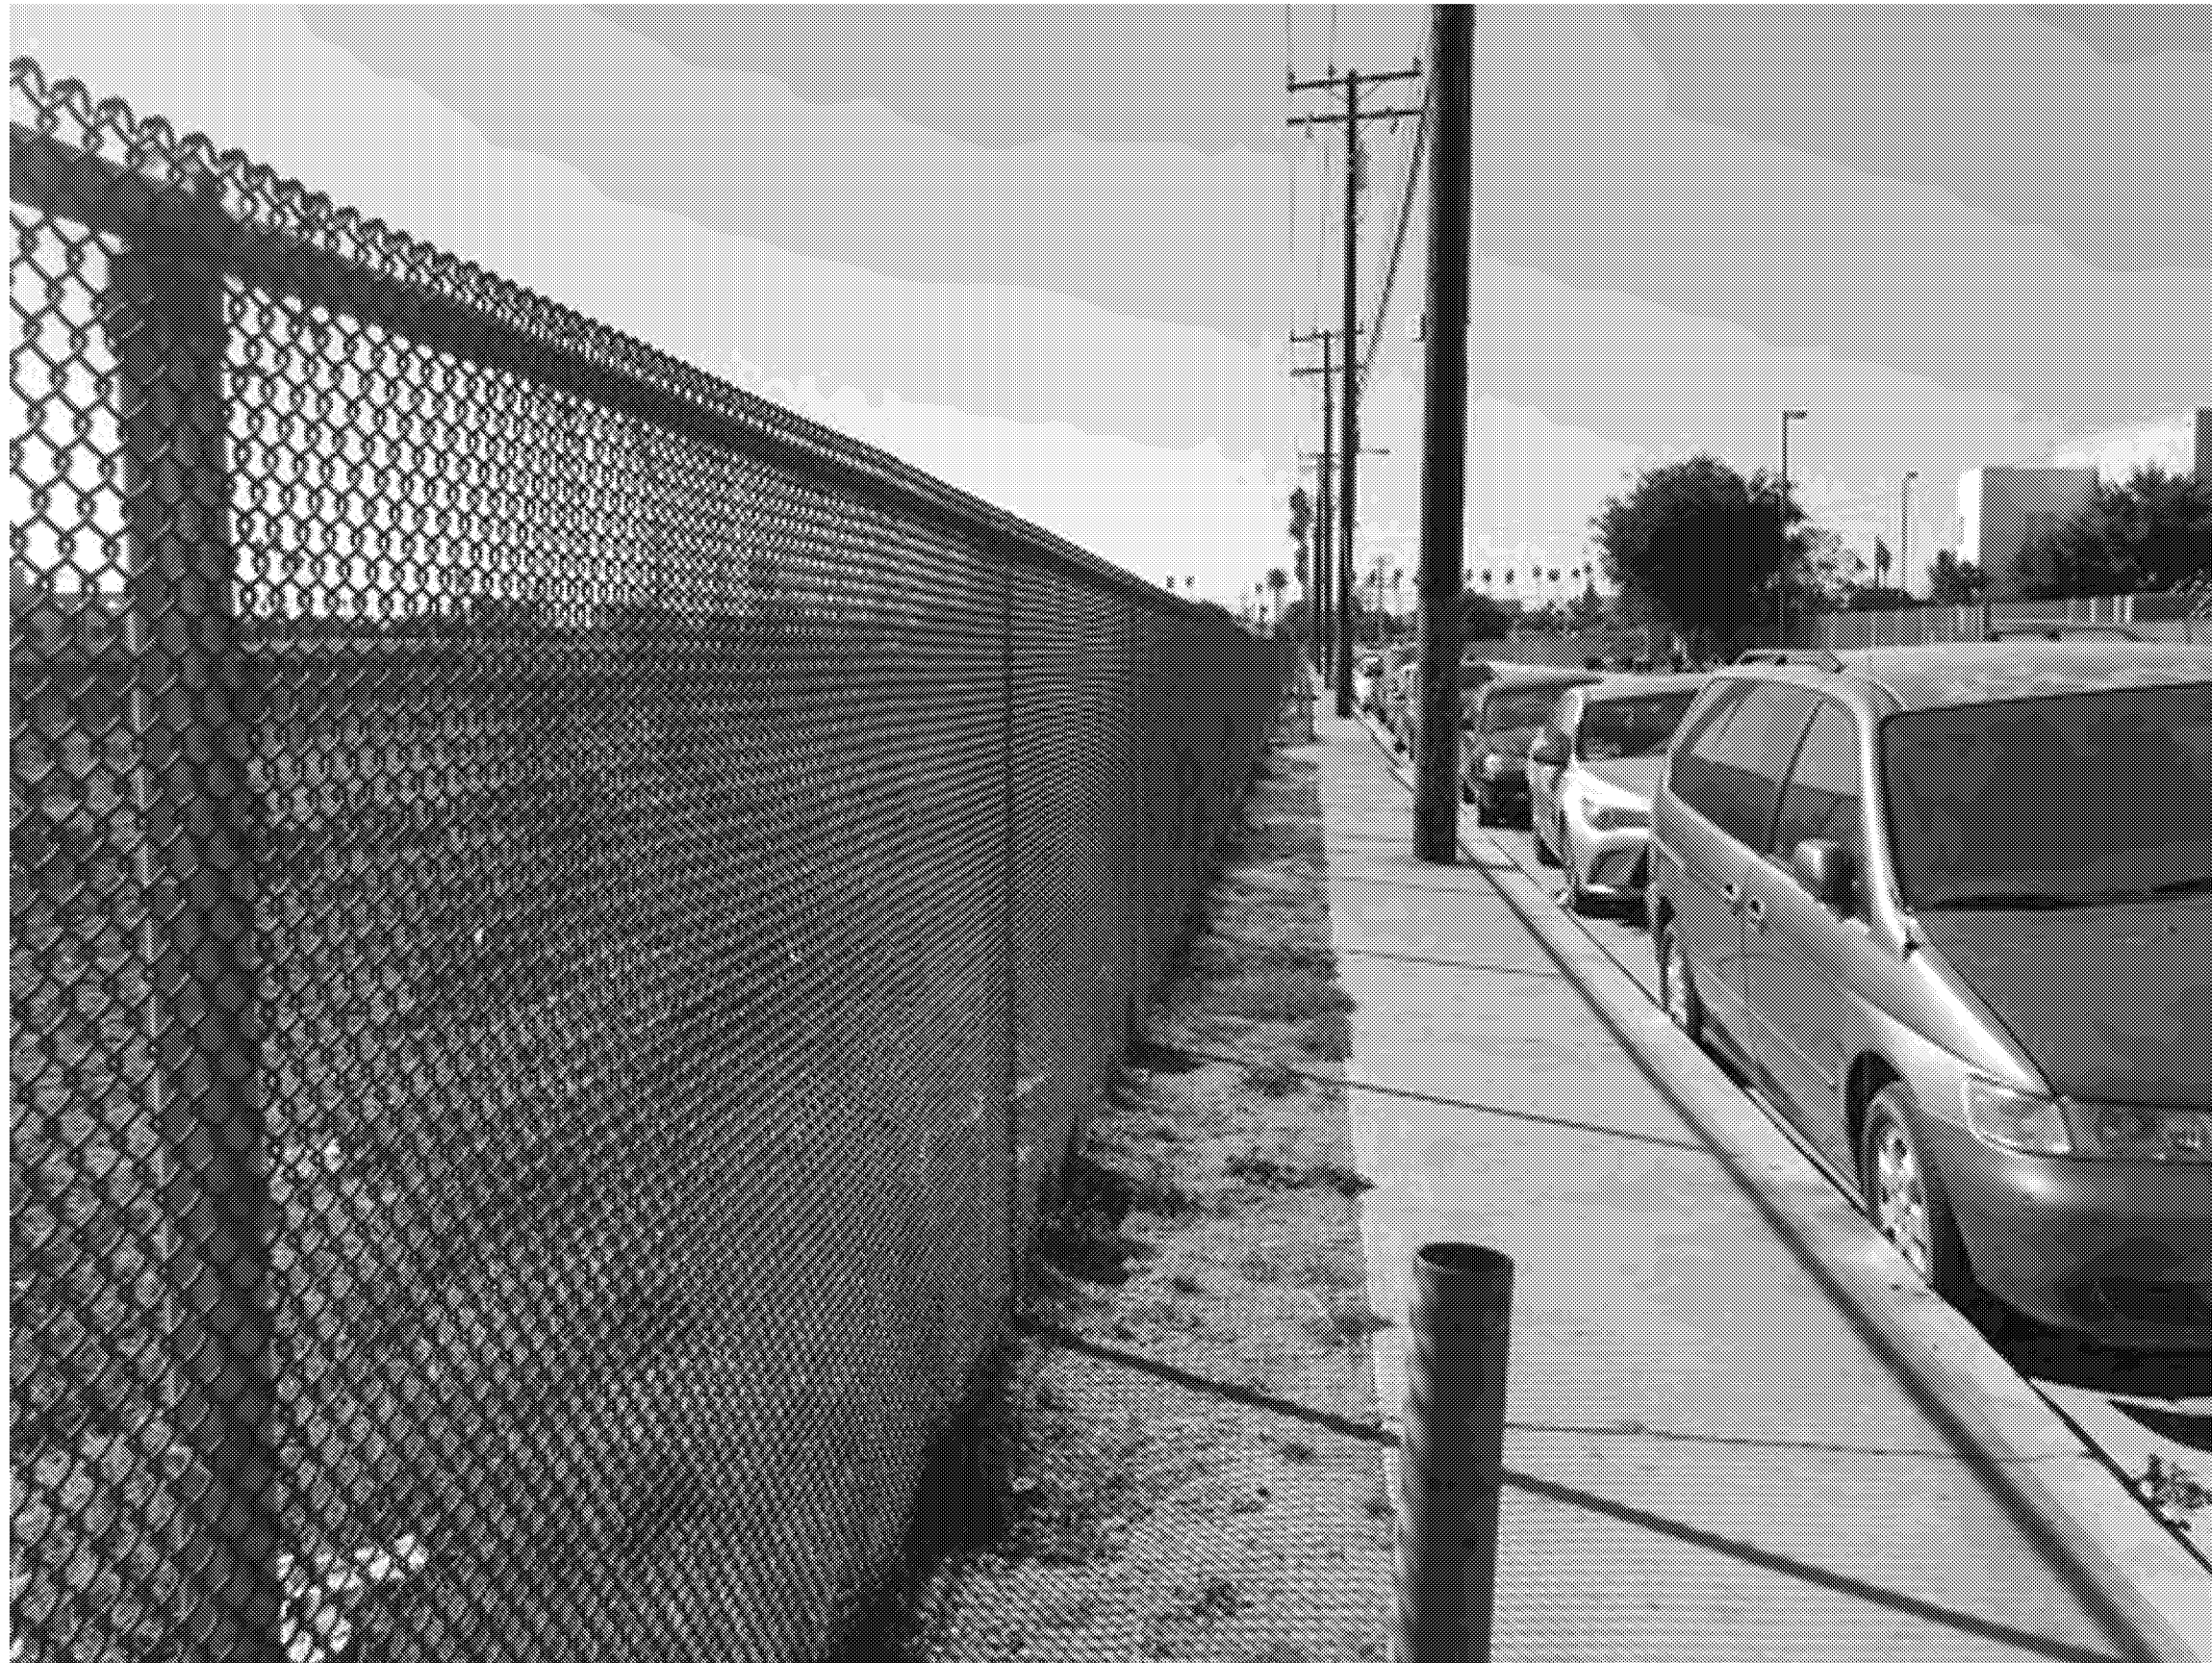
39

WESTBOUND VIEW FROM NORTHEAST
CORNER OF PARCEL, ALONG 102ND

SITE SURROUNDED BY CHAIN LINK
FENCE, CMU WALLS, BUILDINGS

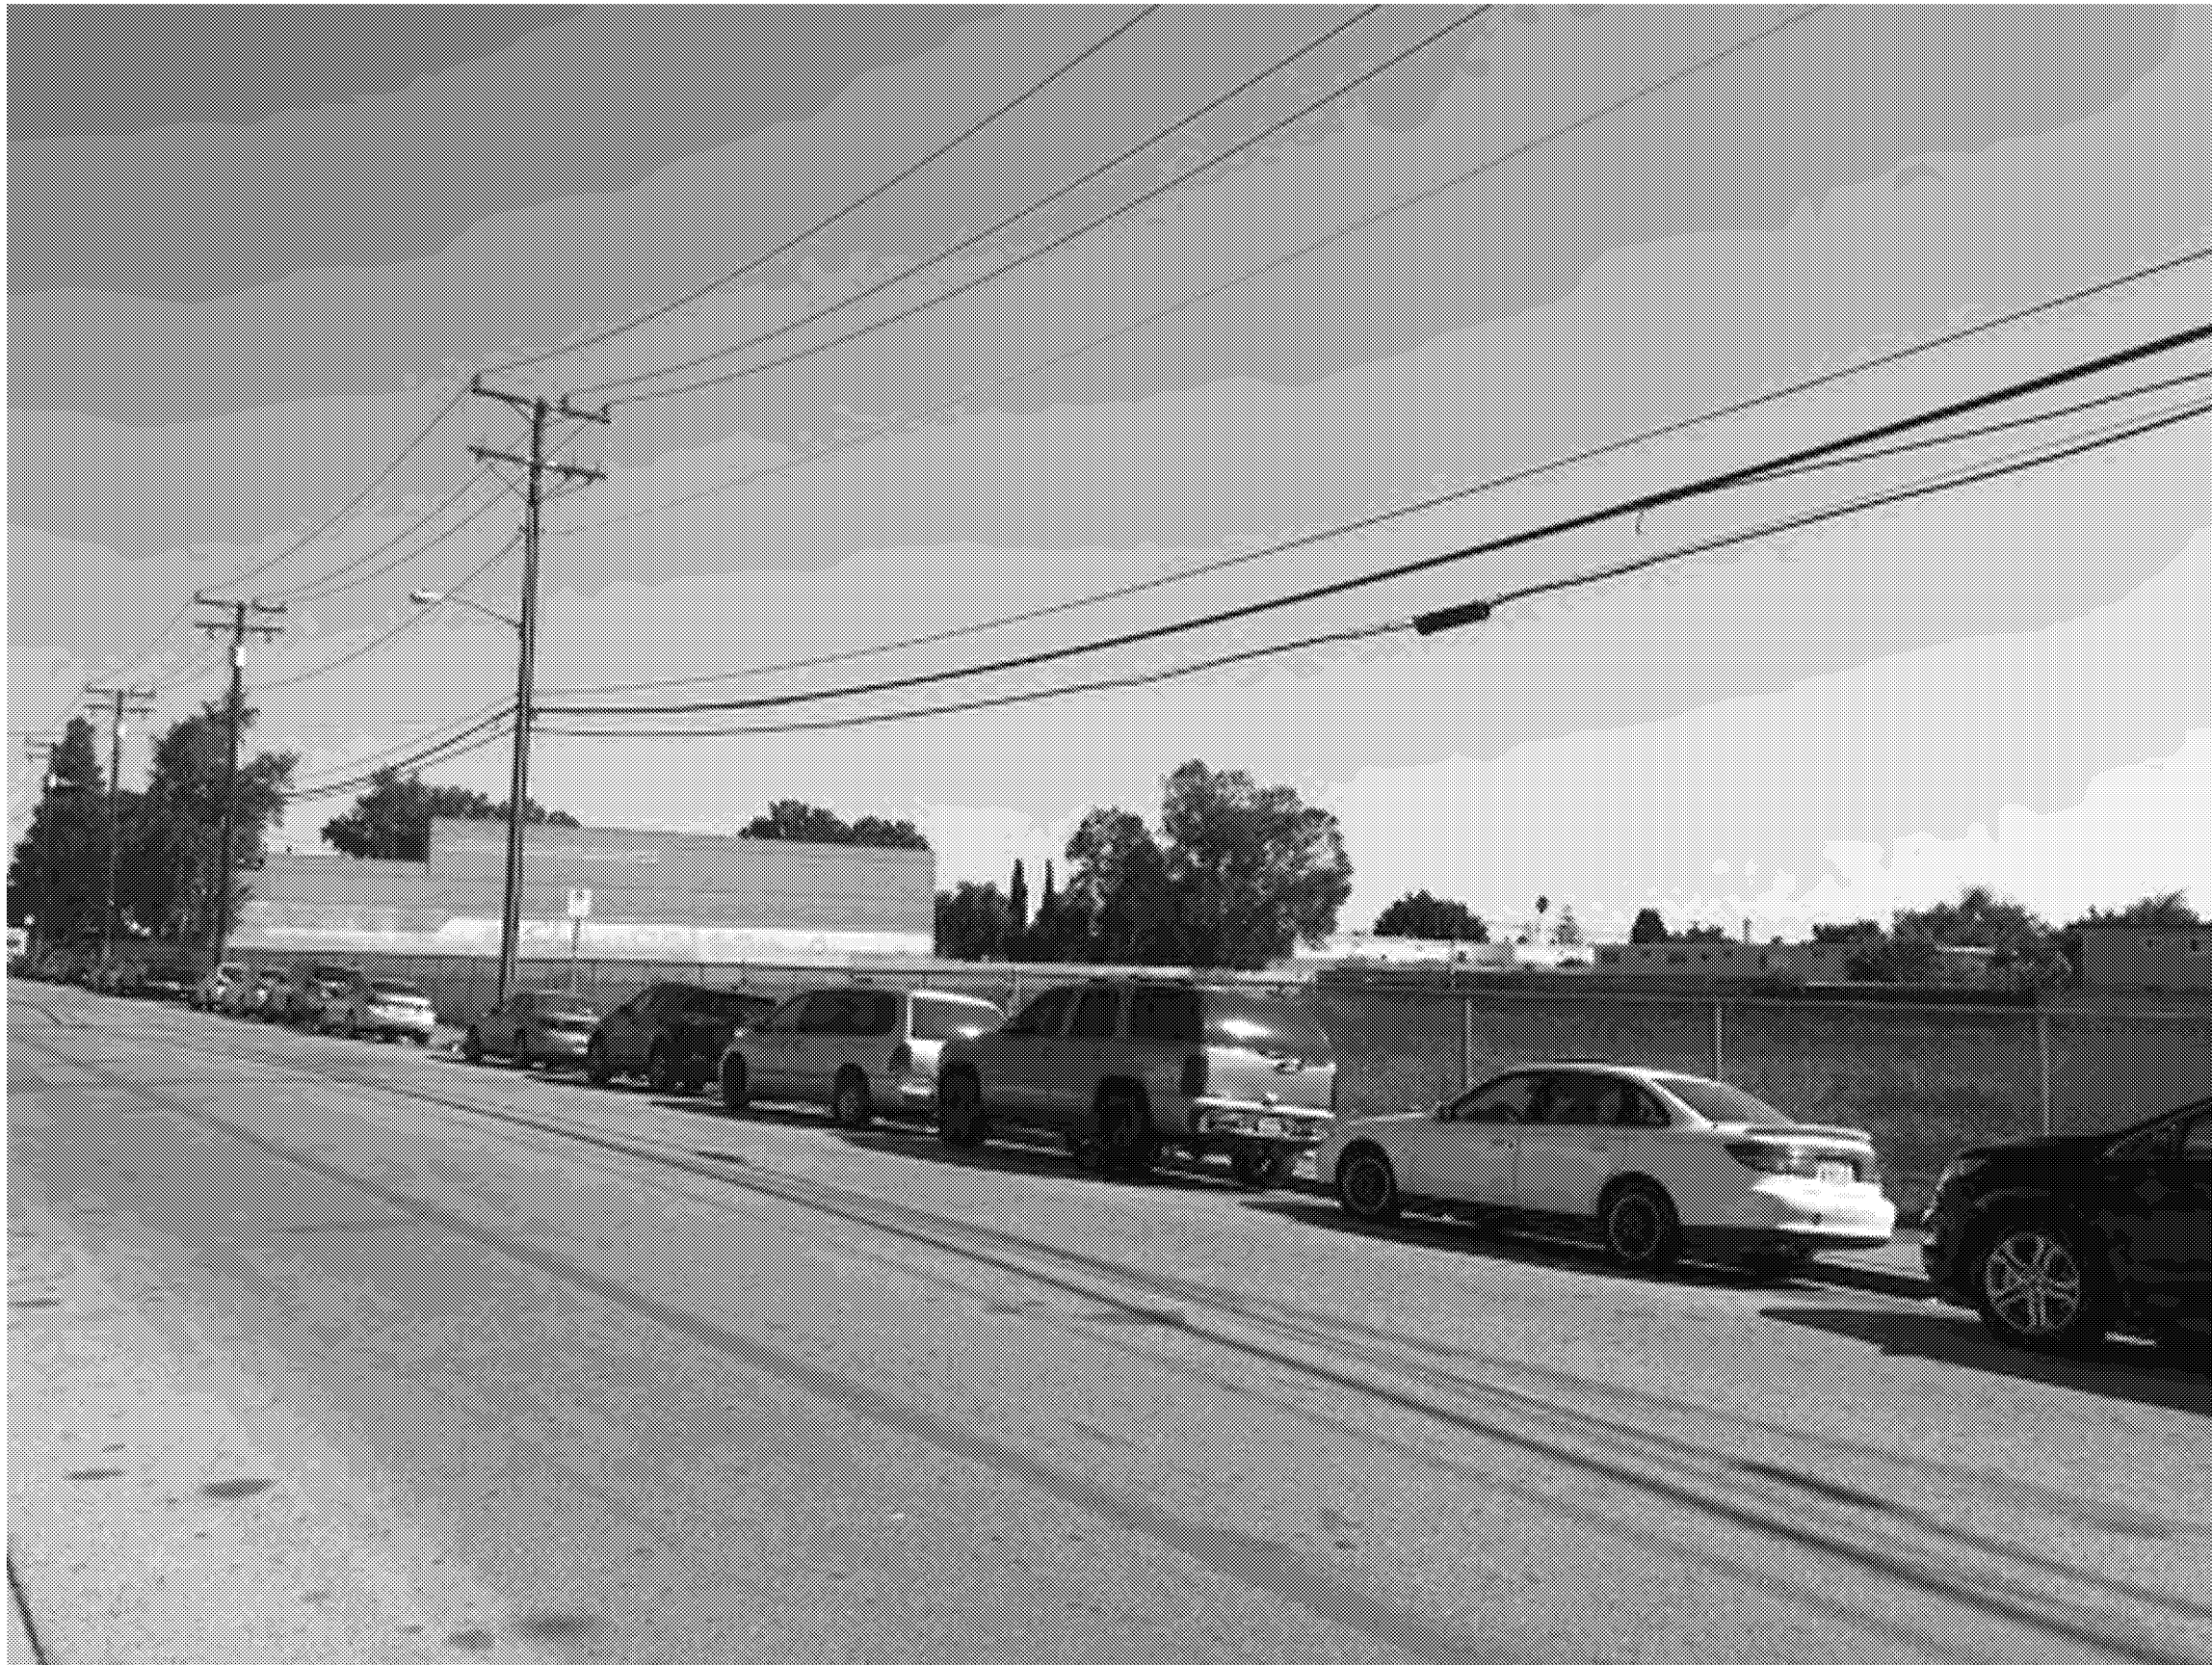
40

SOUTHEASTBOUND VIEW FROM MIDDLE
OF PARCEL, ALONG 102ND

SITE SURROUNDED BY CHAIN LINK
FENCE, CMU WALLS, BUILDINGS

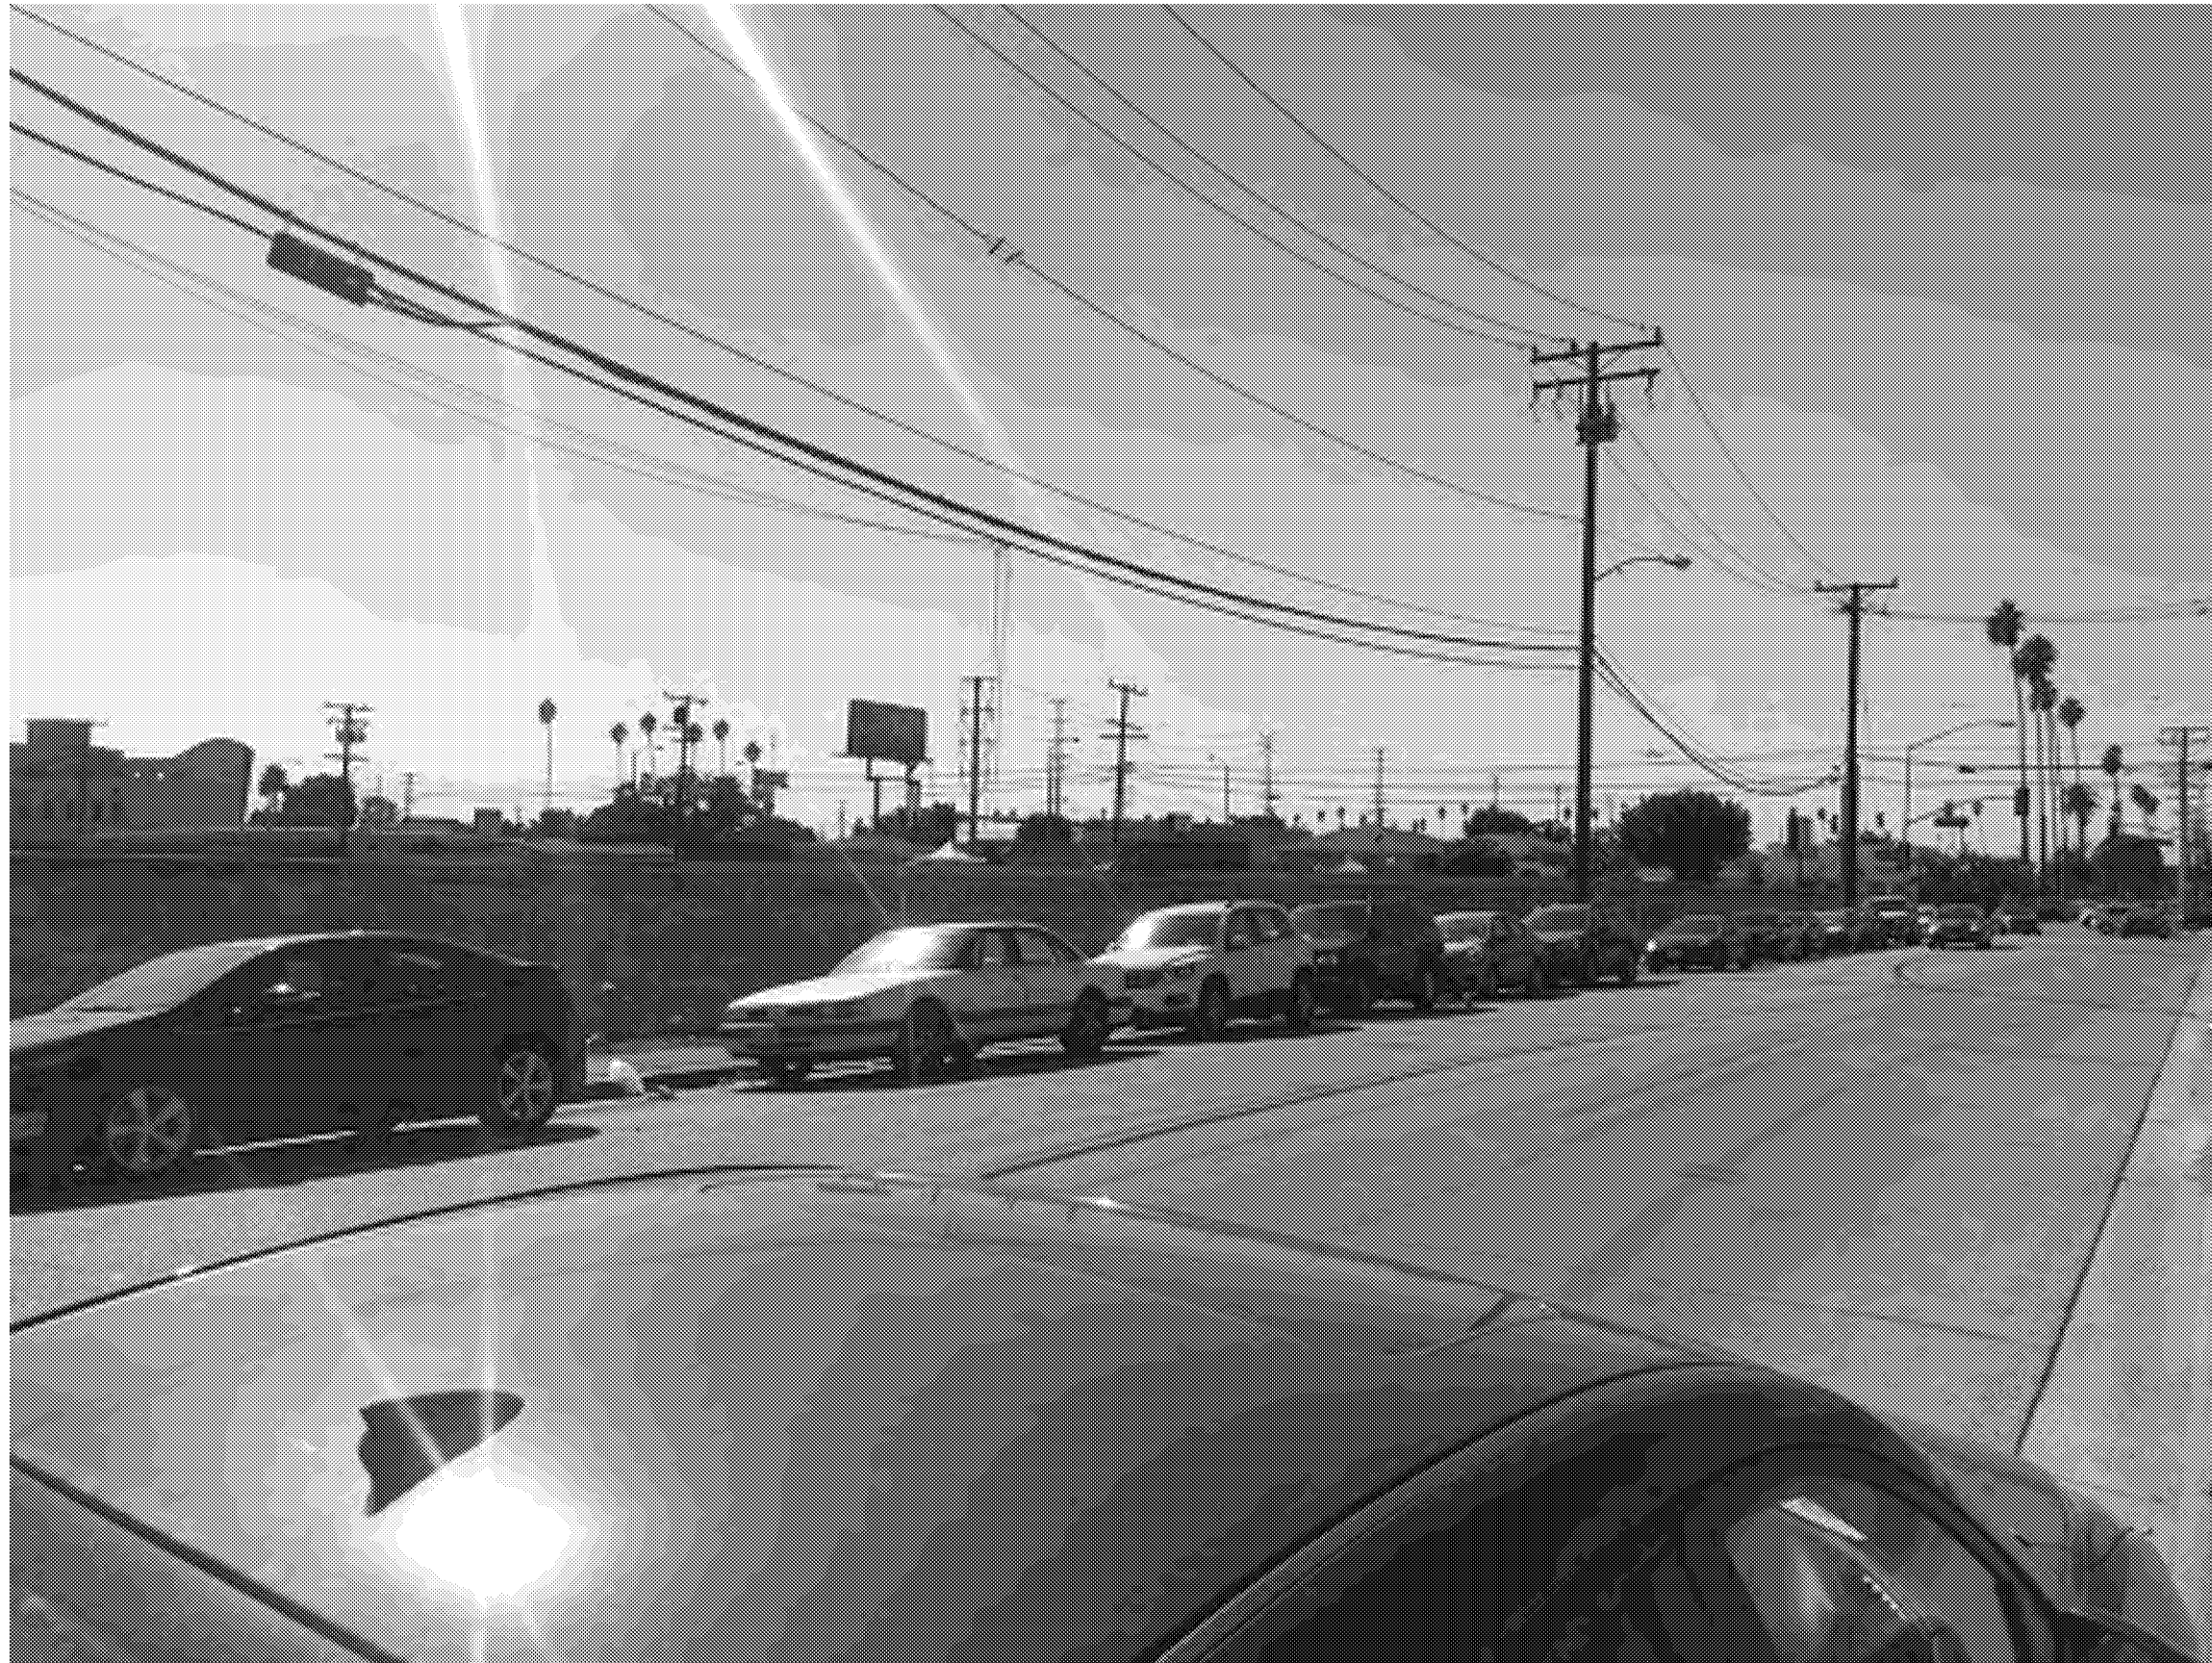
41

SOUTHEASTBOUND VIEW FROM MIDDLE
OF PARCEL, ALONG 102ND

SITE SURROUNDED BY CHAIN LINK
FENCE, CMU WALLS, BUILDINGS

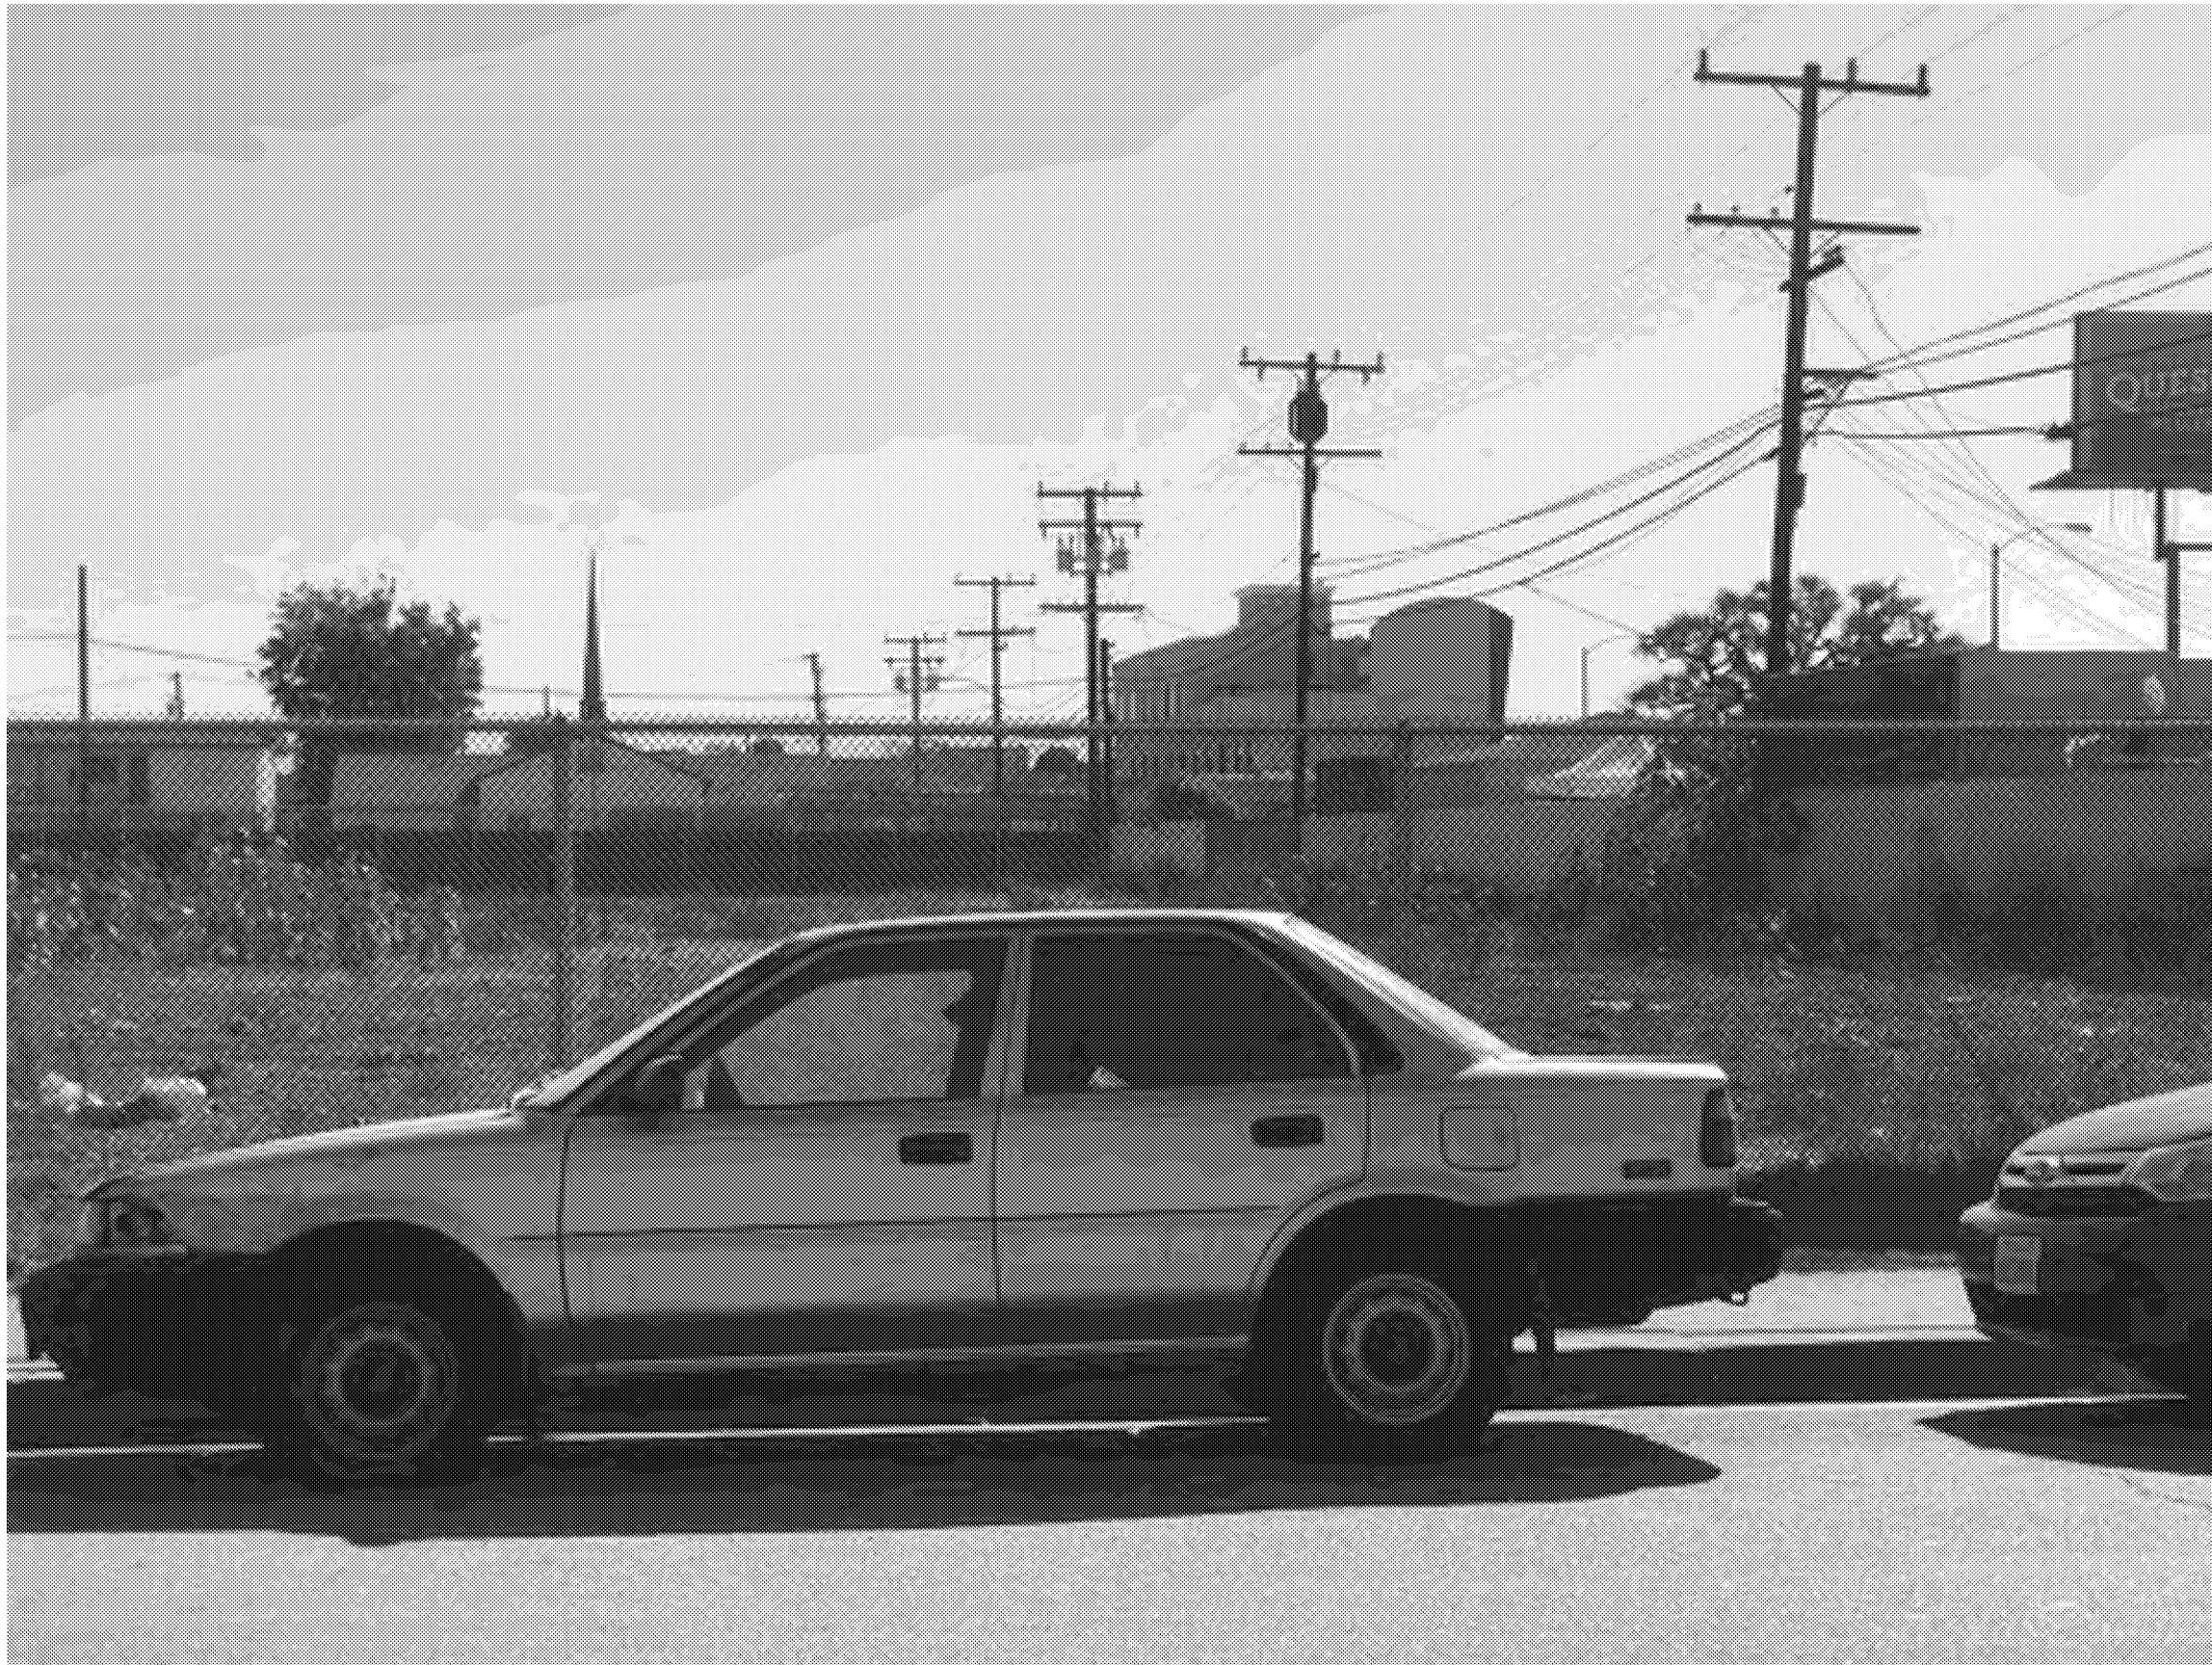
42

SOUTHBOUND VIEW FROM NORTHWEST
CORNER OF PARCEL, ALONG 102ND

SITE SURROUNDED BY CHAIN LINK
FENCE, CMU WALLS, BUILDINGS
