<p>D & D ENGINEERING, INC. 8901 S. LA CIENEGA BLVD, SUITE 106 INGLEWOOD, CA 90301 Phone: 424-393-4122</p>	PROJECT CONDOR	SCALE: AS SHOWN
	PERIMETER CONDITIONS EXHIBIT	DATE: 2017/10/24
		SHT NO.: 01 OF 01

PHOTO KEY MAP

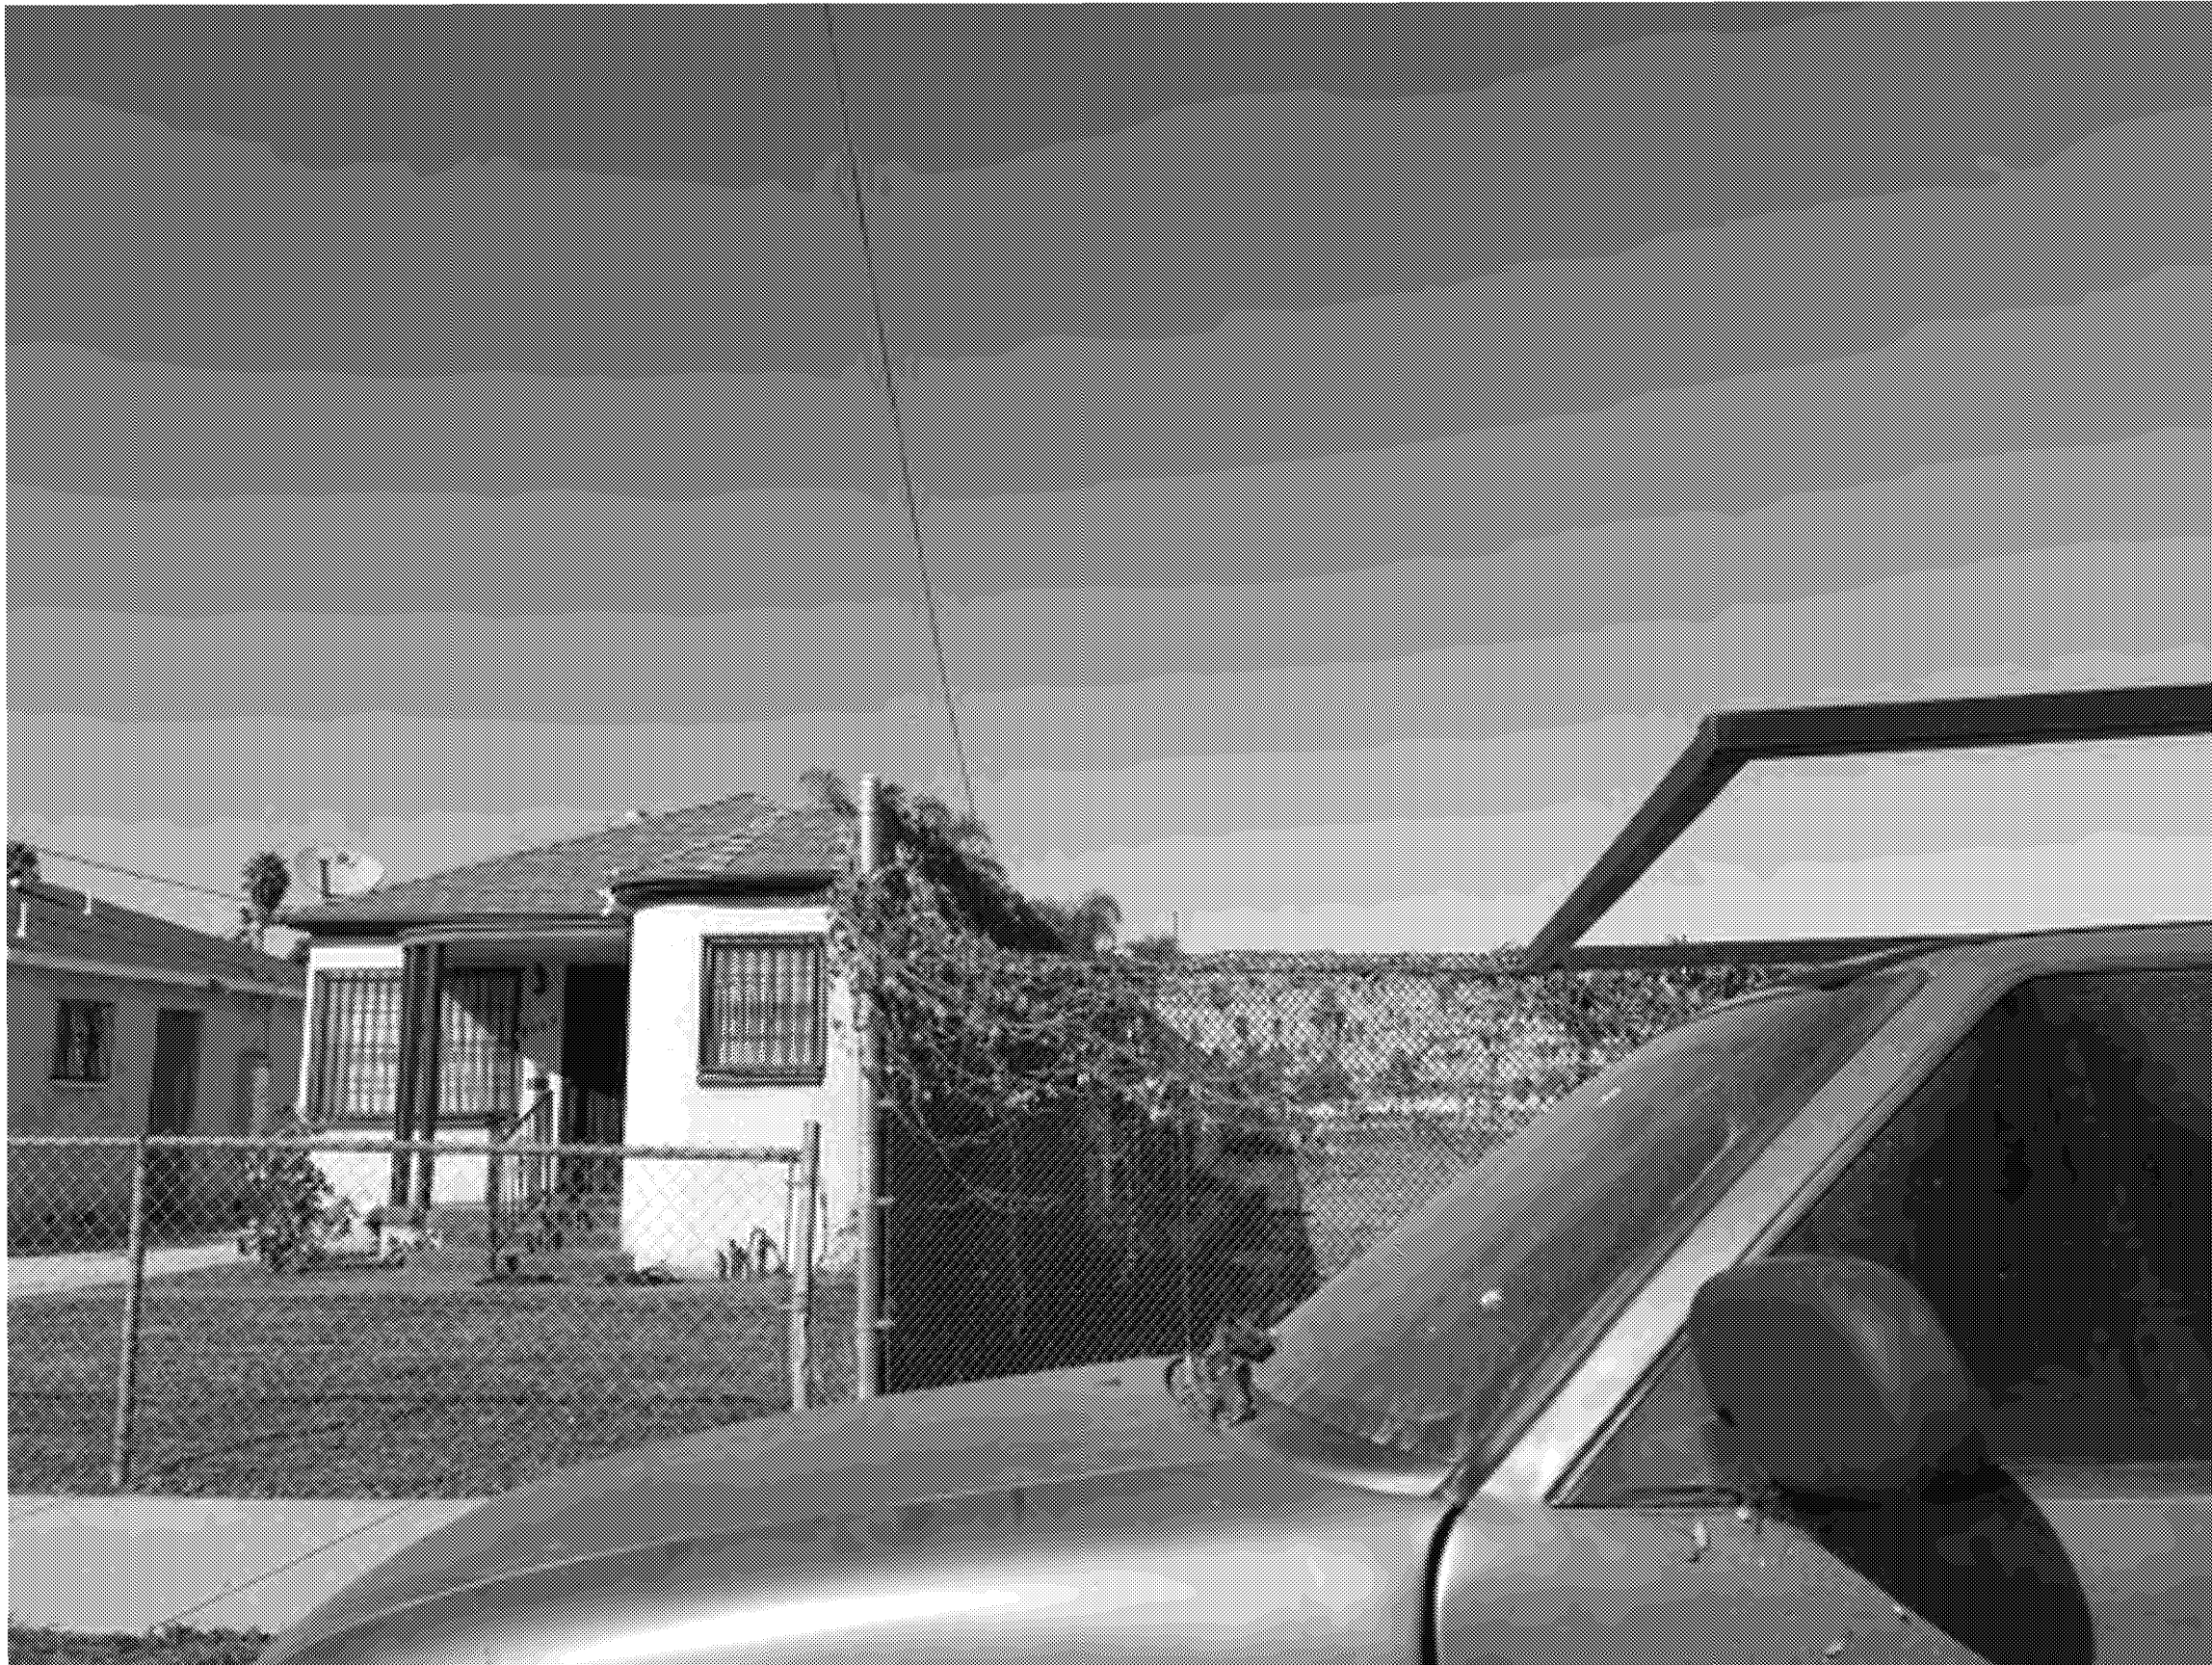
43

NORTHBOUND VIEW FROM SOUTHWEST
CORNER OF PARCEL, ALONG 102ND

SITE SURROUNDED BY CHAIN LINK
FENCE, CMU WALLS, BUILDINGS

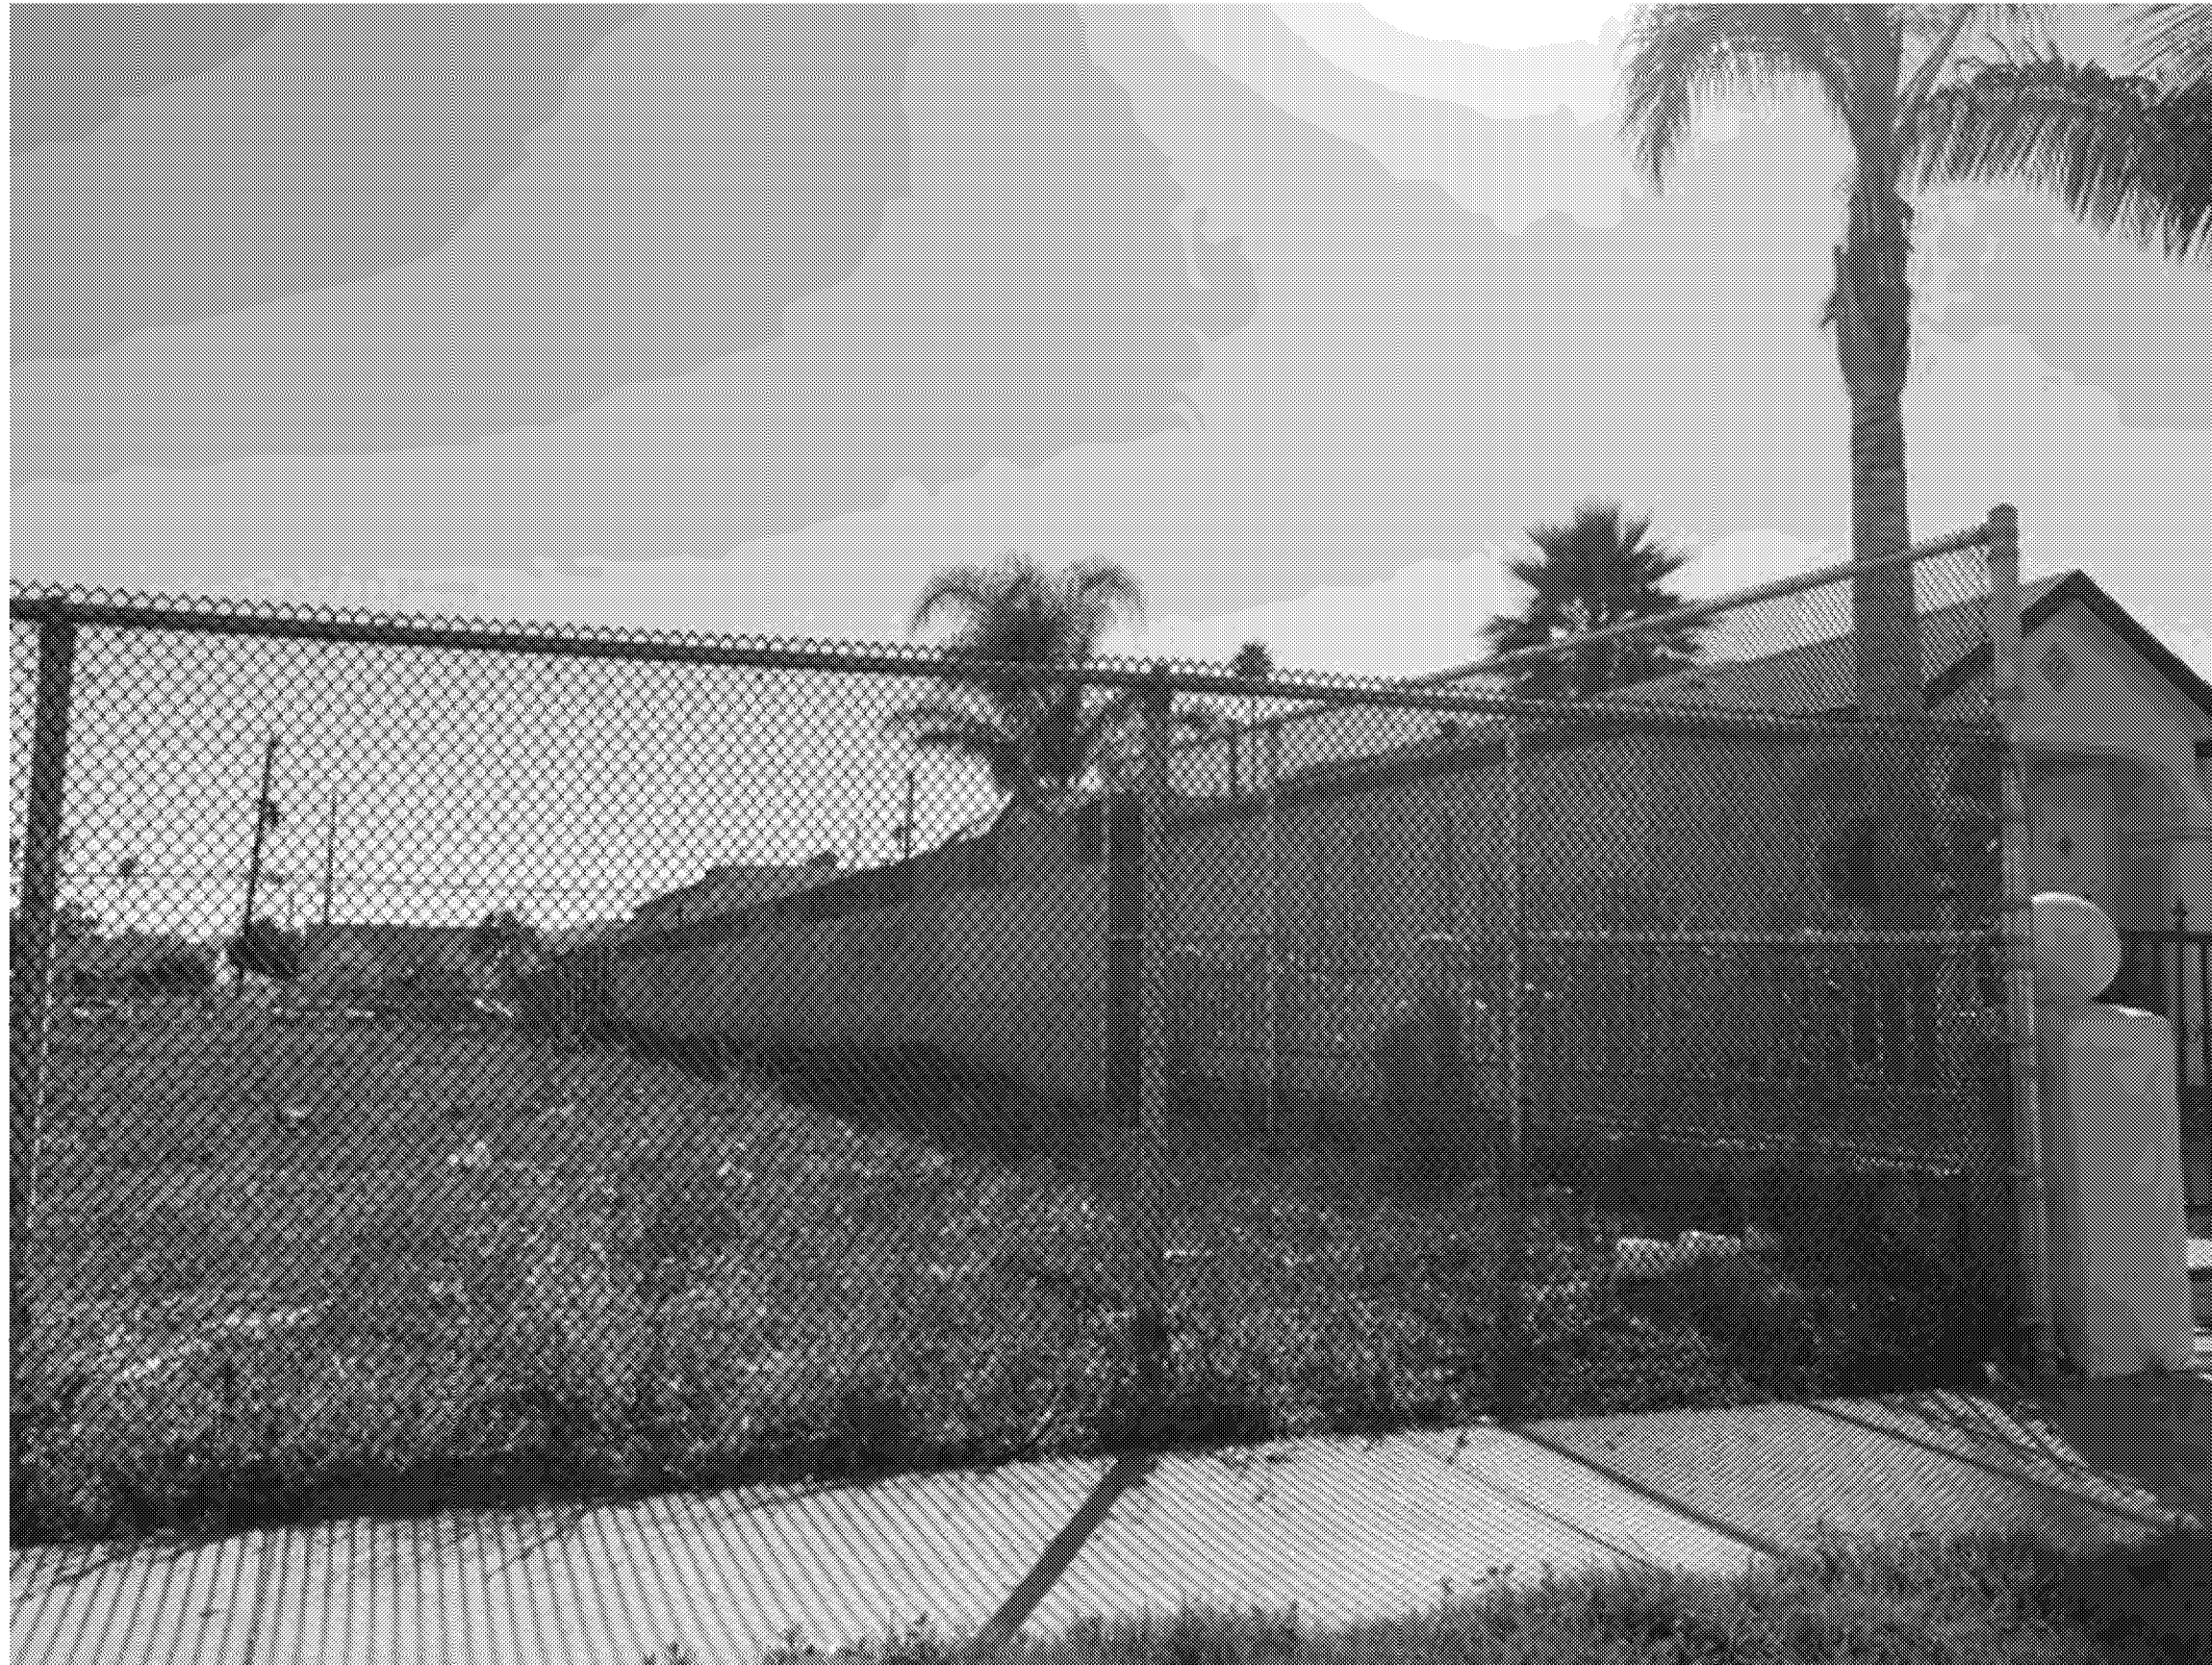
44

WESTBOUND VIEW FROM NORTHWEST
CORNER OF PARCEL, ALONG 102ND

SITE SURROUNDED BY CHAIN LINK
FENCE, CMU WALLS, BUILDINGS

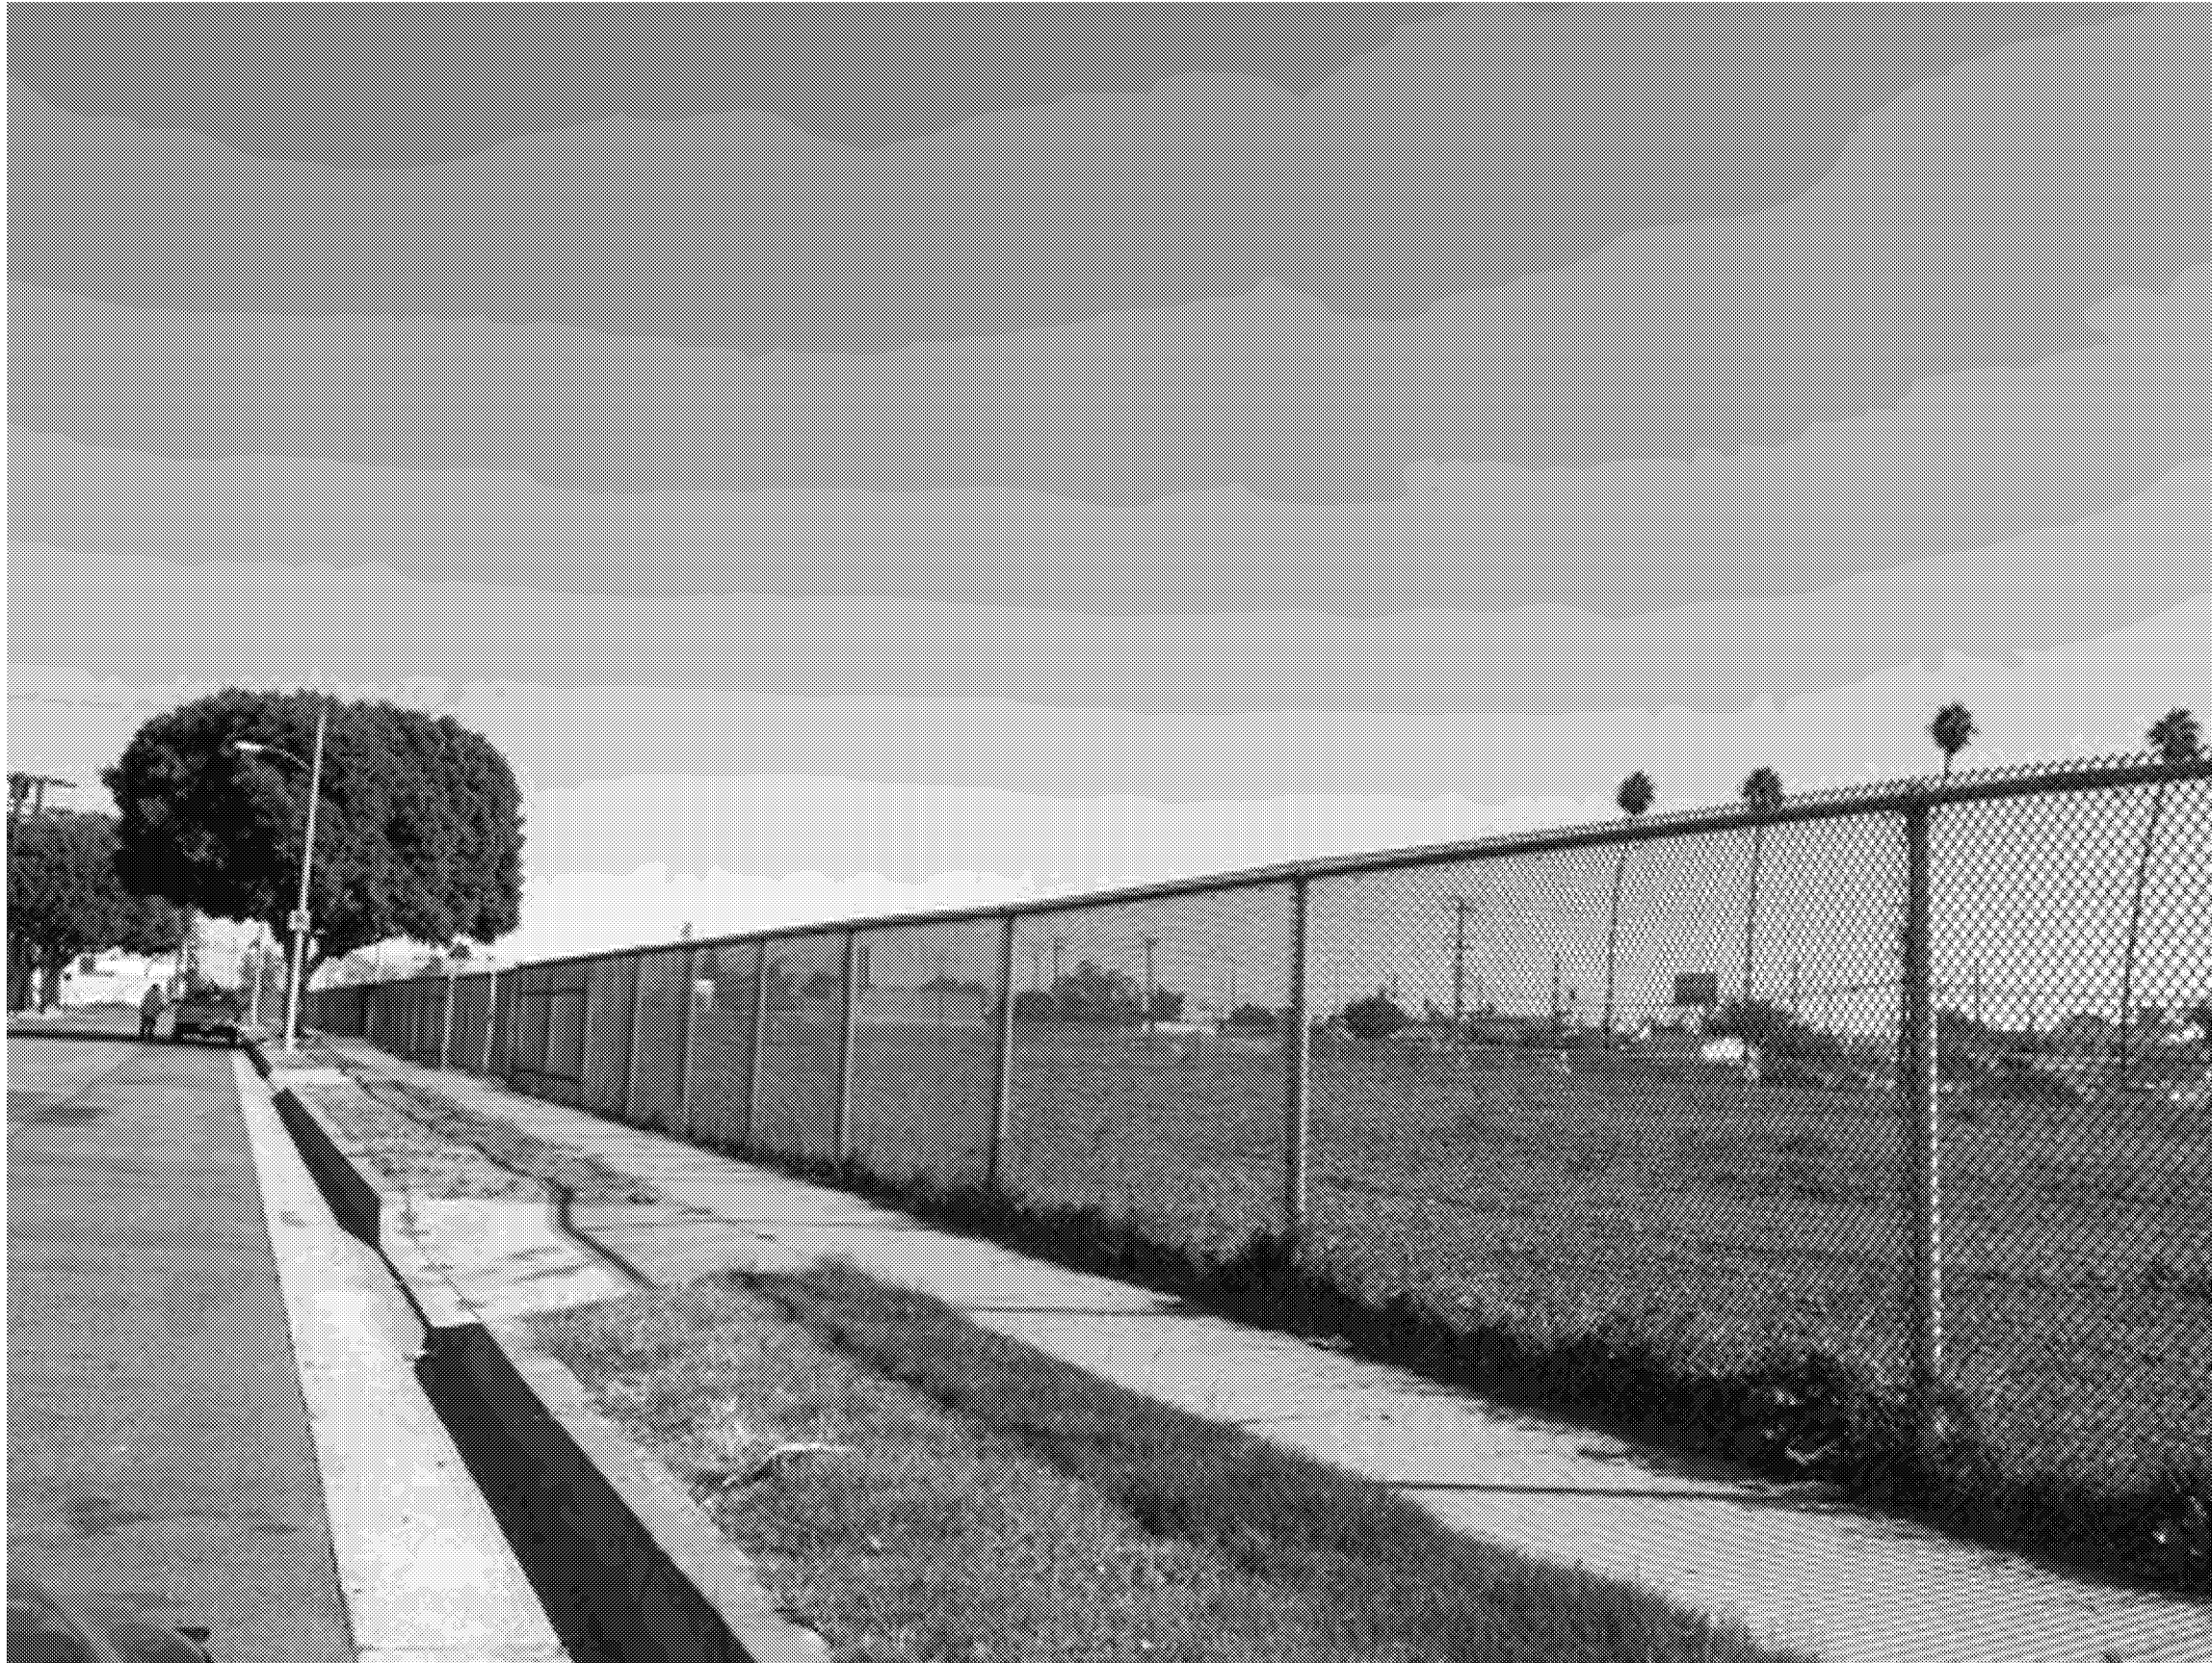
45

SOUTHEASTBOUND VIEW FROM
NORTHWEST CORNER OF PARCEL, ALONG
101ST

SITE SURROUNDED BY CHAIN LINK
FENCE, CMU WALLS, BUILDINGS

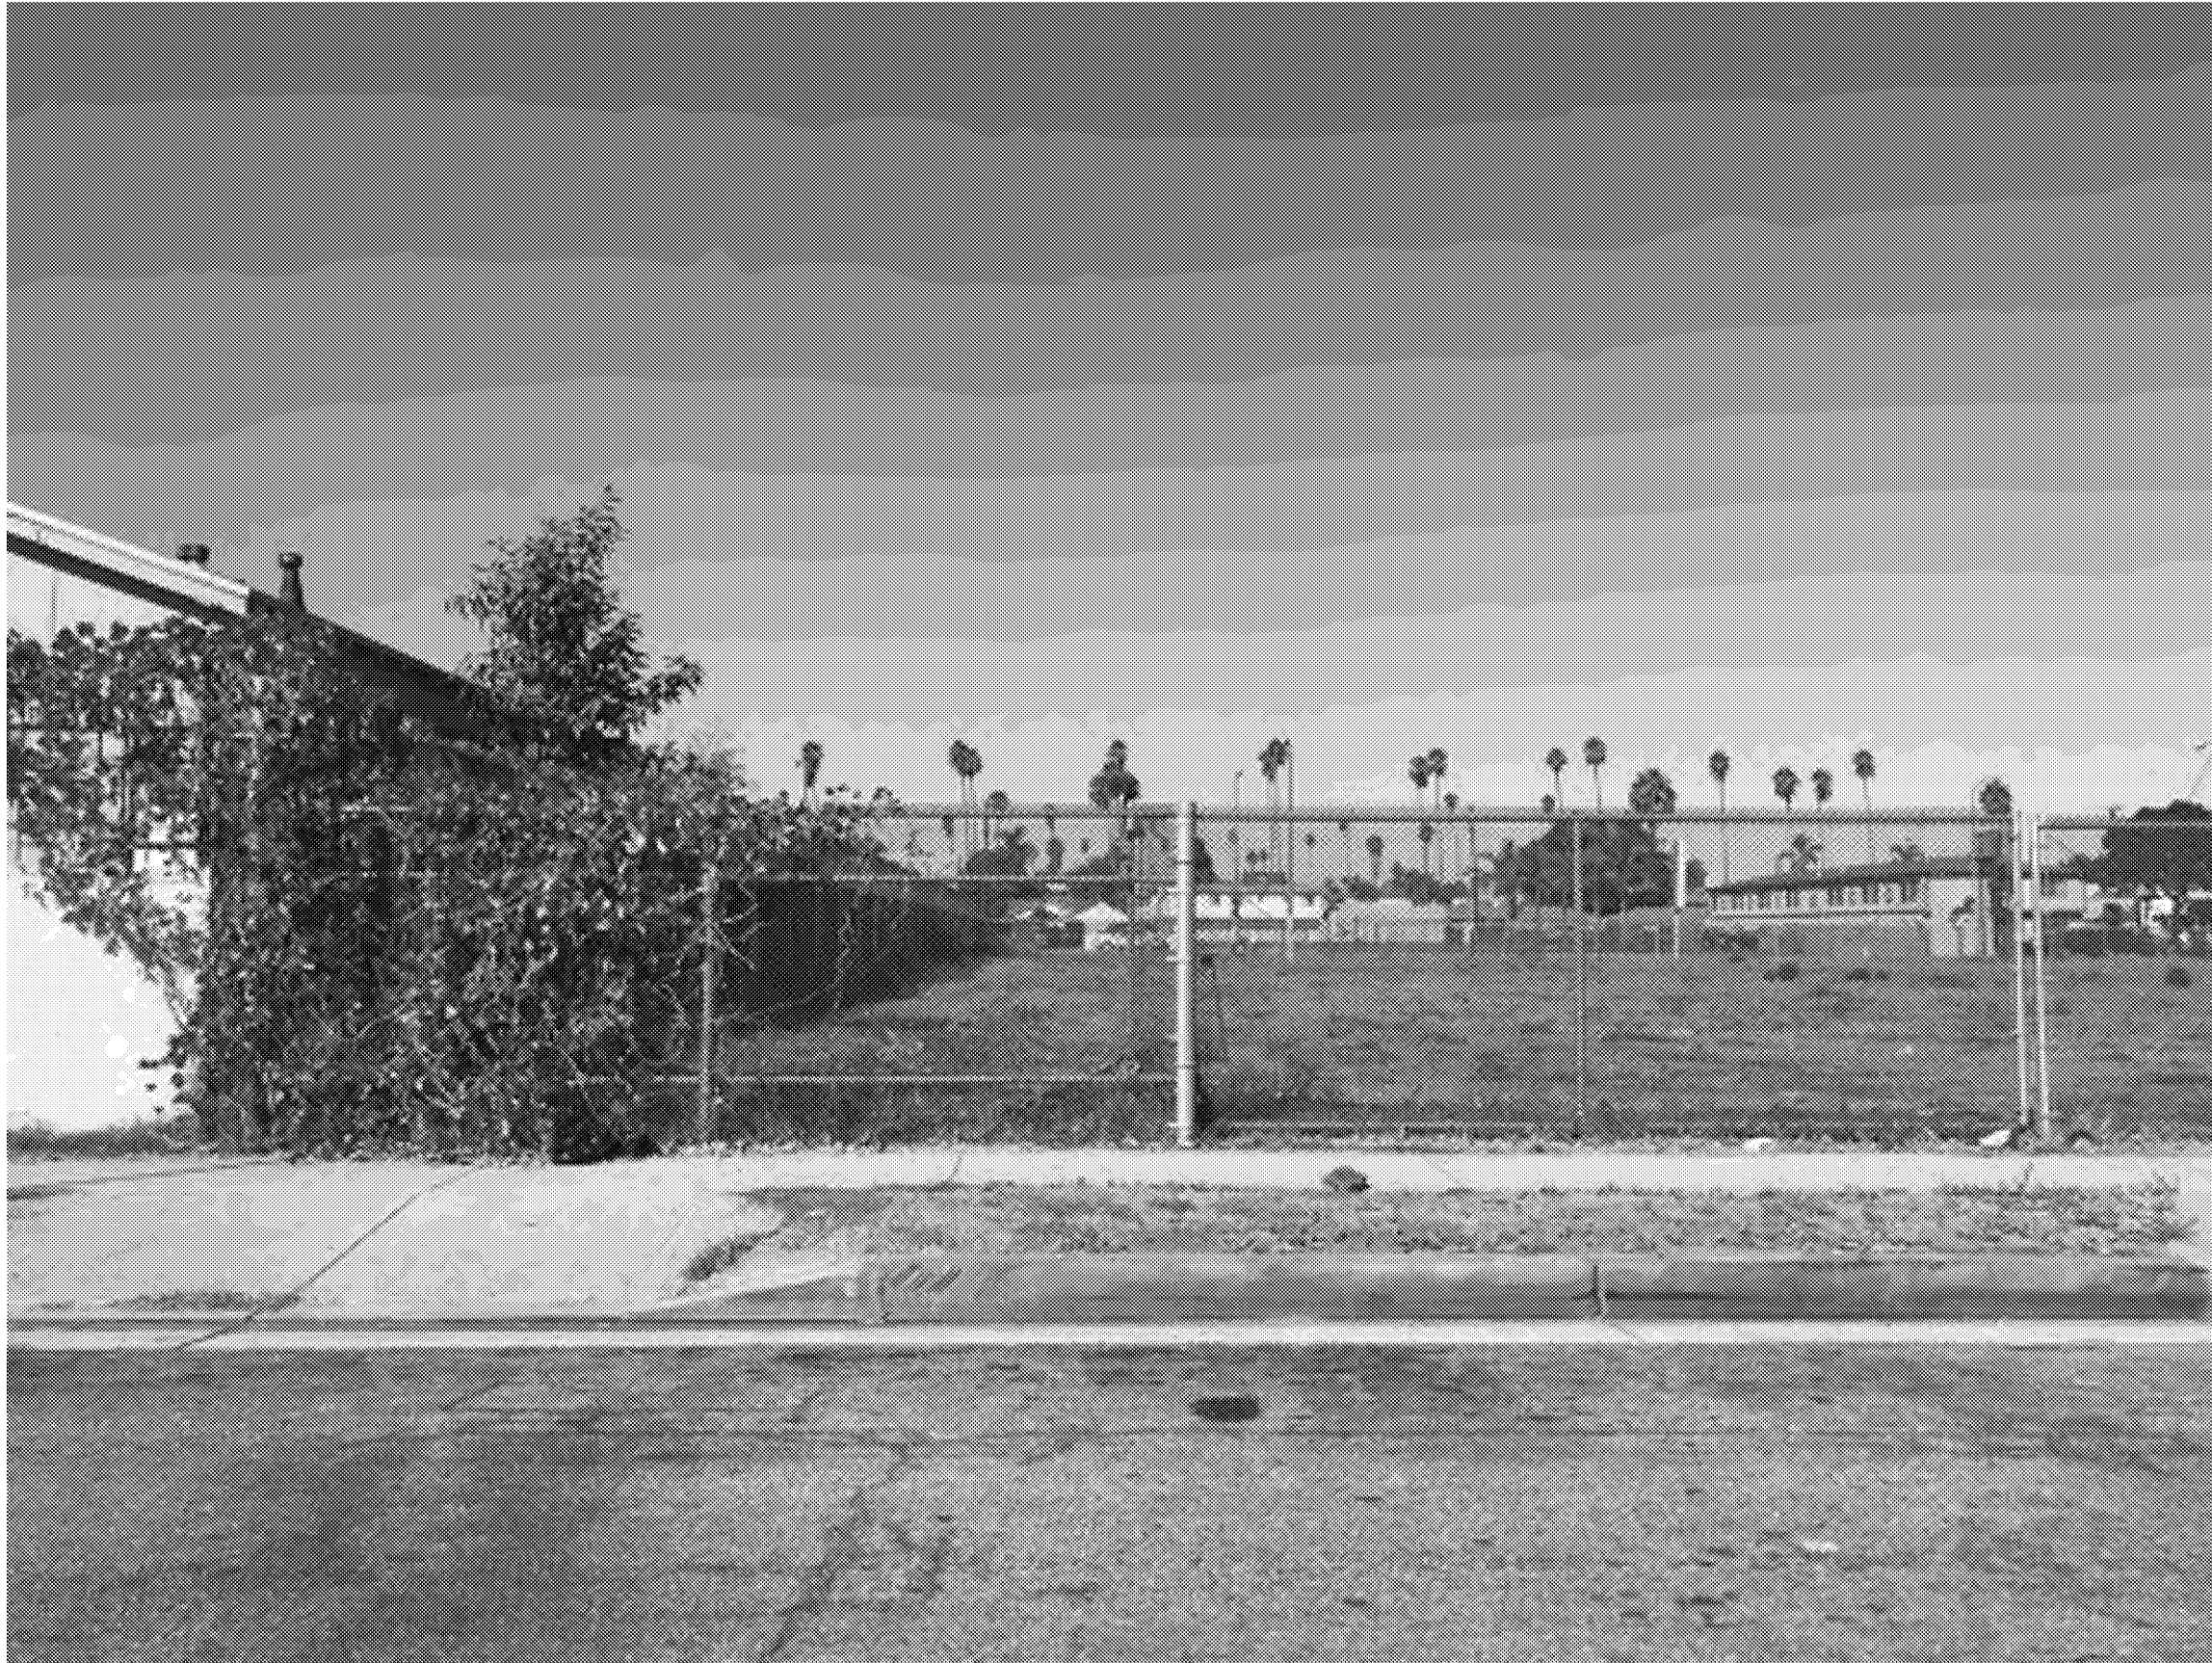
46

NORTHBOUND VIEW FROM SOUTHWEST
CORNER OF PARCEL, ALONG 101ST

SITE SURROUNDED BY CHAIN LINK
FENCE, CMU WALLS, BUILDINGS

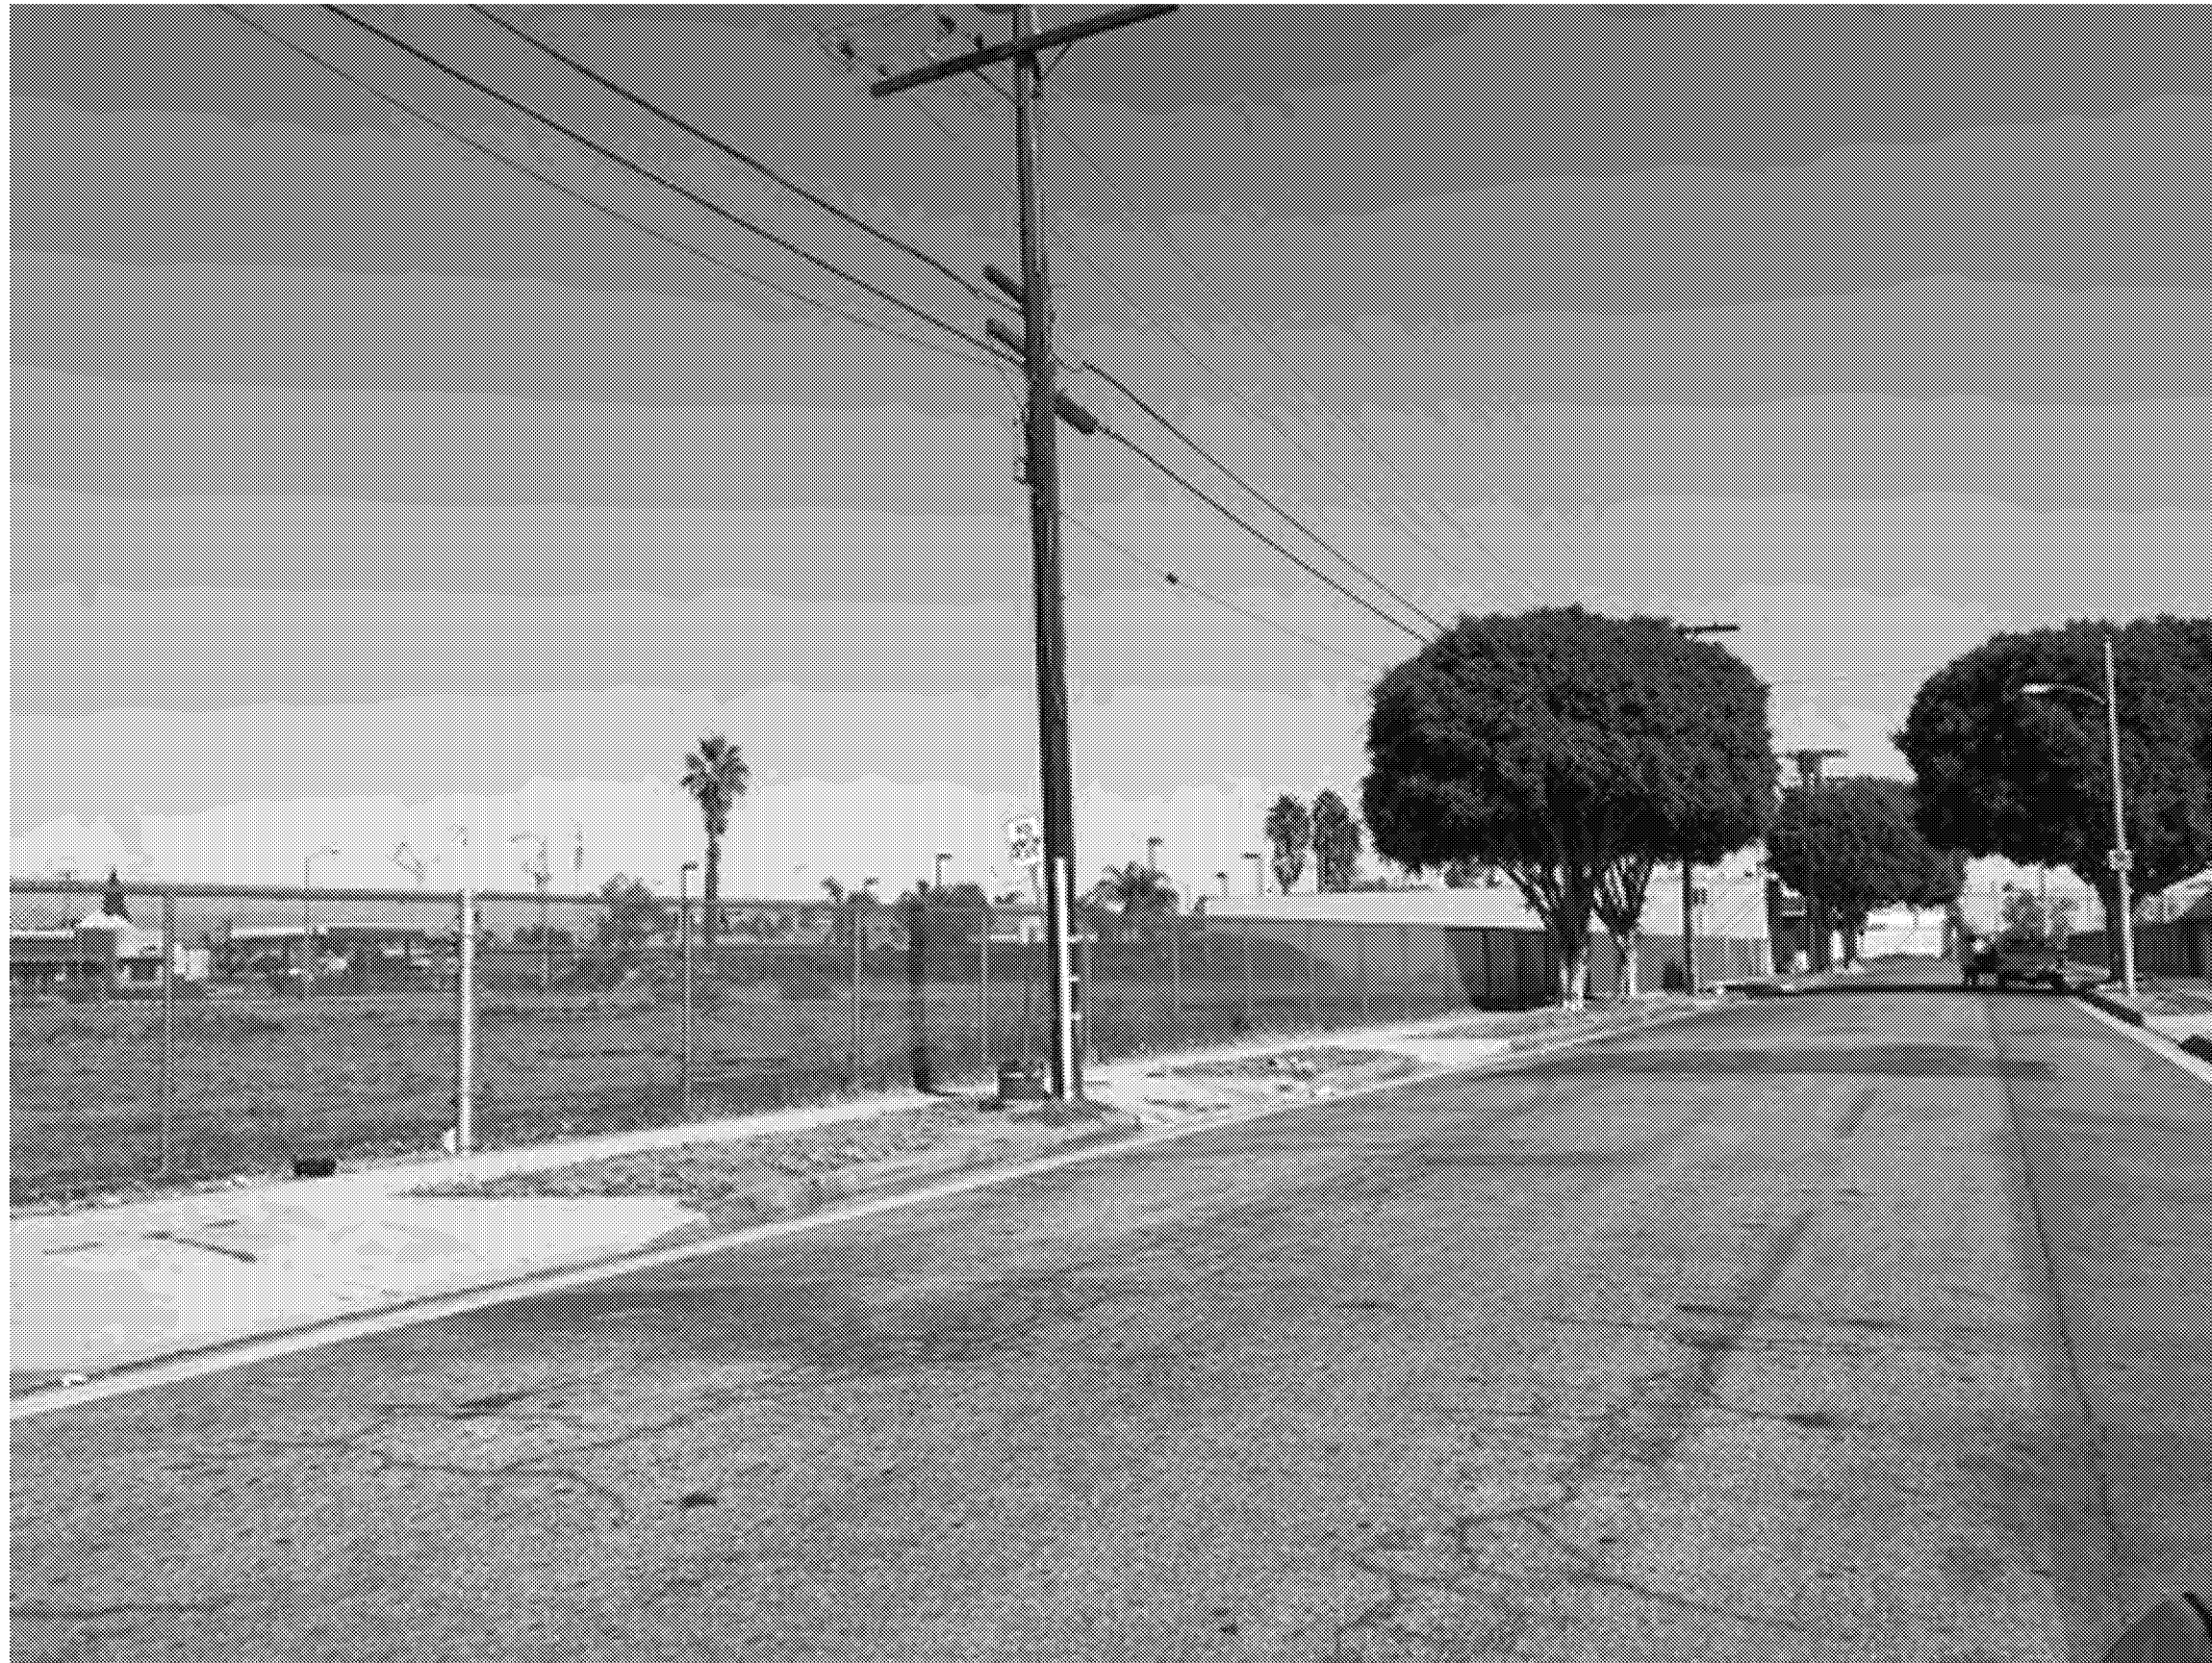
47

EASTBOUND VIEW FROM SOUTHWEST
CORNER OF PARCEL, ALONG 101ST

SITE SURROUNDED BY CHAIN LINK
FENCE, CMU WALLS, BUILDINGS
