# Appendix H

## **Geotechnical Report**

**I Preliminary Geotechnical Report**

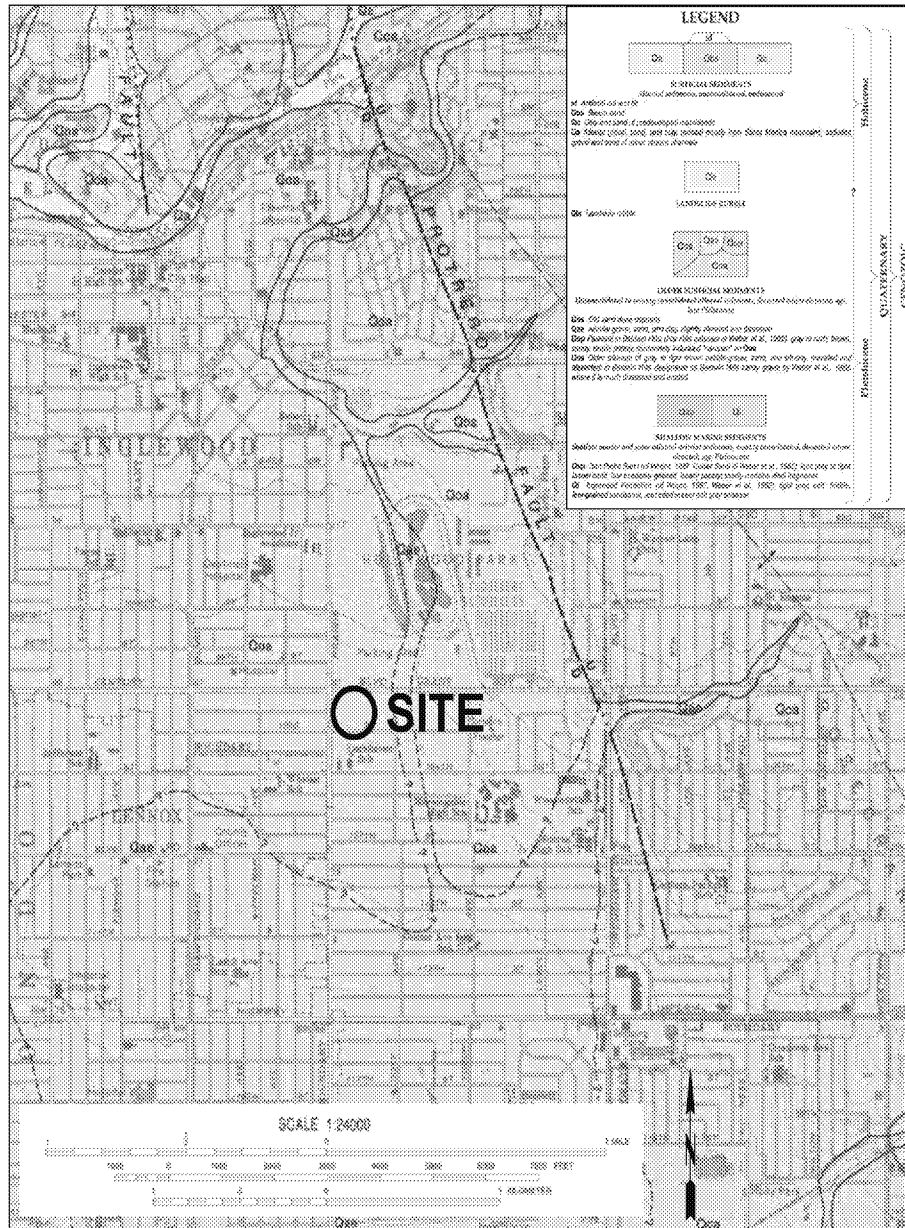
\*Source: Dibblee (2007), Geologic map of the Venice and Inglewood Quadrangles, Los Angeles County, California

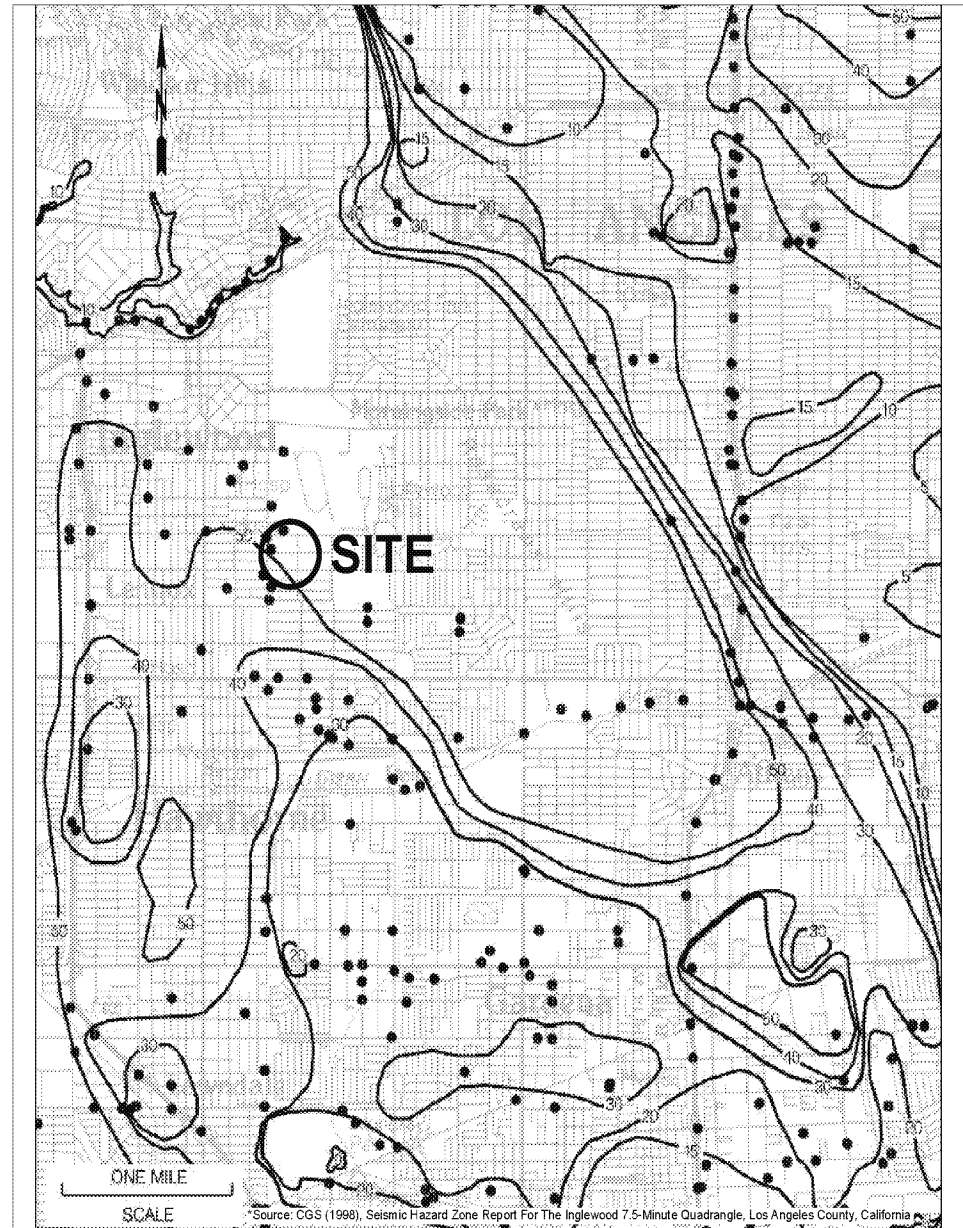
\*Source: CGS (1998), Seismic Hazard Zone Report For The Inglewood 7.5-Minute Quadrangle, Los Angeles County, California

According to the Seismic Hazard Zone Report 027 for the Inglewood 7.5-Minute Quadrangle, the historically highest groundwater in the area has been inferred to be greater than 50 feet below existing grade (see Figure 4 – Historical Groundwater Levels).

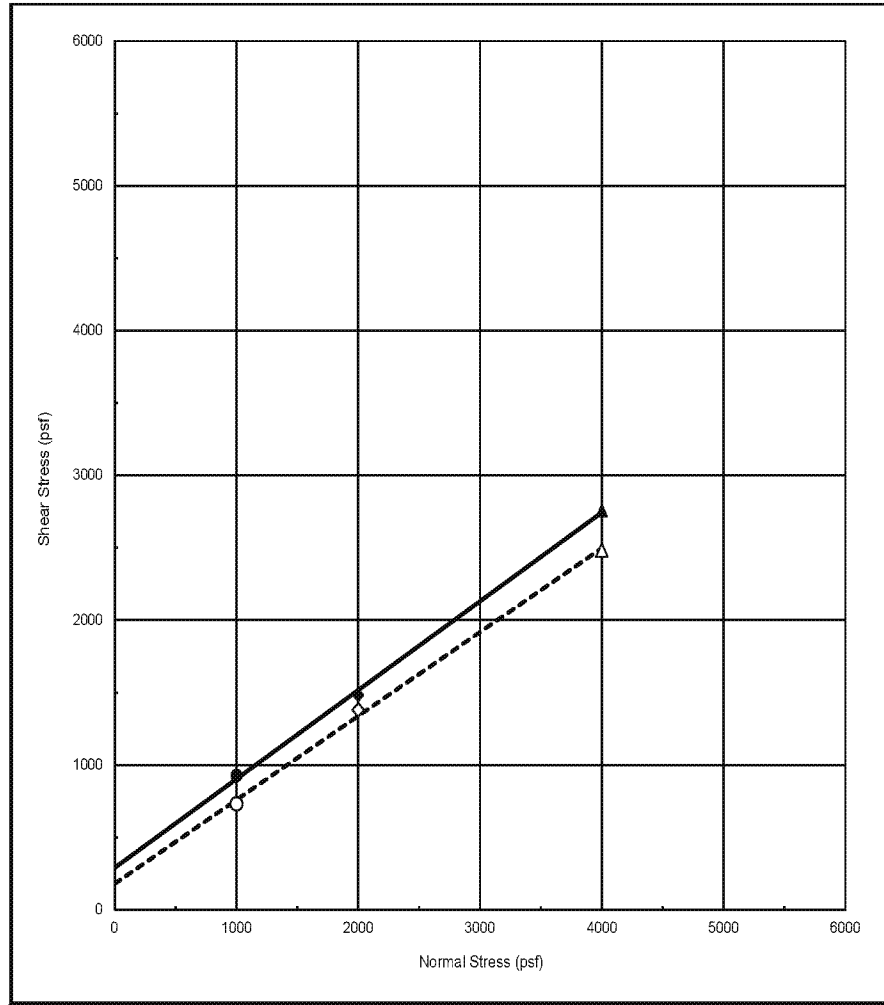
Boring No.:		B-1		Strength Intercept ( C ):		291.0 psf		Peak		180.0 psf		Ultimate	
Sample No.:		1		Friction Angle ( φ ):		13.9 kPa		Peak		8.6 kPa		Ultimate	
Depth (ft.):		5.0		Friction Angle ( φ ):		32 degree		Peak		30 degree		Ultimate	
Description:		Dark Brown Silty Fine SAND				Shear rate:		0.0050 (in/min), 0.0127 (cm/min)					
SYMBOL	% Water Content	Total Unit Weight		Dry Unit Weight		Normal Stress		Peak Stress		Ultimate Stress			
		(pcf)	(kN/m <sup>3</sup> )	(pcf)	(kN/m <sup>3</sup> )	(psf)	(kPa)	(psf)	(kPa)	(psf)	(kPa)	(psf)	(kPa)
Initial / Set up	7.0	125.0	19.6	116.8	18.4	XXXXX	XXXXX	XXXXX	XXXXX	XXXXX	XXXXX	XXXXX	XXXXX
● spec. 1	7.5	125.9	19.8	117.1	18.4	1000	48	928	44	732	35		
◆ spec. 2	8.2	126.8	19.9	117.2	18.4	2000	96	1482	71	1380	66		
▲ spec. 3	9.6	128.9	20.3	117.6	18.5	4000	192	2756	132	2484	119		
<b>AECOM</b>		Project Condor				DIRECT SHEAR TEST							
		Project Number		60545923		ASTM D3080

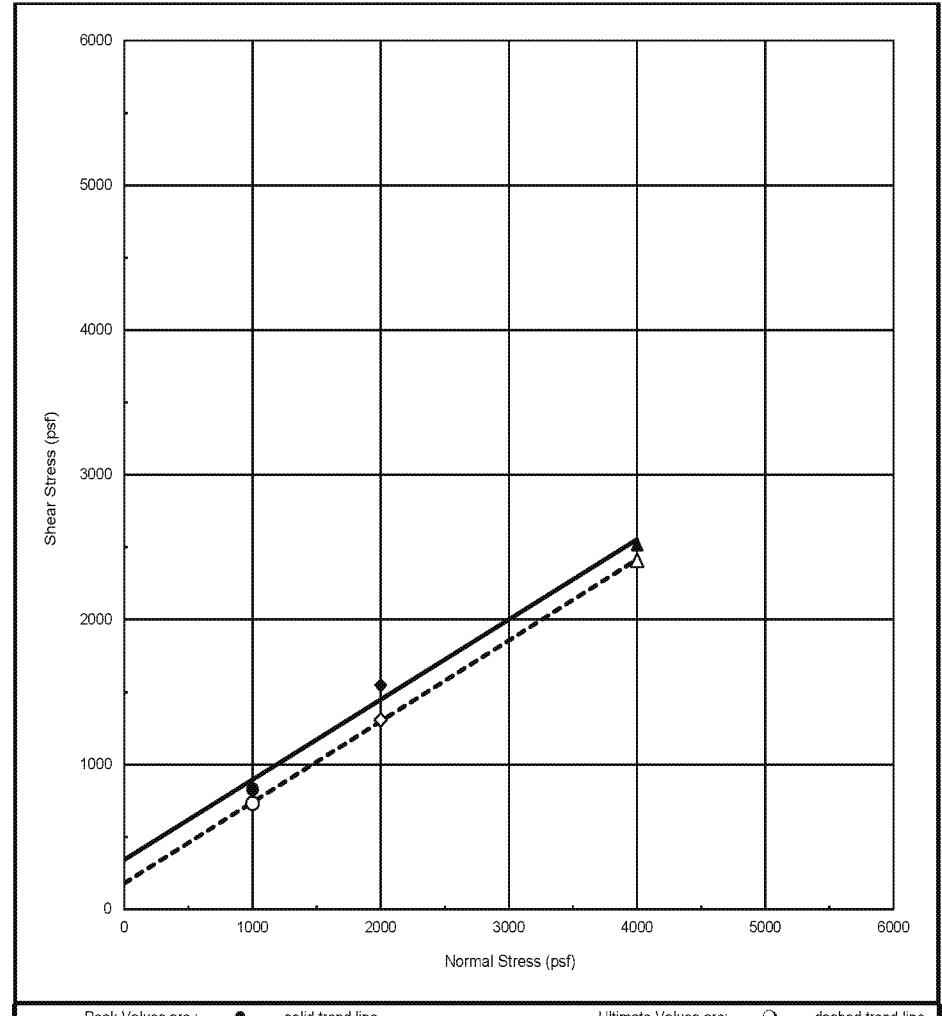
Boring No.:		B-4		Strength Intercept ( C ):		342.0 psf		Peak		180.0 psf		Ultimate	
Sample No.:		6		Friction Angle ( φ ):		16.4 kPa		Peak		8.6 kPa		Ultimate	
Depth (ft.):		30.0		Friction Angle ( φ ):		29 degree		Peak		29 degree		Ultimate	
Description:		Dark olive brown silty fine SAND				Shear rate:		0.0050 (in/min), 0.0127 (cm/min)					
SYMBOL	% Water Content	Total Unit Weight		Dry Unit Weight		Normal Stress		Peak Stress		Ultimate Stress			
		(pcf)	(kN/m <sup>3</sup> )	(pcf)	(kN/m <sup>3</sup> )	(psf)	(kPa)	(psf)	(kPa)	(psf)	(kPa)	(psf)	(kPa)
Initial / Set up	8.4	125.7	19.8	116.0	18.2	XXXXX	XXXXX	XXXXX	XXXXX	XXXXX	XXXXX	XXXXX	XXXXX
● spec. 1	10.2	131.8	20.7	119.6	18.8	1000	48	828	40	732	35		
◆ spec. 2	11.8	133.9	21.0	119.7	18.8	2000	96	1548	74	1308	63		
▲ spec. 3	12.7	139.4	21.9	123.7	19.4	4000	192	2520	121	2412	115		
<b>AECOM</b>		Project Condor				DIRECT SHEAR TEST							
		Project Number		60545923		ASTM D3080

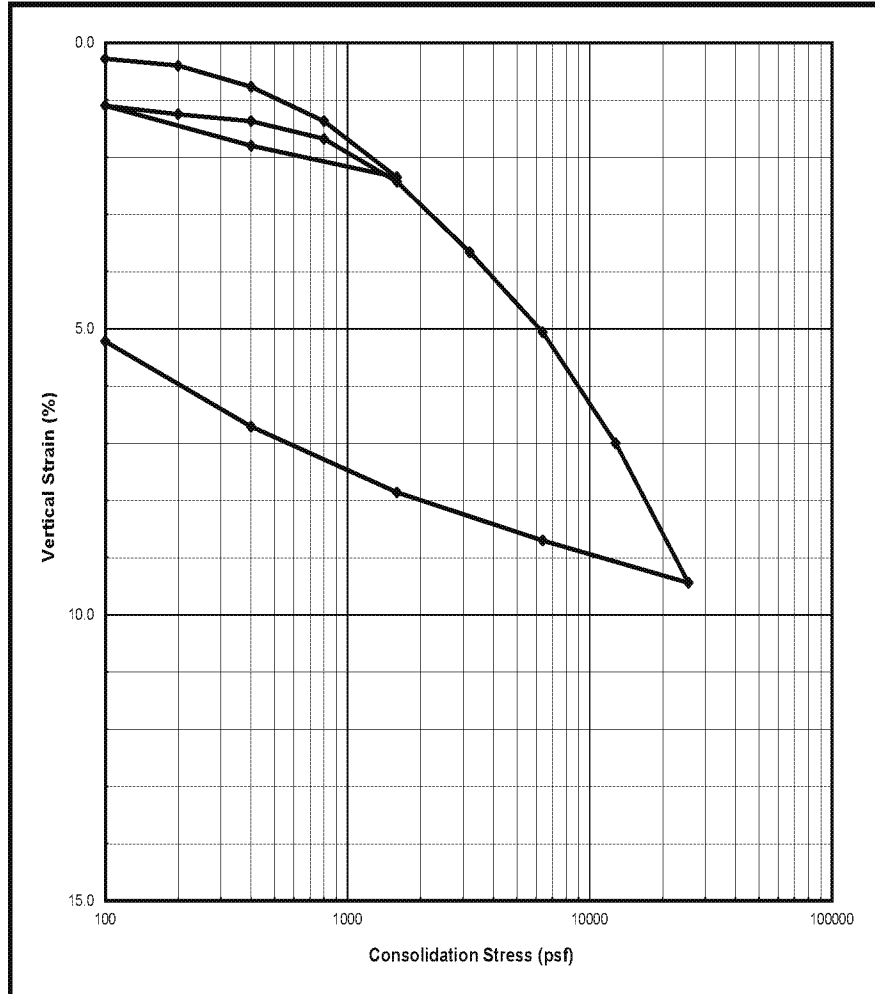
Description		Dark Brown Silty Fine SAND with Clay							
Boring No.	B-1	Liquid Limit	XXXXXX	%	Specific Gravity	2.70	assumed		
Sample No.	3		Plasticity Index	XXXXXX		%	Strain for Saturation	2.80	%
Depth (ft)	15.0		Fines Content	XXXXXX		%	Water added at	100.0	psf
	Water Content (%)	Total Unit Weight (pcf)	Dry Unit Weight (pcf)	Saturation (%)	Void Ratio	Height (inches)	Diameter (inches)		
Initial	12.12	131.0	116.8	74.4	0.440	1.000	2.416		
Final	14.14	140.7	123.3	104.7	0.365	0.948			
<b>AECOM</b>		Project Condor		CONSOLIDATION TEST ASTM D2435					
		Project Number	60545923

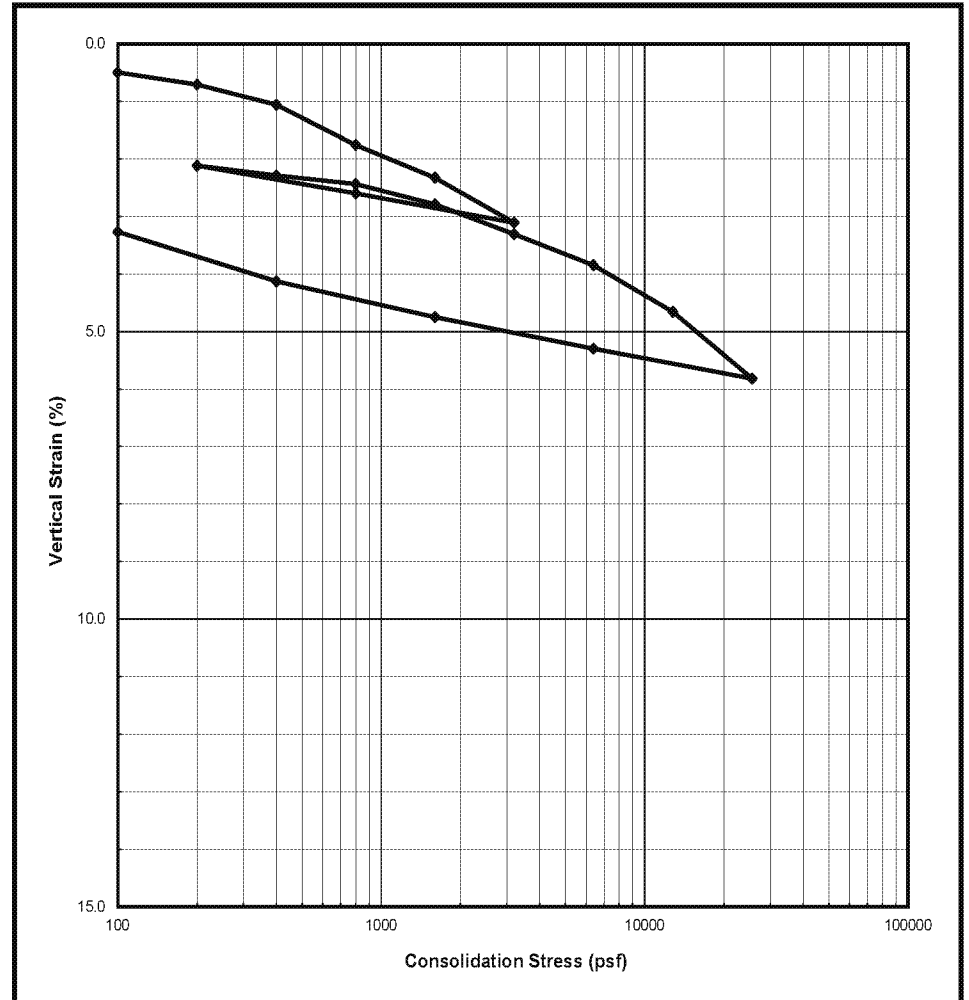
Description		Dark olive brown silty fine SAND with Clay							
Boring No.	B-5	Liquid Limit	XXXXXX	%	Specific Gravity	2.70	assumed		
Sample No.	6		Plasticity Index	XXXXXX		%	Strain for Saturation	2.80	%
Depth (ft)	30.0		Fines Content	XXXXXX		%	Water added at	100.0	psf
	Water Content (%)	Total Unit Weight (pcf)	Dry Unit Weight (pcf)	Saturation (%)	Void Ratio	Height (inches)	Diameter (inches)		
Initial	10.54	136.7	123.6	78.9	0.361	1.000	2.416		
Final	13.06	144.5	127.8	100.0	0.316	0.967			
<b>AECOM</b>		Project Condor		CONSOLIDATION TEST ASTM D2435					
		Project Number	60545923

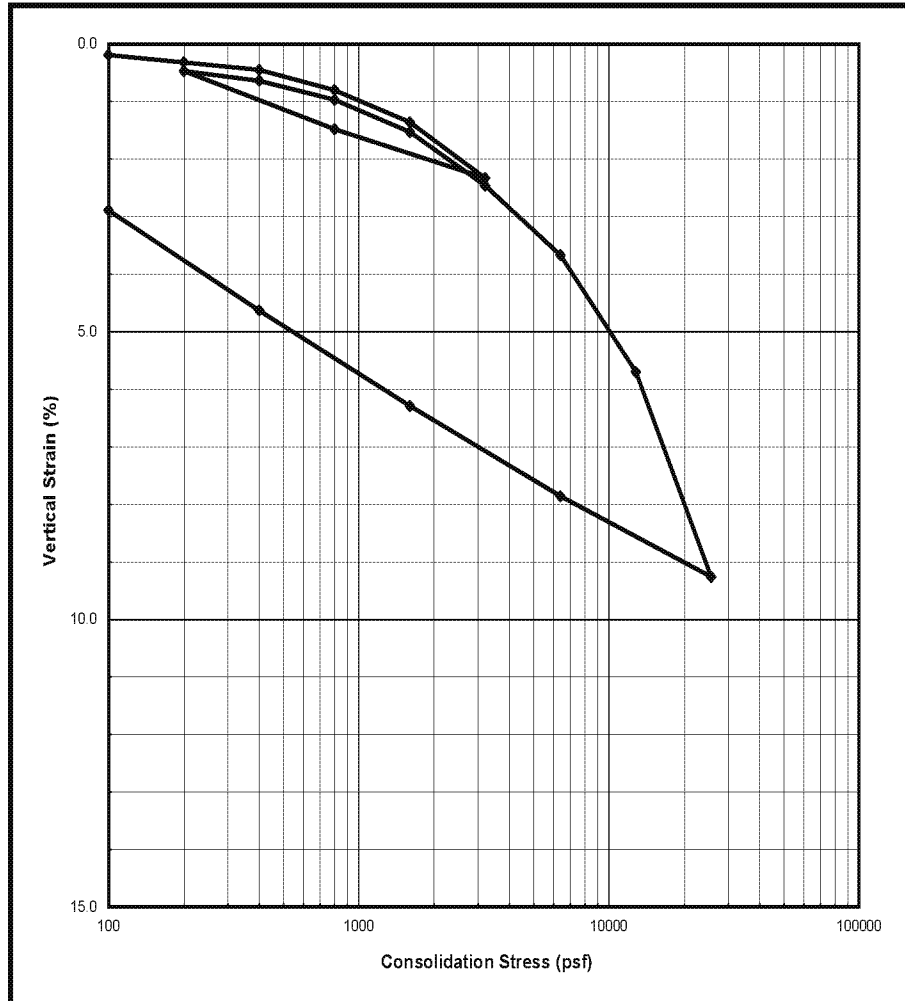
Description		Olive brown SC to sandy CL									
Boring No.	B-6	Liquid Limit	XXXXX %	Specific Gravity	2.70	assumed					
Sample No.	7							Plasticity Index	XXXXX %	Strain for Saturation	2.80 %
Depth (ft)	35.0										
Water Content (%)	Total Unit Weight (pcf)	Dry Unit Weight (pcf)	Saturation (%)	Void Ratio	Height (inches)	Diameter (inches)					
Initial 27.98	120.6	94.2	96.1	0.786	1.000	2.416					
Final 33.20	129.2	97.0	100.0	0.735	0.971

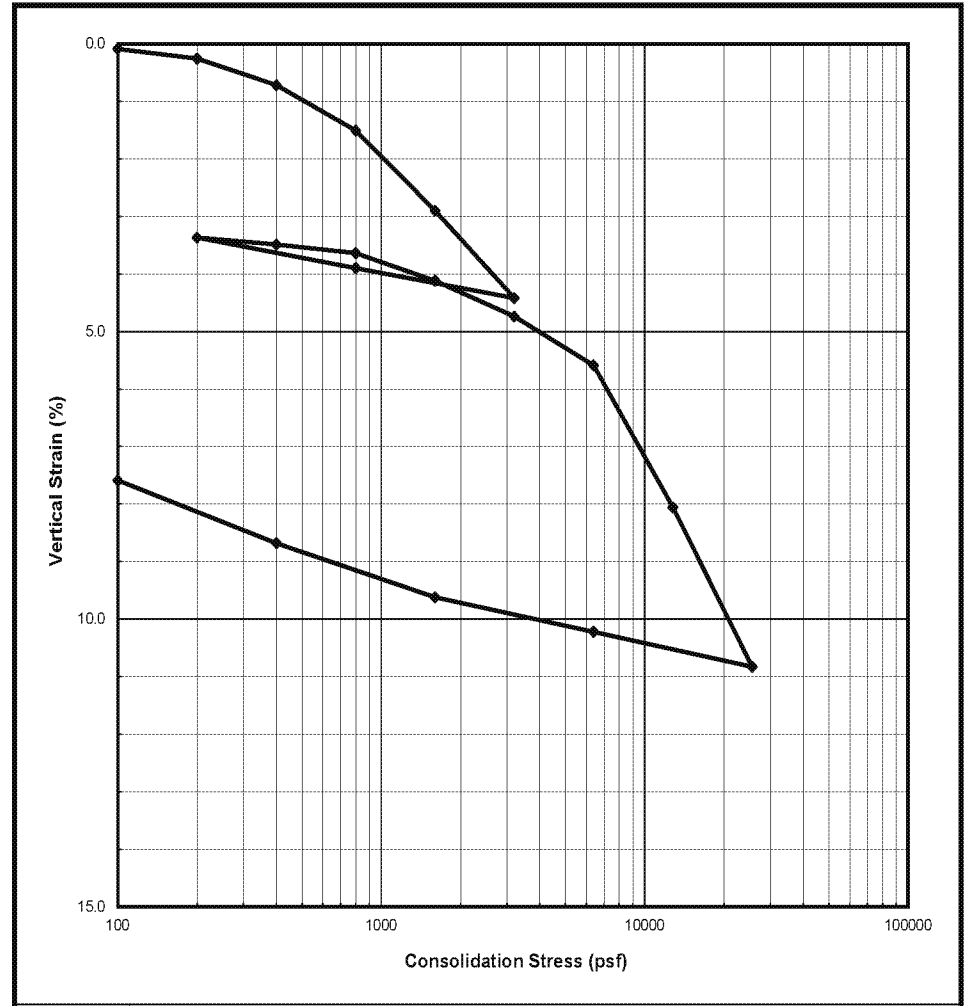
Description		Olive brown silty fine SAND with Clay									
Boring No.	B-7	Liquid Limit	XXXXX %	Specific Gravity	2.70	assumed					
Sample No.	6							Plasticity Index	XXXXX %	Strain for Saturation	2.80 %
Depth (ft)	30.0										
Water Content (%)	Total Unit Weight (pcf)	Dry Unit Weight (pcf)	Saturation (%)	Void Ratio	Height (inches)	Diameter (inches)					
Initial 9.63	122.9	112.1	51.9	0.501	1.000	2.416					
Final 14.90	139.3	121.3	100.0	0.387	0.924

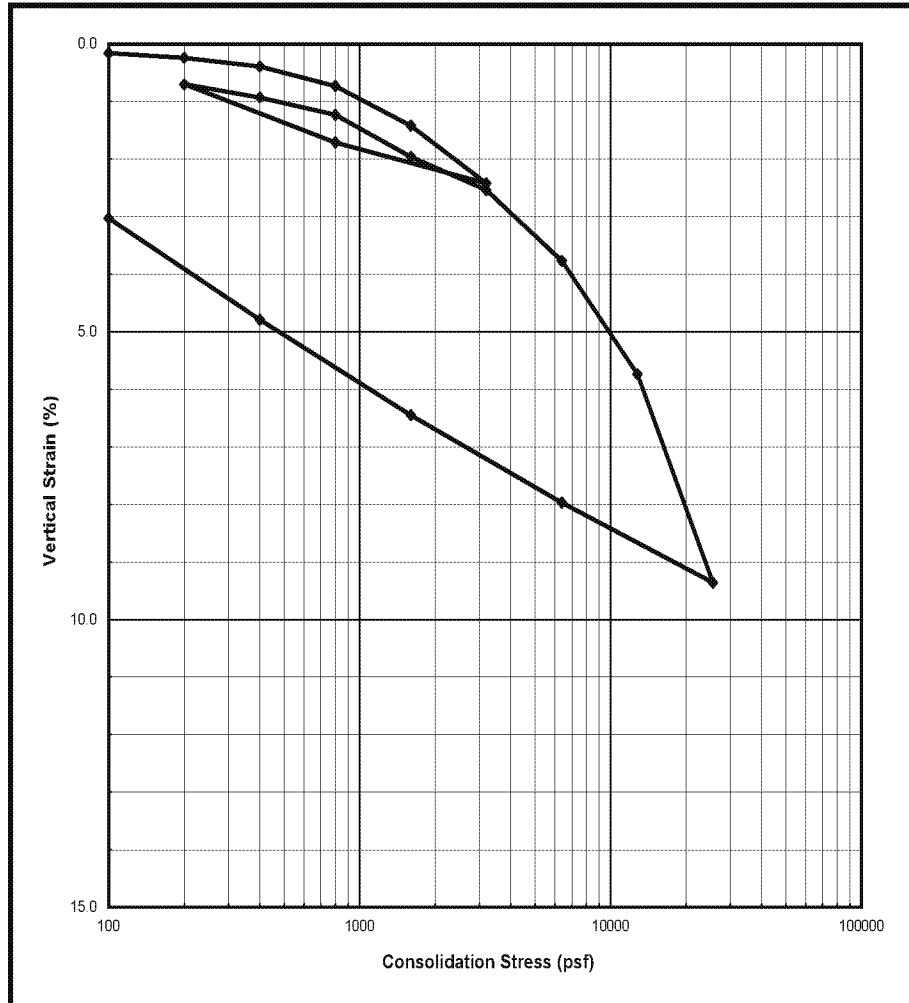
Description	Olive light brown fine sandy SILT with clay						
Boring No.	B-8	Liquid Limit	XXXXX	%	Specific Gravity	2.70	assumed
Sample No.	7	Plasticity Index	XXXXX	%	Strain for Saturation	2.80	%
Depth (ft)	35.0	Fines Content	XXXXX	%	Water added at	100.0	psf
	Water Content (%)	Total Unit Weight (pcf)	Dry Unit Weight (pcf)	Saturation (%)	Void Ratio	Height (inches)	Diameter (inches)
Initial	29.29	118.9	91.9	95.3	0.830	1.000	2.416
Final	31.28	124.5	94.8	100.0	0.775	0.970

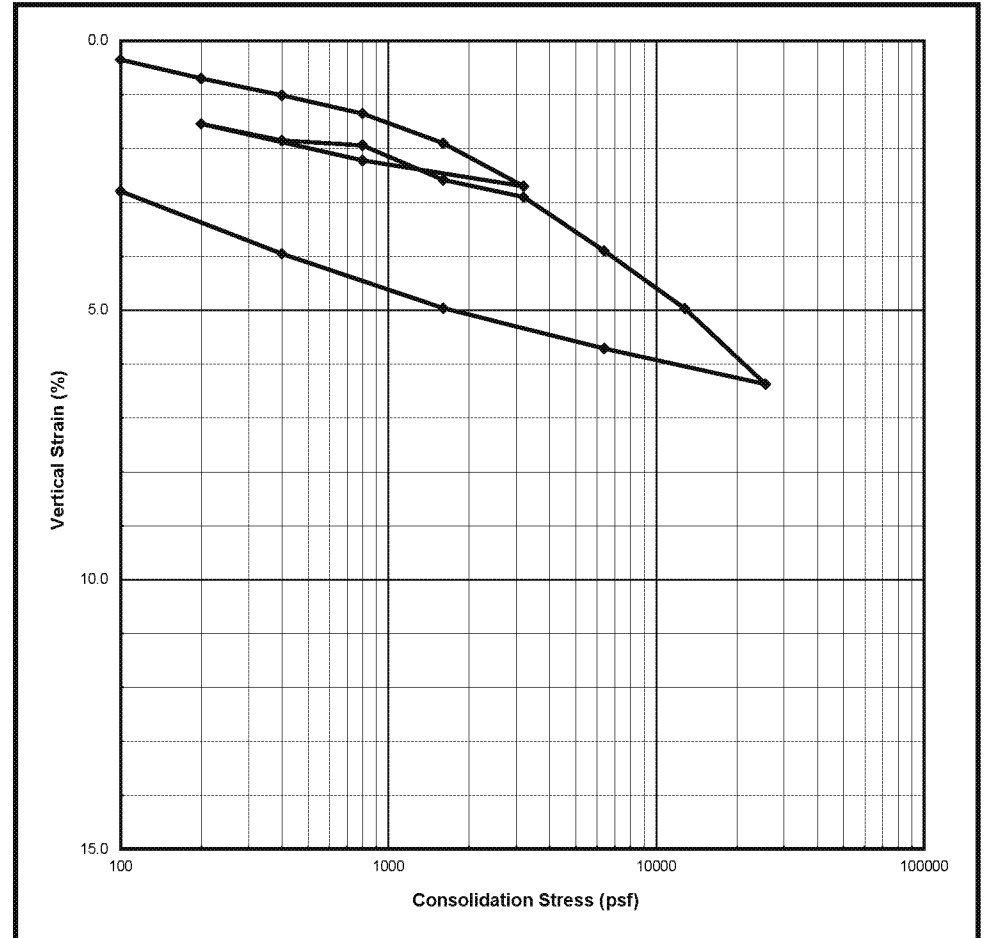
Description	Olive brown fine sandy SILT with Clay						
Boring No.	B-9	Liquid Limit	XXXXX	%	Specific Gravity	2.70	assumed
Sample No.	5	Plasticity Index	XXXXX	%	Strain for Saturation	2.80	%
Depth (ft)	25.0	Fines Content	XXXXX	%	Water added at	100.0	psf
	Water Content (%)	Total Unit Weight (pcf)	Dry Unit Weight (pcf)	Saturation (%)	Void Ratio	Height (inches)	Diameter (inches)
Initial	15.43	113.2	98.0	58.2	0.716	1.000	2.416
Final	28.58	129.7	100.8	100.0	0.668	0.972

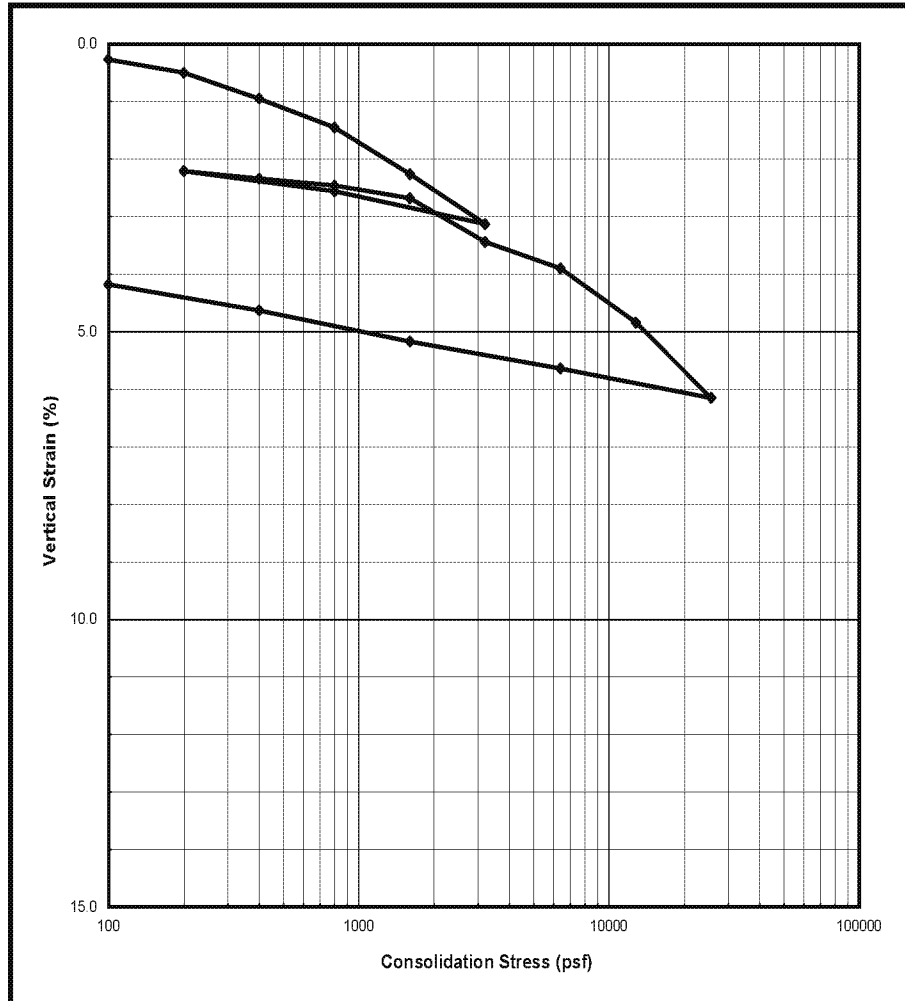
Description		Olive brown silty fine SAND (very sandy)								
Boring No.	B-12	Liquid Limit	XXXXX %	Specific Gravity	2.70	assumed	Strain for Saturation	2.80 %		
Sample No.	5								Plasticity Index	XXXXX %
Depth (ft)	25.0								Fines Content	XXXXX %
Water Content (%)	Total Unit Weight (pcf)	Dry Unit Weight (pcf)	Saturation (%)	Void Ratio	Height (inches)	Diameter (inches)				
Initial 9.72	100.3	91.4	31.2	0.841	1.000	2.416				
Final 23.70	127.6	103.1	100.0	0.631	0.958

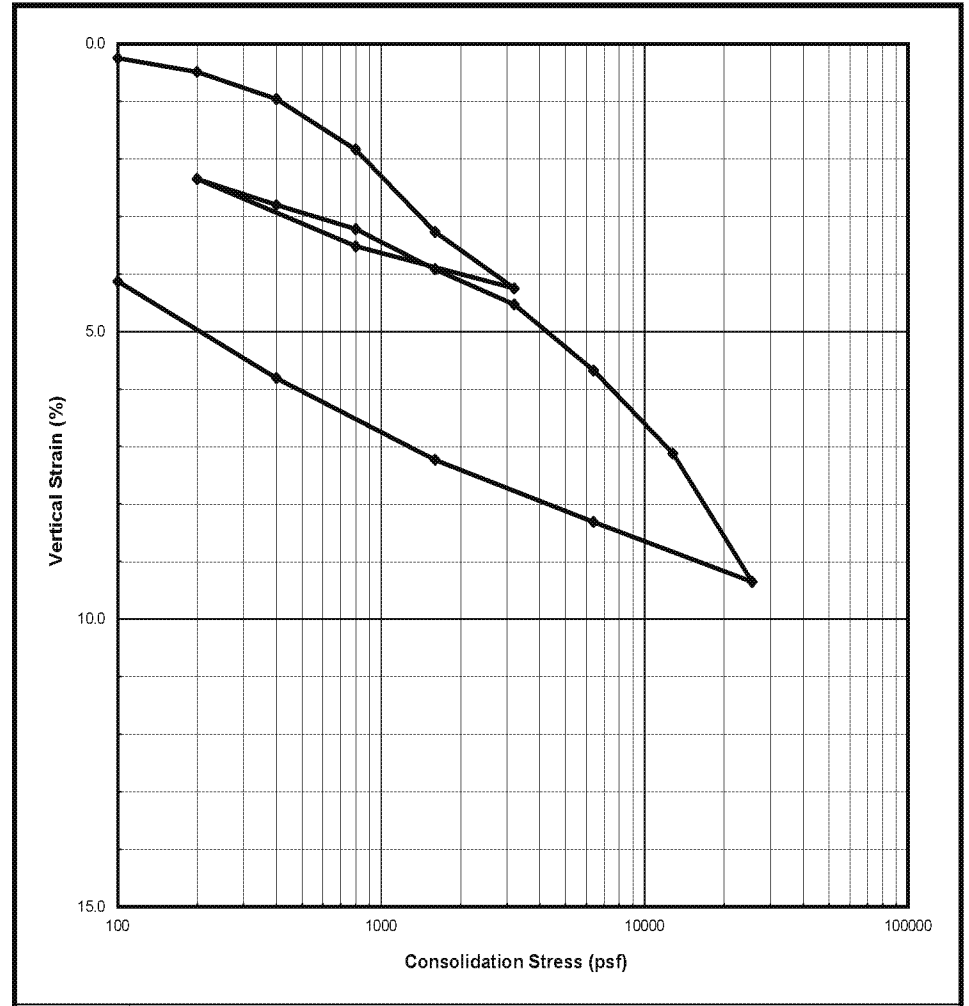
Description		Olive brown ML-CL with sand								
Boring No.	B-16	Liquid Limit	XXXXX %	Specific Gravity	2.70	assumed	Strain for Saturation	2.80 %		
Sample No.	5								Plasticity Index	XXXXX %
Depth (ft)	25.0								Fines Content	XXXXX %
Water Content (%)	Total Unit Weight (pcf)	Dry Unit Weight (pcf)	Saturation (%)	Void Ratio	Height (inches)	Diameter (inches)				
Initial 24.04	118.7	95.7	85.7	0.758	1.000	2.416				
Final 28.67	128.5	99.9	100.0	0.685	0.959

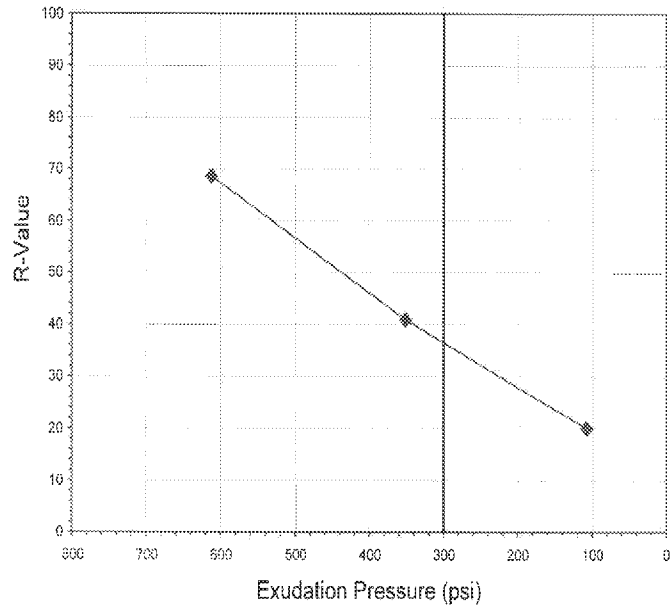
Test No.	Compaction Pressure (psi)	Density (pcf)	Moisture (%)	Expansion Pressure (psi)	Horizontal Pressure (psi) @ 160 psi	Sample Height (in)	Exudation Pressure (psi)	R-Value	R-Value Correction
1	150	123.4	11.6	0.00	112	2.45	107	20	20
2	250	125.5	10.2	0.00	78	2.45	352	41	41
3	350	127.8	8.9	0.27	41	2.48	612	69	69

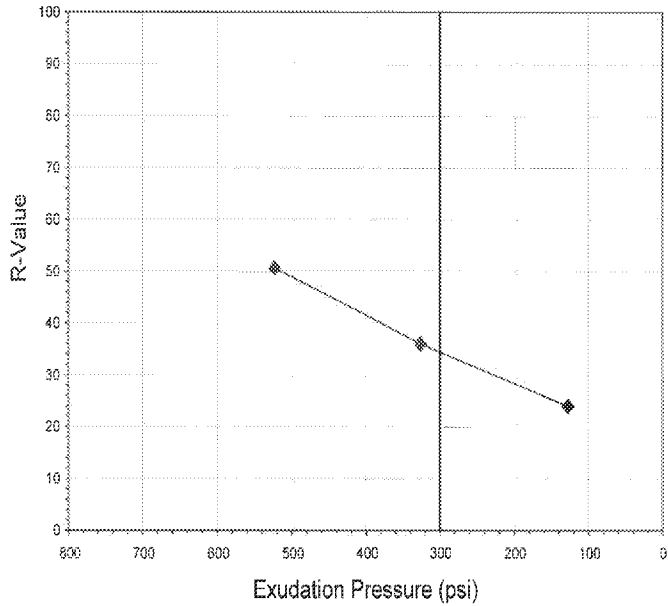
Test No.	Compaction Pressure (pcf)	Density (pcf)	Moisture (%)	Expansion Pressure (psi)	Horizontal Pressure (psi) @ 160 psi	Sample Height (in)	Exudation Pressure (psi)	R-Value	R-Value Correction
1	350	128.2	8.4	0.00	63	2.50	523	51	51
2	250	126.2	9.3	0.00	84	2.51	326	36	36
3	150	124.4	10.1	0.00	104	2.52	129	24	24

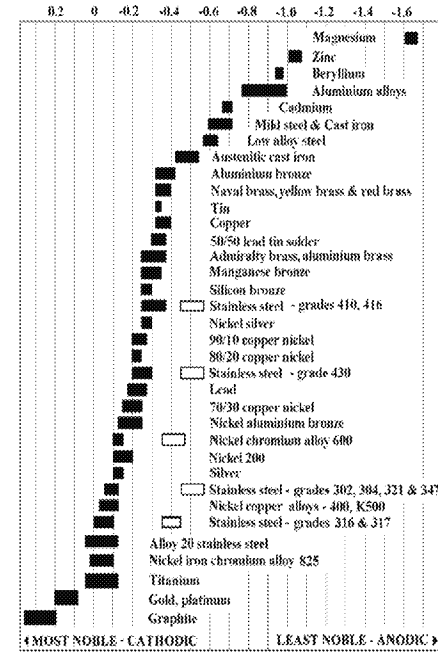
**Figure 3 - Galvanic series of metals relative to CSE half cell.**

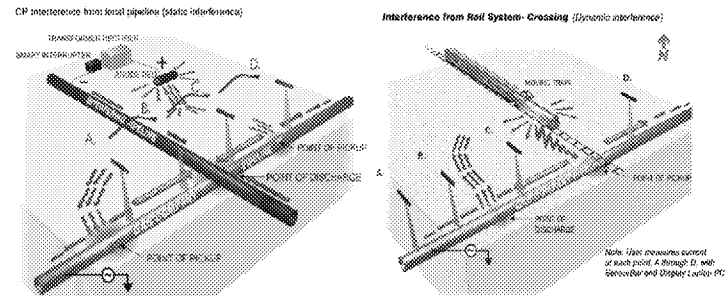
Figure 4 Examples of Stray Current<sup>11</sup>
