# REPORT

PRELIMINARY GEOTECHNICAL INVESTIGATION  
PROJECT CONDOR  
SE CORNER OF PRAIRIE AVENUE & W CENTURY BOULEVARD  
INGLEWOOD, CALIFORNIA

PREPARED FOR:  
Murphy's Bowl LLC  
10400 NE 4<sup>th</sup> Street, Suite 3000  
Bellevue, WA 98004

JULY 6, 2018

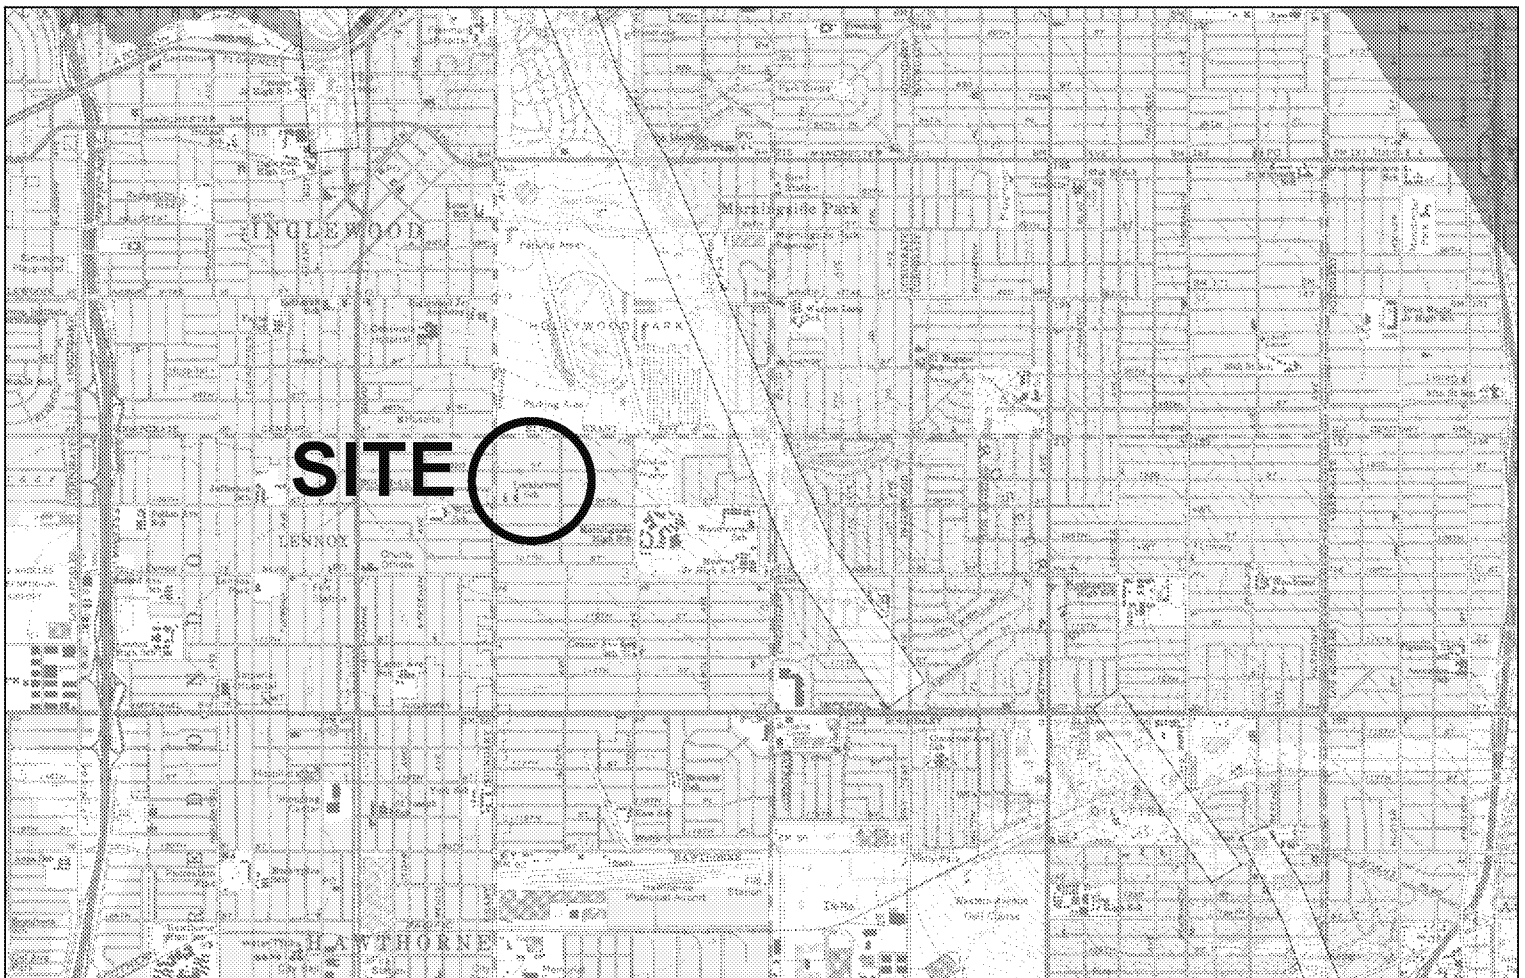
\*Source: CGS, Earthquake Zones of Required Investigation, Inglewood Quadrangle

Hazards associated with seismic-induced slope instability include landslides and mudflows. According to the Seismic Hazard Zones Map for the Inglewood Quadrangle as shown in Figure 5, the project site is not located within areas designated by the state geologist where previous occurrence of landslide movement or local topographic, geological, geotechnical and subsurface conditions indicating a potential for permanent ground displacement to the event that mitigation would be required. The Project site is located in a relatively flat, low-lying sediment-filled plain. The potential for slope stability hazards at the Project site is negligible.

No known active, sufficiently active, or well-defined faults traces have been recognized as crossing the Project site, and the CGS does not delineate any part of the site as being within an Earthquake Fault Zone. As shown in Figure 5, the closest Earthquake Fault Zones to the proposed site are the Potrero Fault, approximately 0.18 miles (0.3 kilometers) to the northeast and the Inglewood Fault located approximately 1.13 miles (1.84 kilometers) to the northwest. Because there are no known active faults on or adjacent to the site, the potential for surface fault rupture at the site is considered low.

According to the Seismic Hazard Zones Map, Figure 5, the project site is not located within the liquefaction zone area. According to the Seismic Hazard Zones Report No. 027 for the Inglewood Quadrangle published by the California Geological Survey, the historic high groundwater level is greater than 50 feet below existing ground surface.

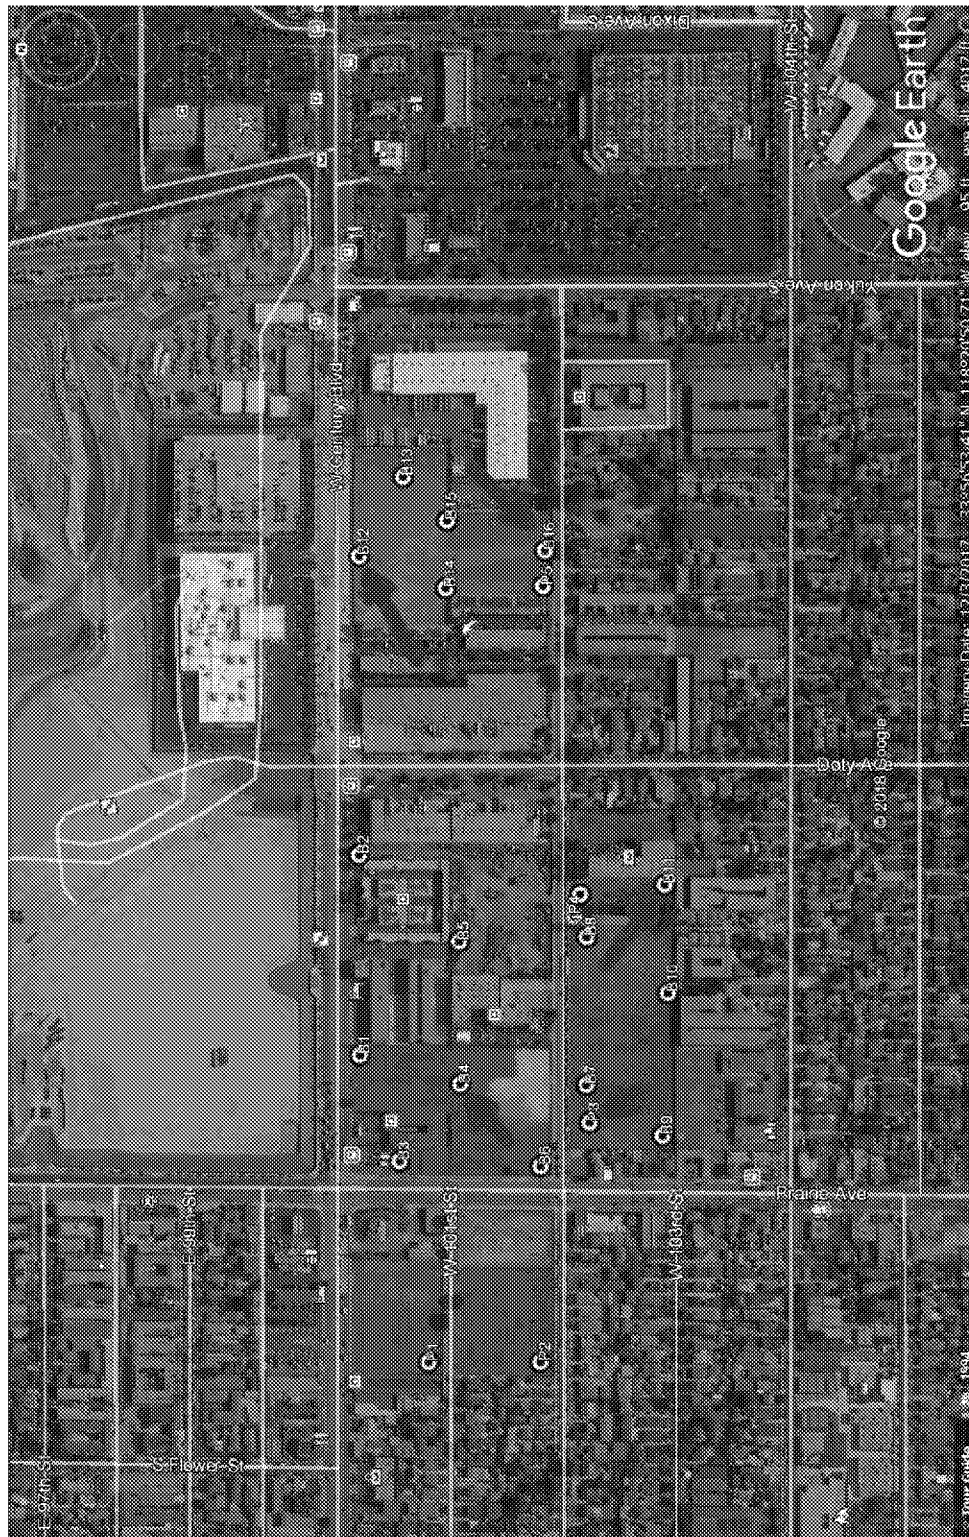
**Figure 1 Soil Sample Locations, 3700 W Century Blvd Inglewood, CA 90303**
